**GEOLOGY, LANDFORM AND SOILS  
STUDY  
ARROW ENERGY SURAT GAS PROJECT,  
SURAT BASIN, QUEENSLAND**

Report Date: 6 December 2011  
Project Ref: ENAUBRIS07040AC-  
9097\_GLS\_Rev4.docx

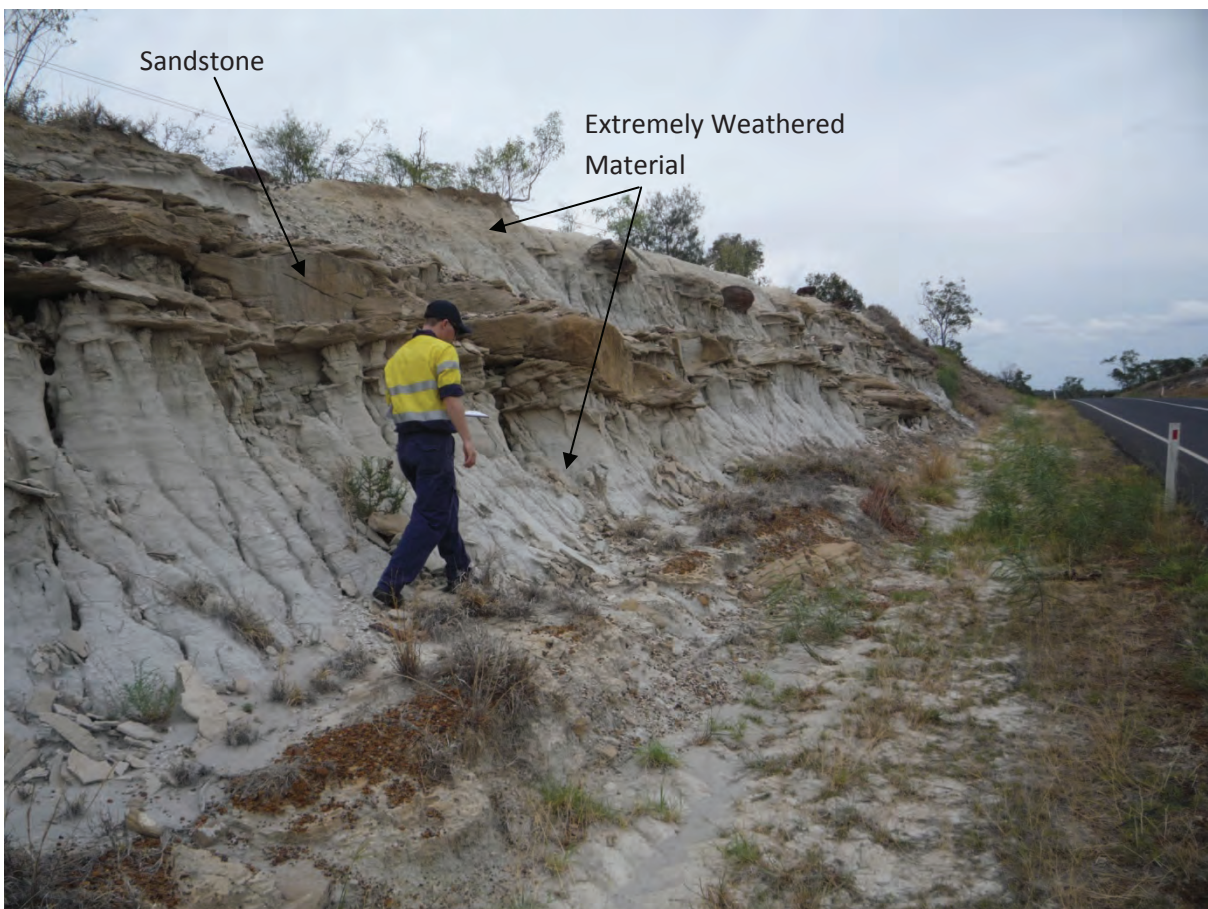
Figure 1: Road cutting, view to Northwest

Location ID	Feature/Exposure Type	Location Co-ordinates		
		Zone	Easting	Northing
1	Road Cutting	56	0200955	7101128

Description
Extremely weathered material comprising SAND, fine to medium grained, pale brown to pale grey
With
Interbedded SANDSTONE, fine to coarse grained, pale brown, assessed highly weathered and low strength to medium strength, cross bedded

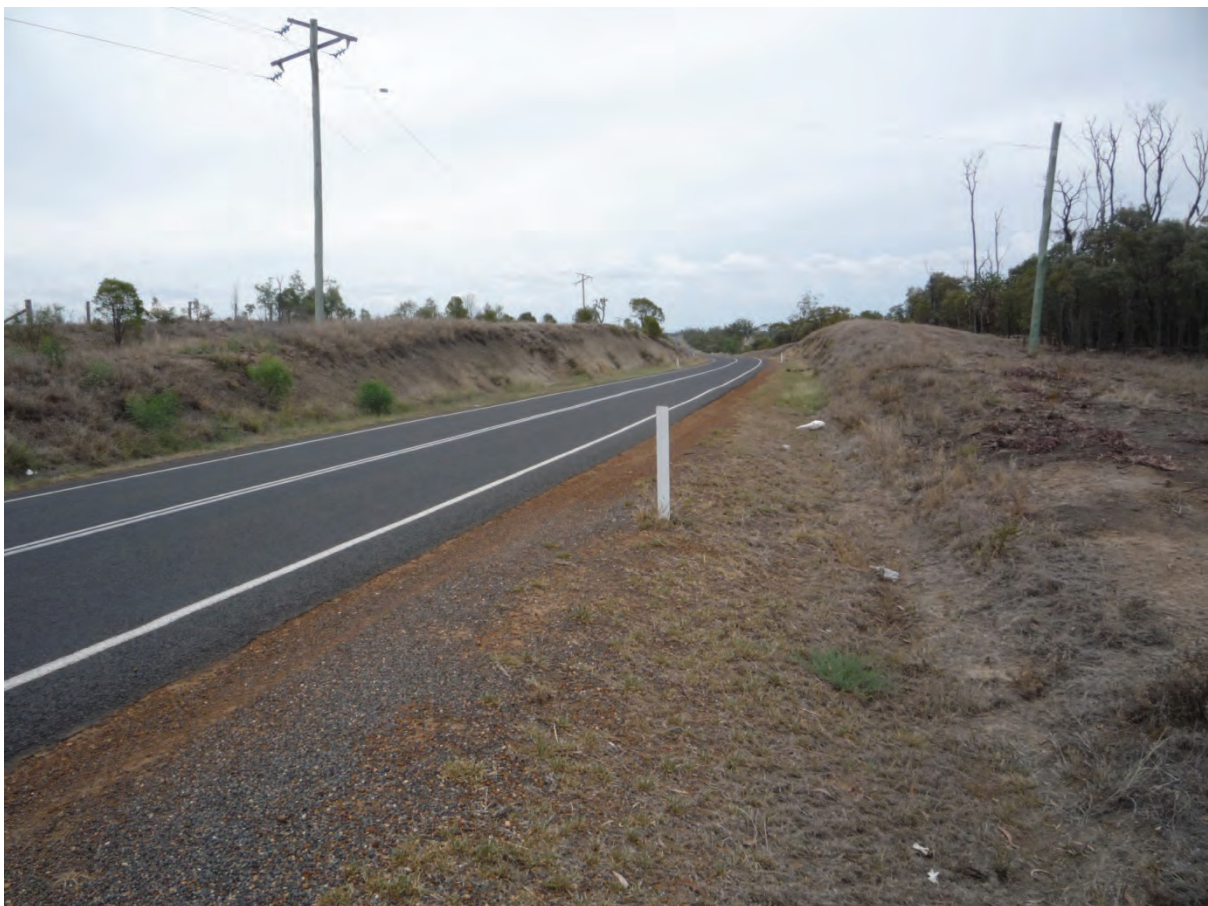
Figure 2: Road cutting, view to Northwest

Location ID	Feature/Exposure Type	Location Co-ordinates		
		Zone	Easting	Northing
2	Road Cutting	56	0201704	7099848

Description
Extremely weathered profile comprising clayey SAND, fine to medium grained, pale brown, low to medium plasticity clay  With  Interbedded SANDSTONE, medium to coarse grained, pale brown to pale orange with some black, assessed highly weathered and low strength, crossbedded

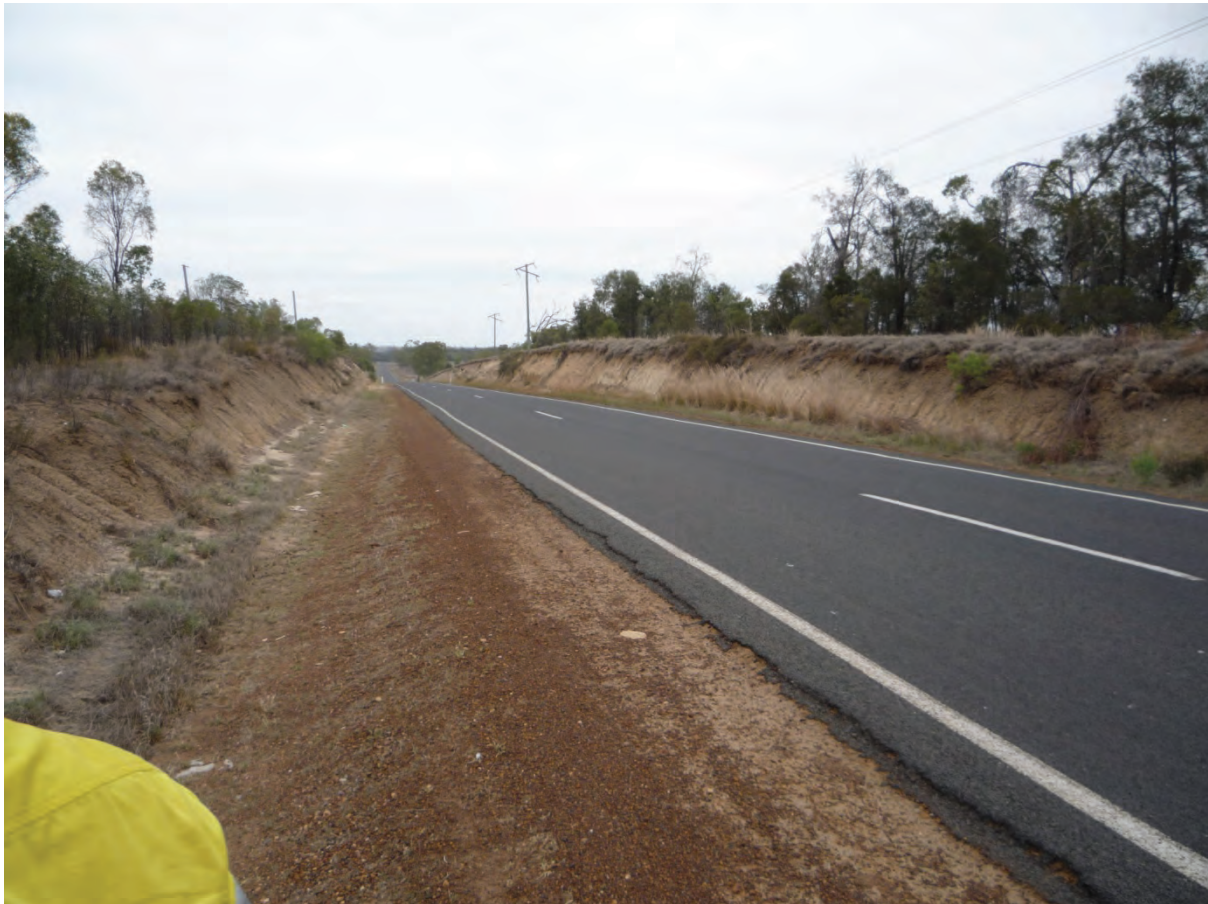
Figure 3: Road cutting, view to South

Description
Alluvial profile, comprising Cobbles, Gravels, Sands and clayey Sands

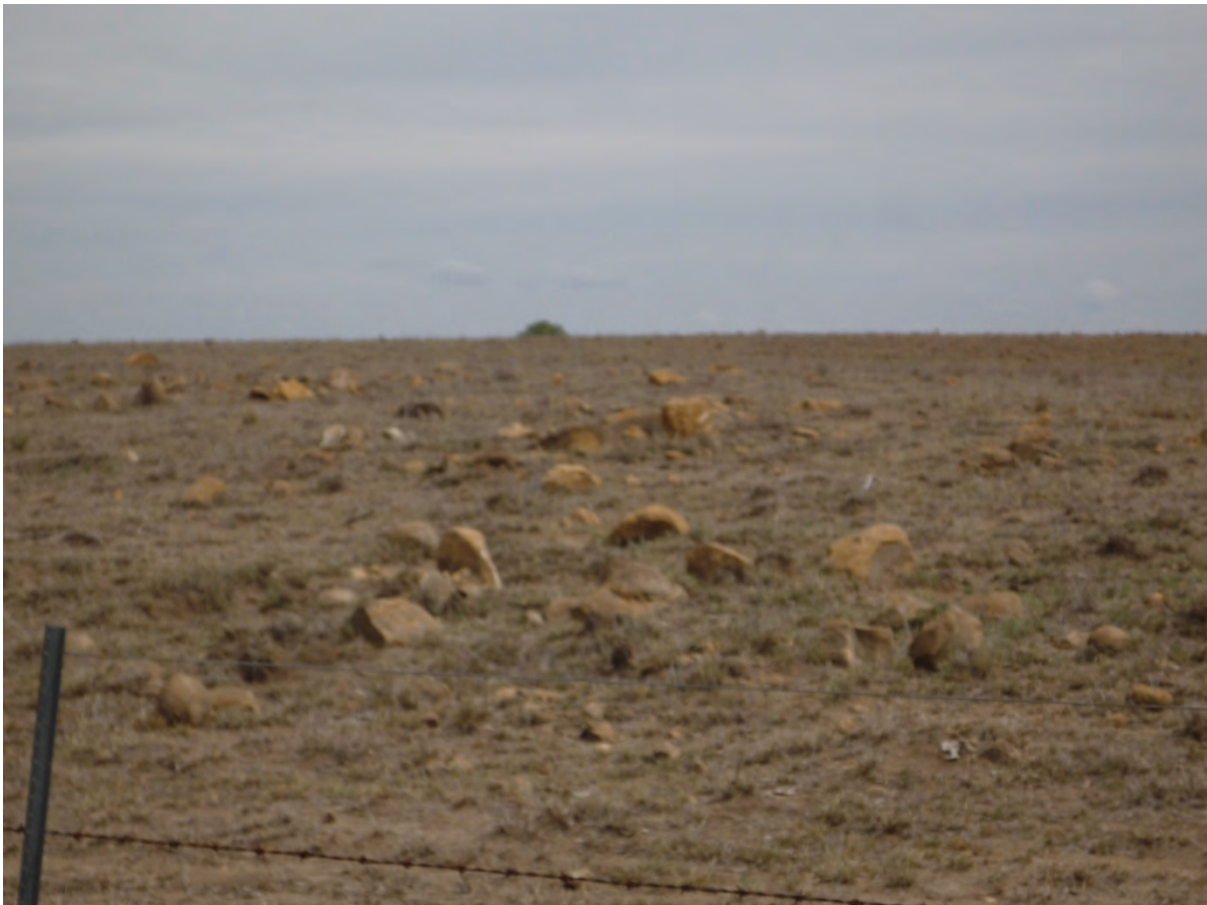
Figure 4: Rock outcrop, view to Southeast

Description
SANDSTONE, medium grained, pale brown to pale orange, some black, assessed moderately weathered and medium to high strength, some interbedded coarse grained sandstone horizons

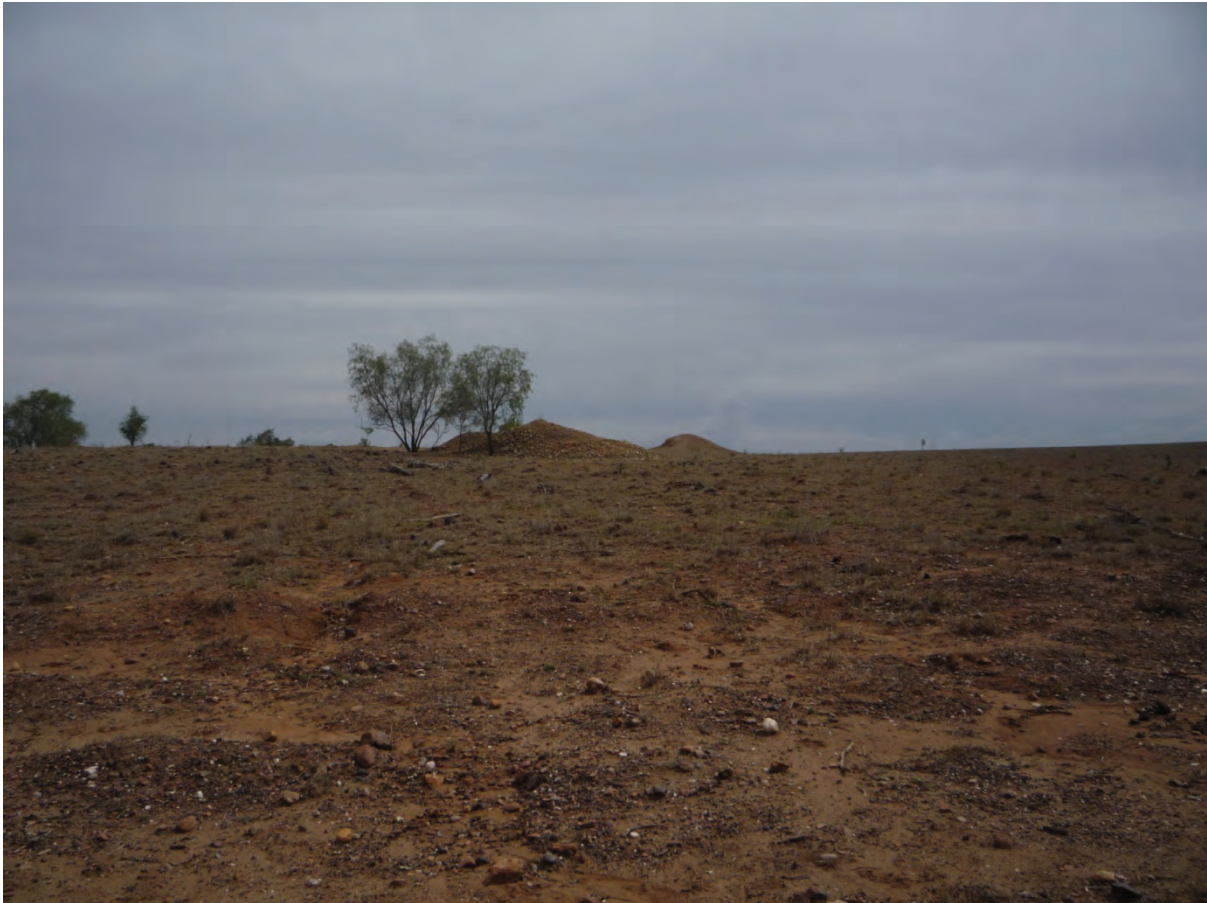
Figure 5: Borrow pit, view to South

Description
Gravels and Cobbles (weathered conglomerate)

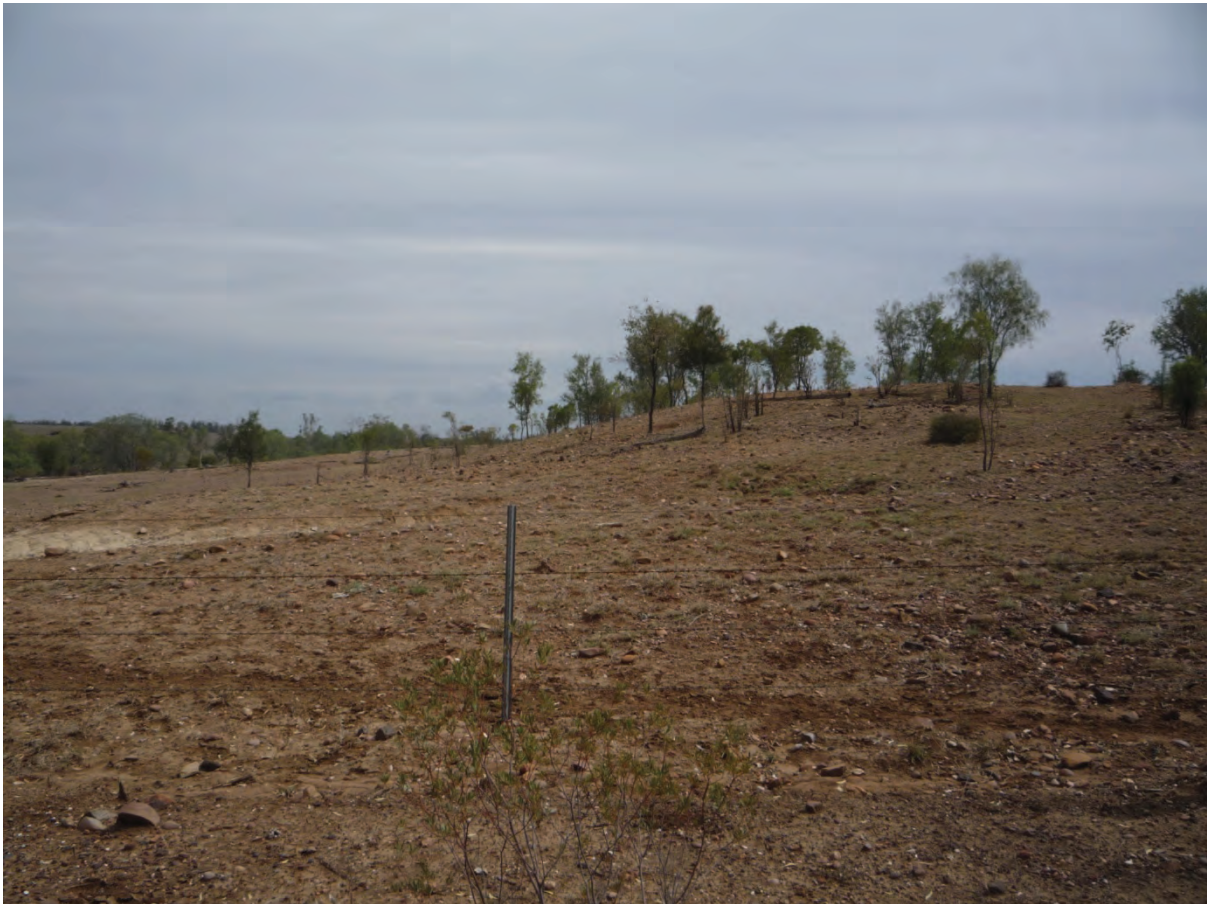
Figure 6: Landscape, view to South

Description
Gravels and Cobbles (weathered conglomerate)

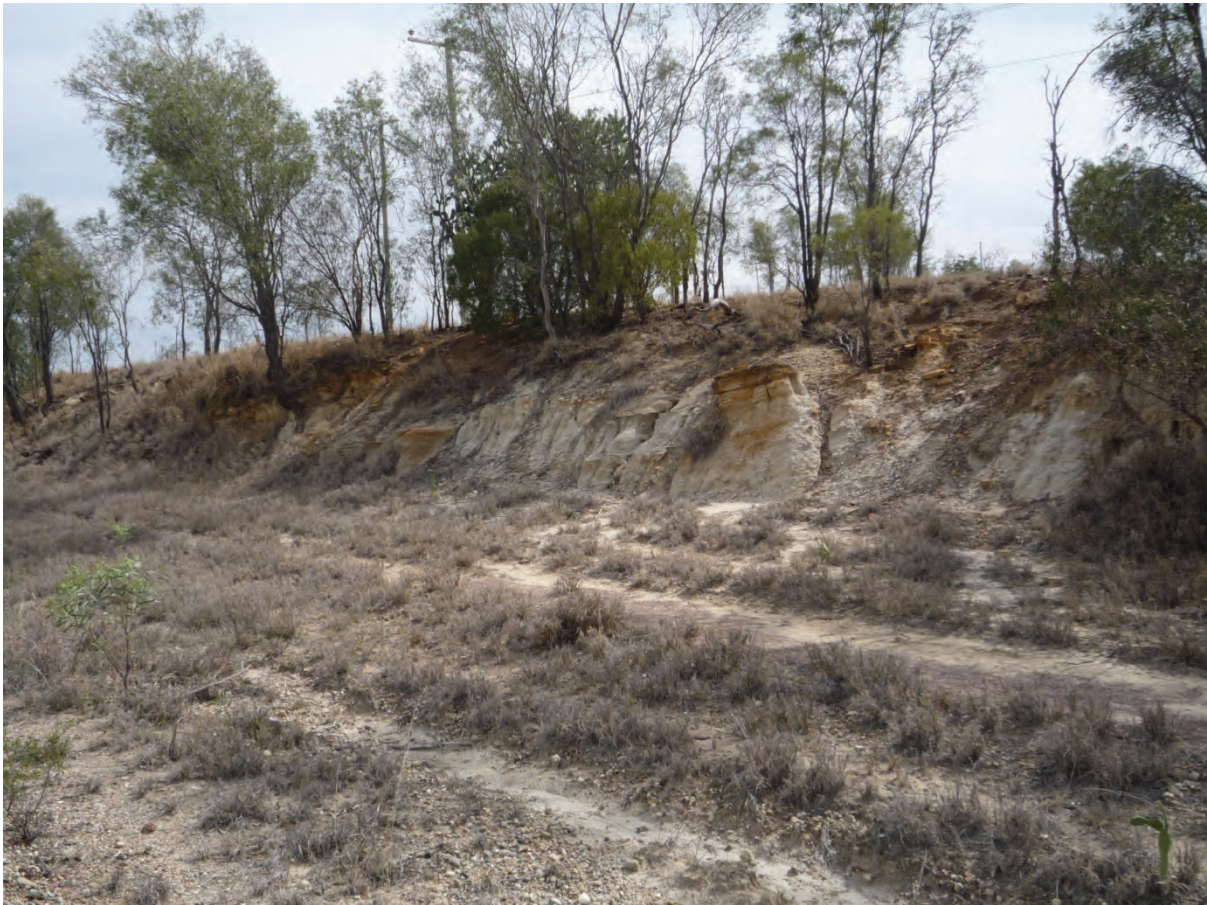
Figure 7: Road cutting, view to South

Description
SANDSTONE, medium to coarse grained, pale brown – pale orange – pale grey, assessed highly to moderately weathered and very low to medium strength, with some extremely weathered material and residual soil

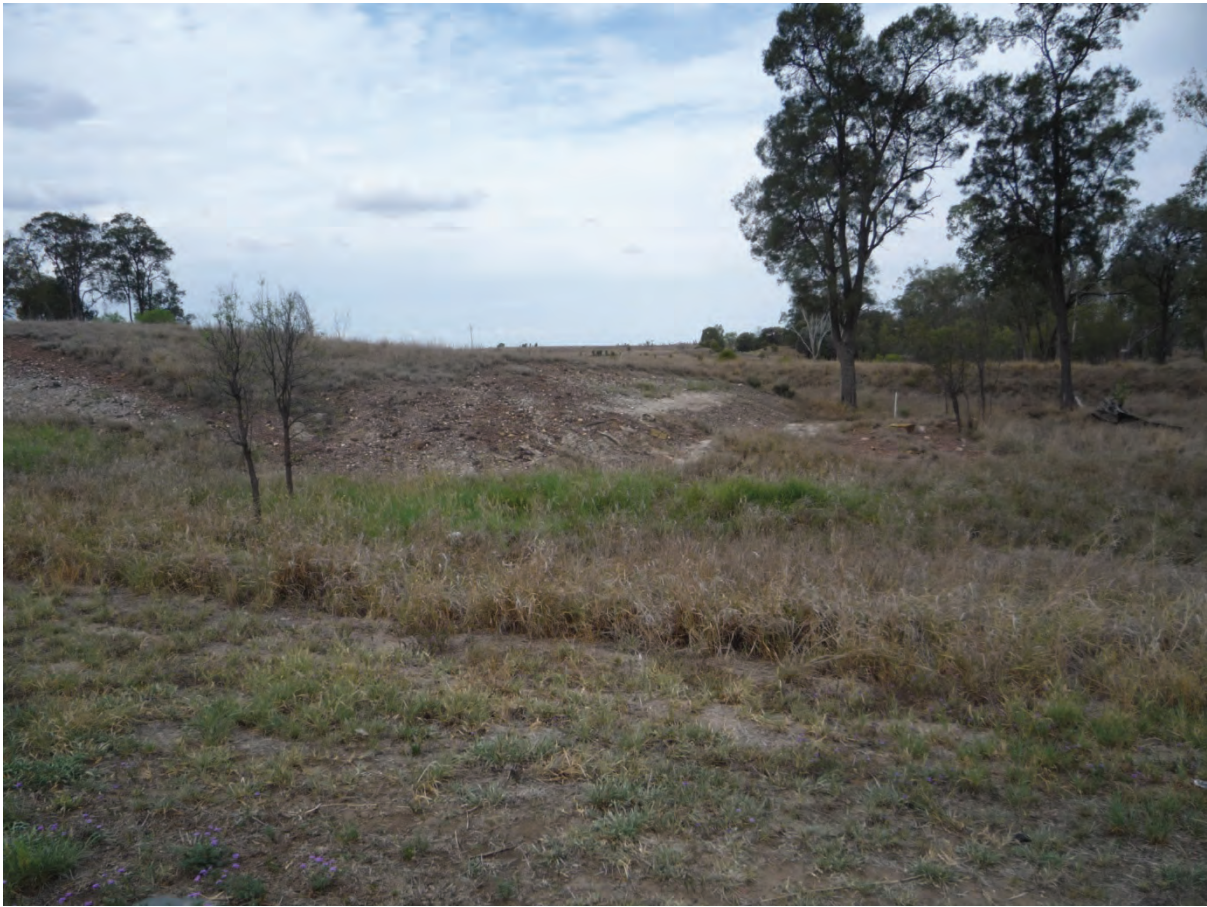
Figure 8: Borrow pit, view to North - Northeast

Description
Between old road and existing road, possible FILL material: Residual soil (weathered Conglomerate) comprising Cobbles/Gravels/ Sands and clayey Sands

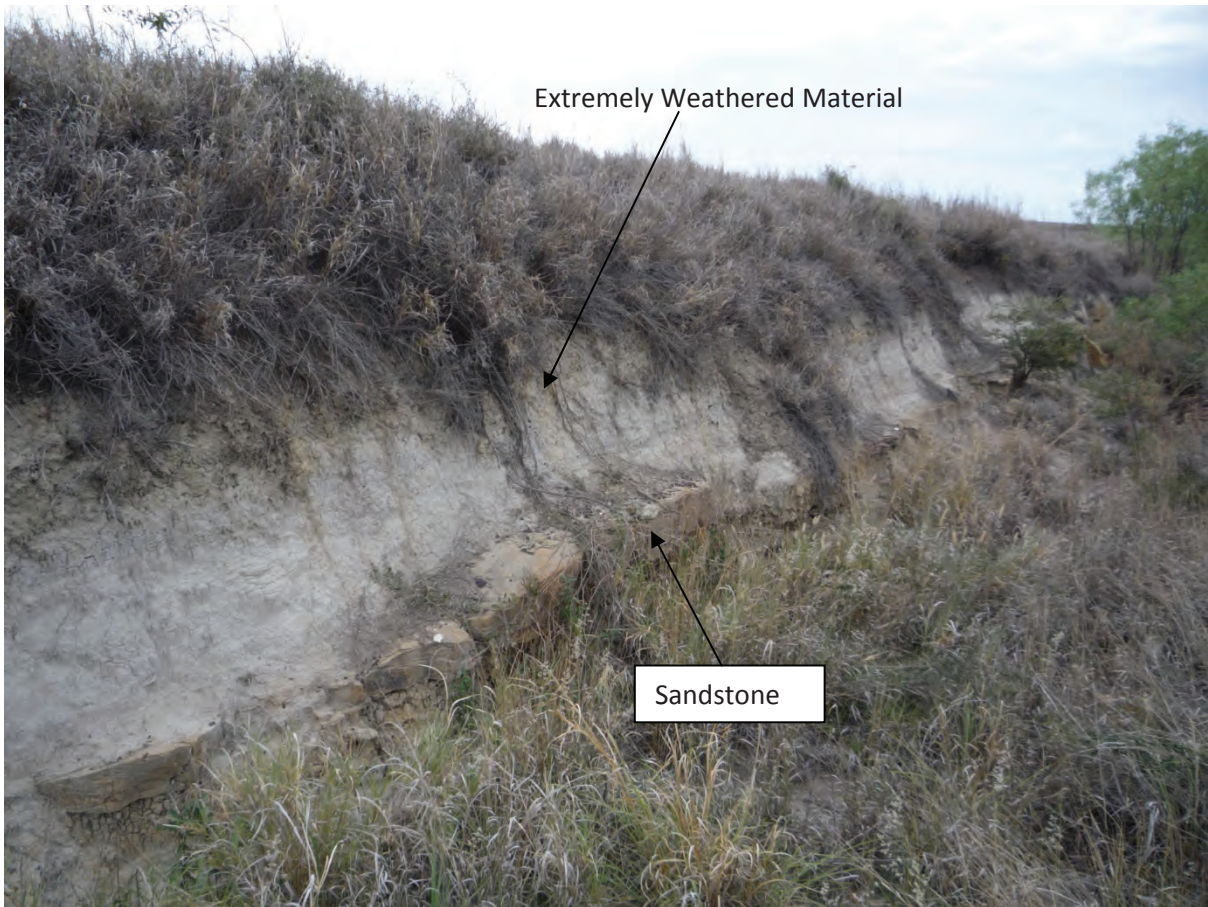
Figure 9: Road cutting, view to Northwest

Description
Extremely weathered material with interbedded SANDSTONE, pale orange and pale grey, assessed highly to moderately weathered and low to medium strength, crossbedded, some palaeo channels observed

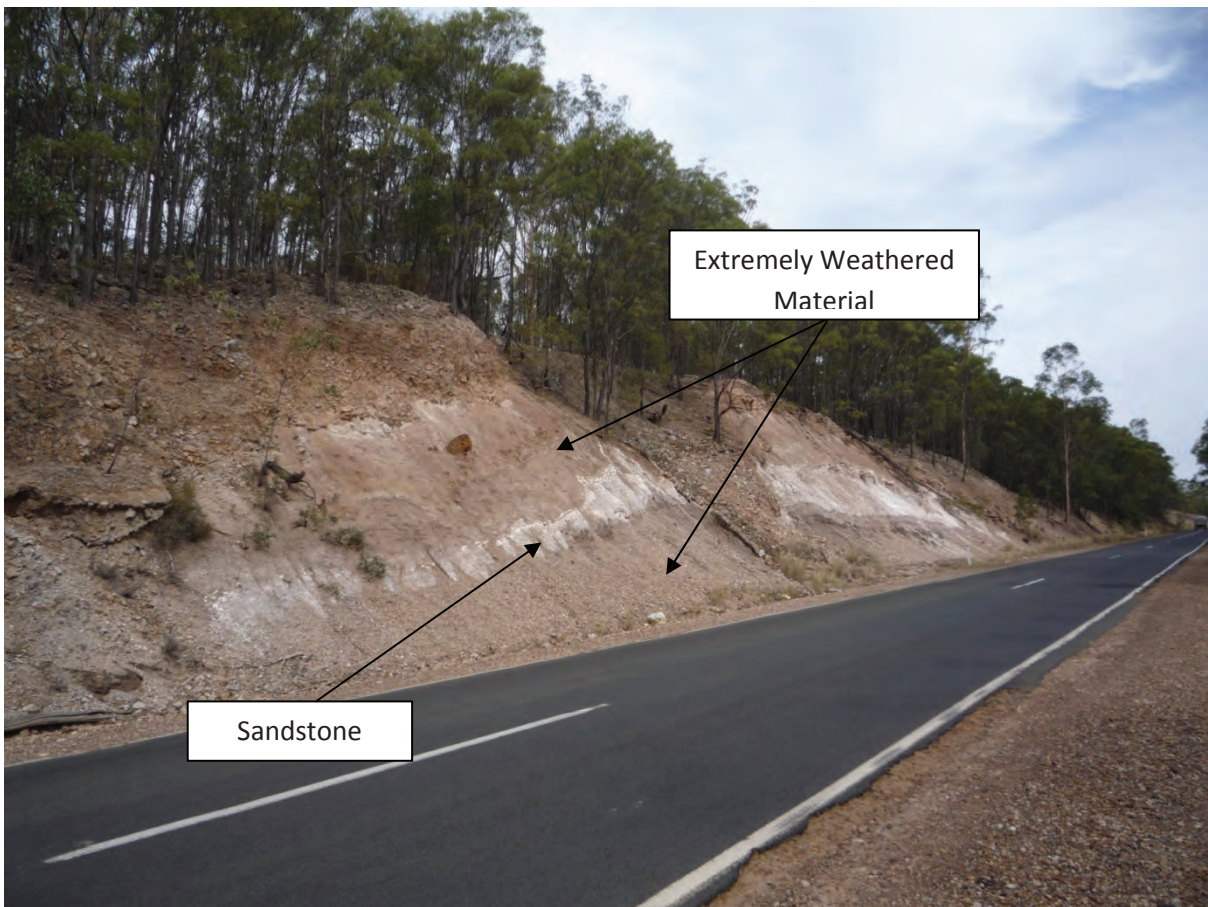
Figure 10: Road cutting, view to Northeast

Description
Extremely Weathered material comprising SAND, fine to medium grained, pale brown to pale grey, With Interbedded SANDSTONE, fine to coarse grained, pale brown, assessed highly weathered and low to medium strength, crossbedded

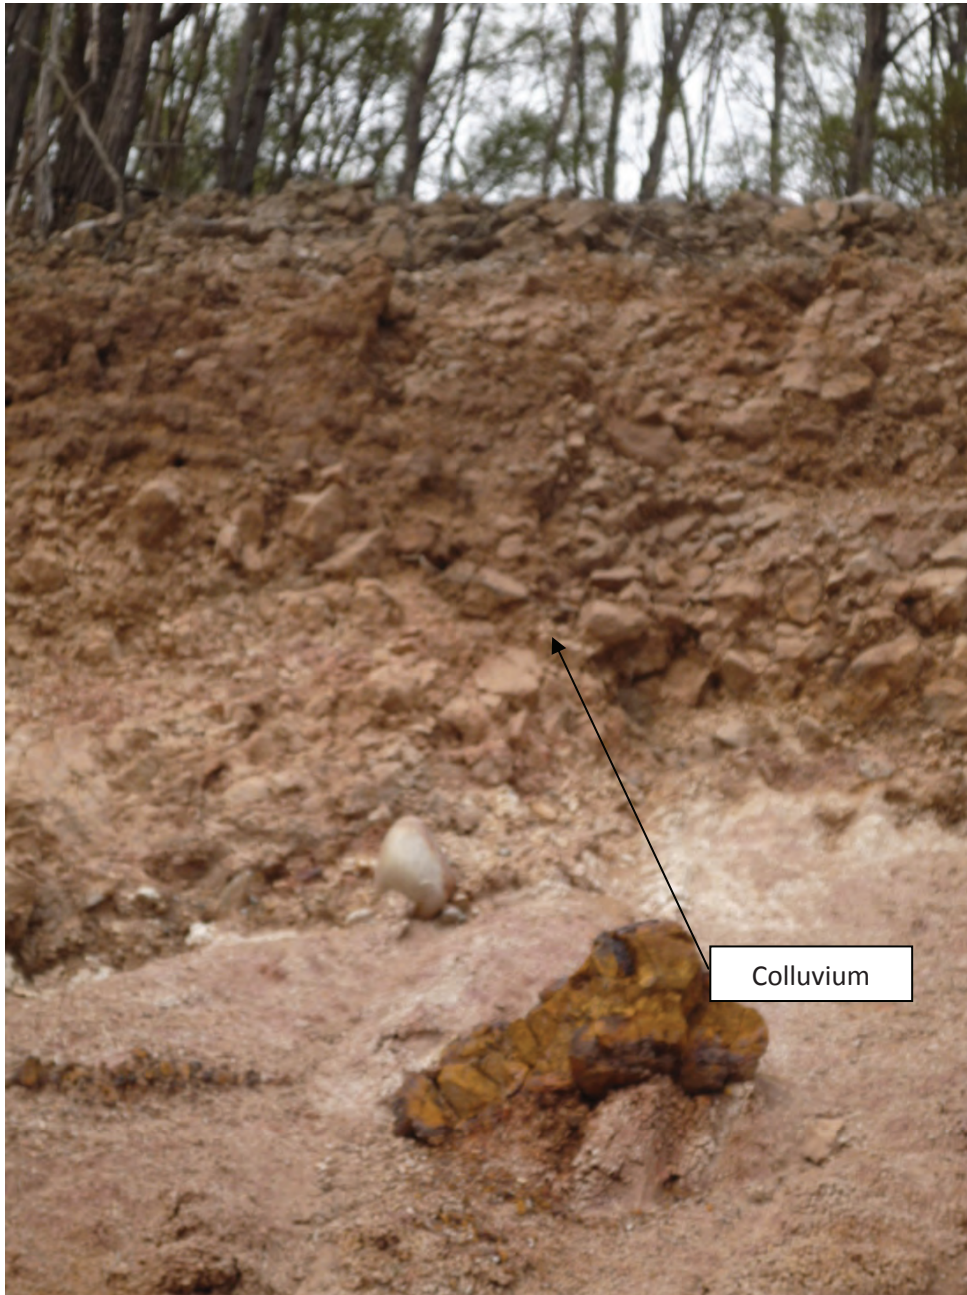
Figure 11: Colluvium in road cutting, view to North - Northeast

Description
Colluvium

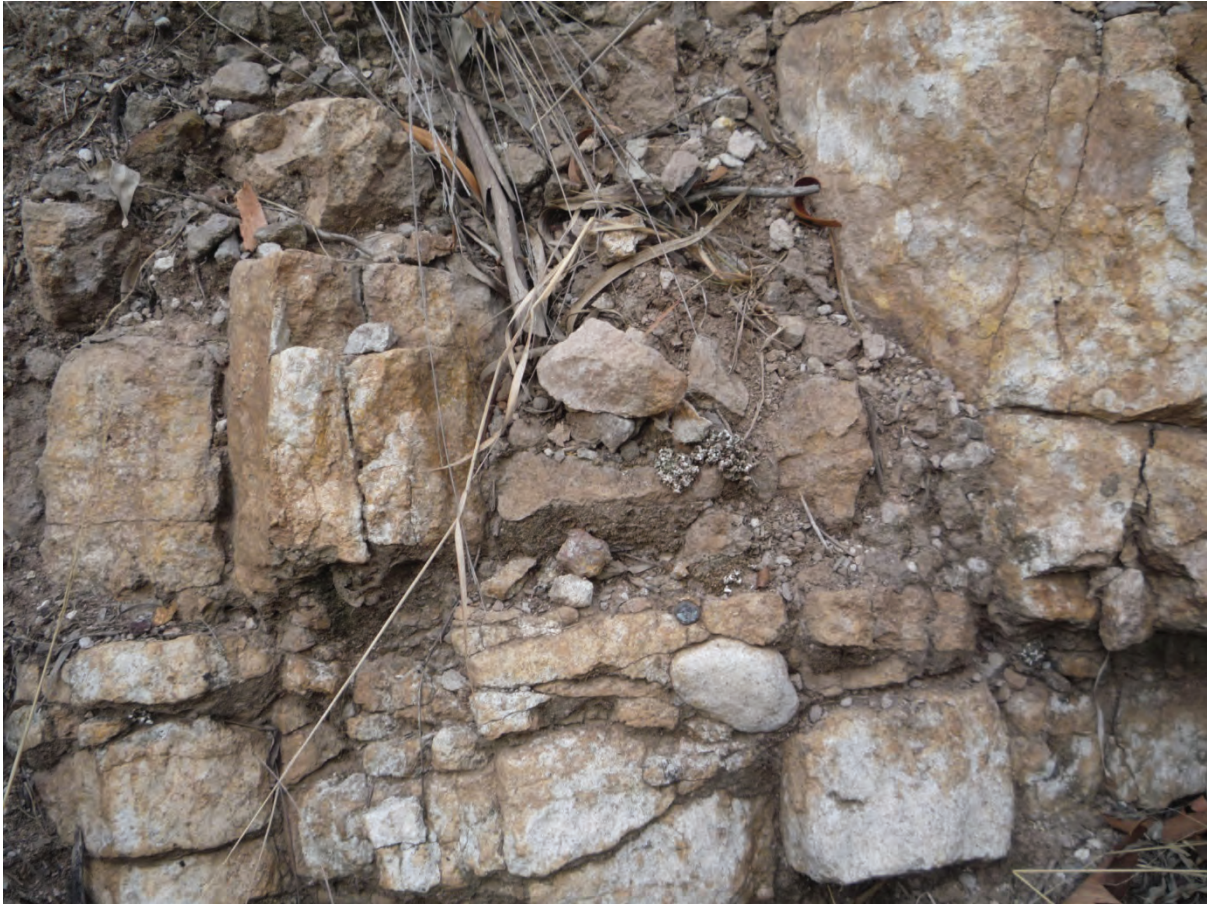
Description
Conglomerate, fine to coarse gravel and cobble clasts in medium to coarse grained sand matrix, pale brown – pale grey – white

Figure 12: Conglomerate in road cutting, view to East

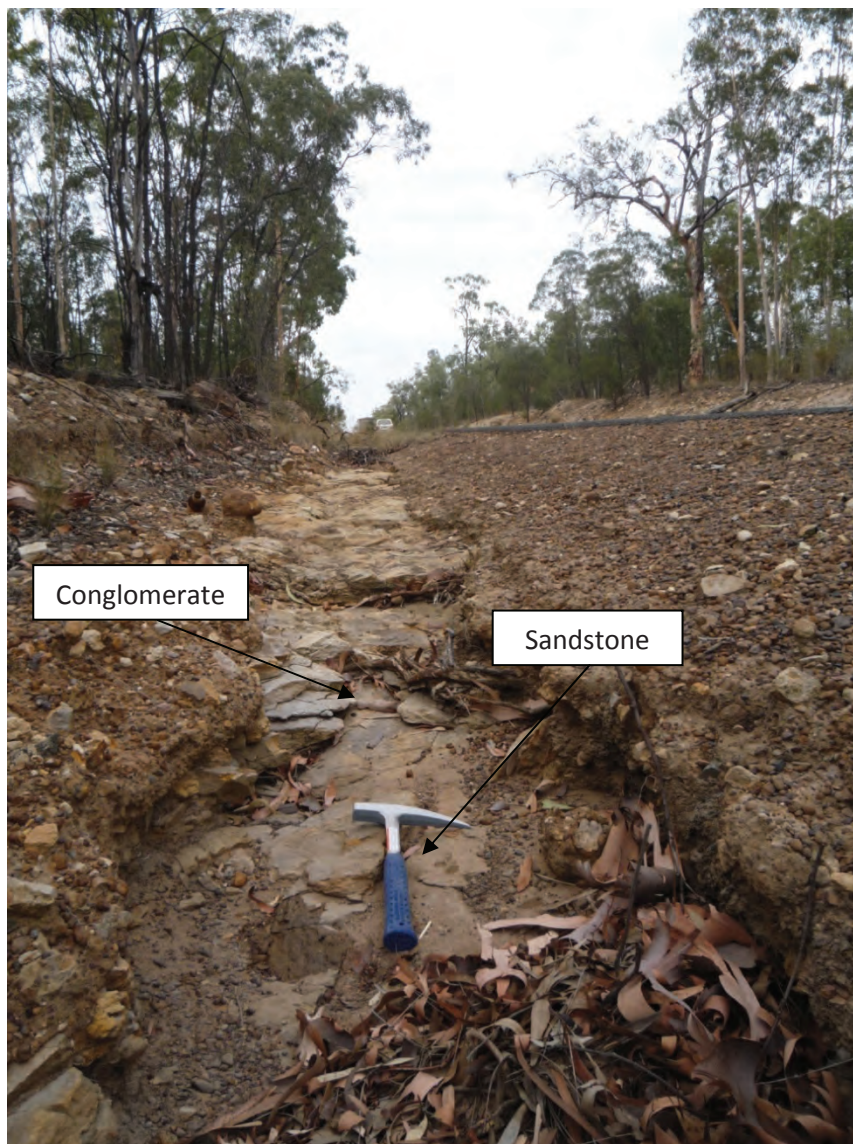
Figure 13: Road cutting and road drain, view to North – Northwest

Description
<p>SANDSTONE, medium to coarse grained, pale brown – pale grey – white, assessed moderately weathered and medium to high strength</p> <p>With</p> <p>CONGLOMERATE, fine to coarse gravel clasts in medium to coarse grained sand matrix, pale brown – pale grey - white</p>

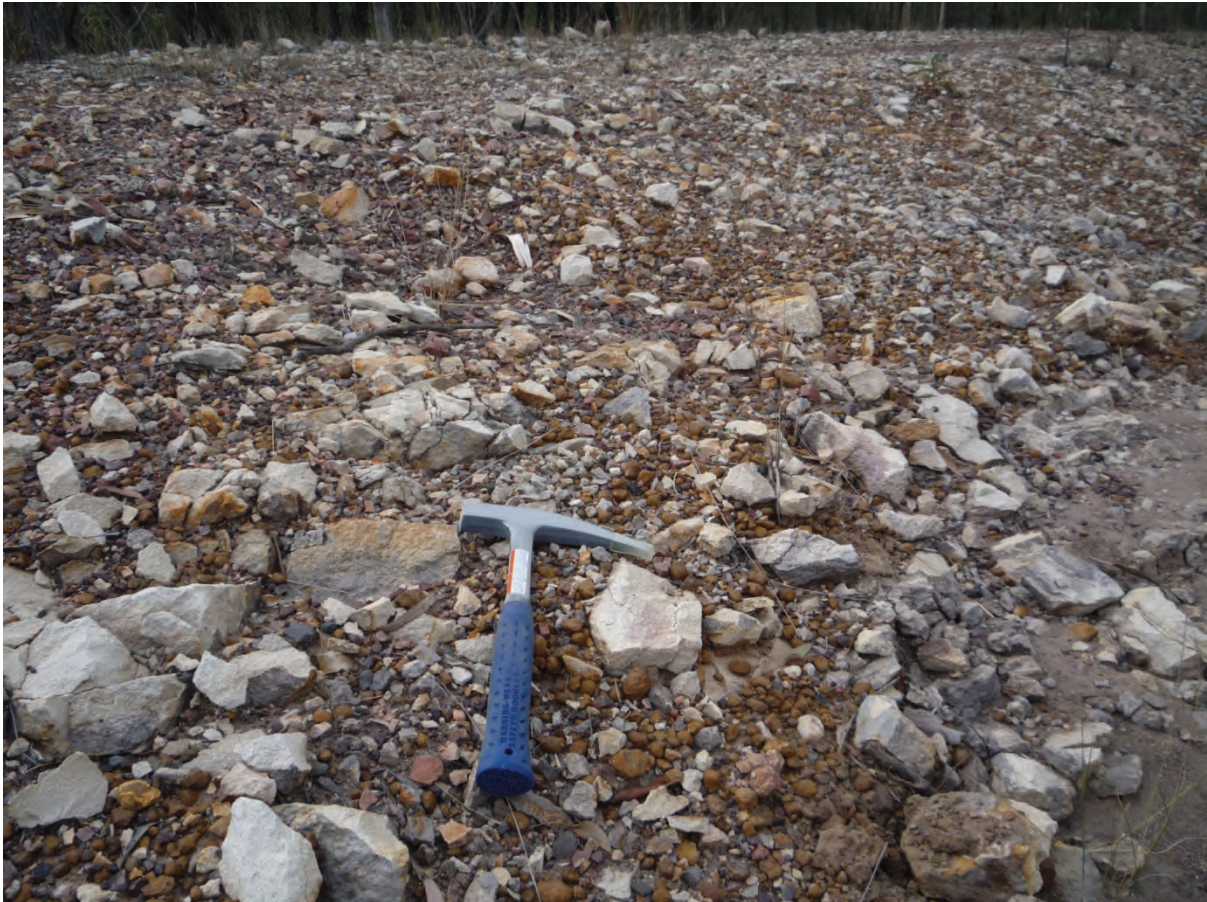
Figure 14: Road cutting, view to North West

Description
SANDSTONE, medium to coarse grained, pale brown – pale grey – white, assessed moderately weathered and medium to high strength

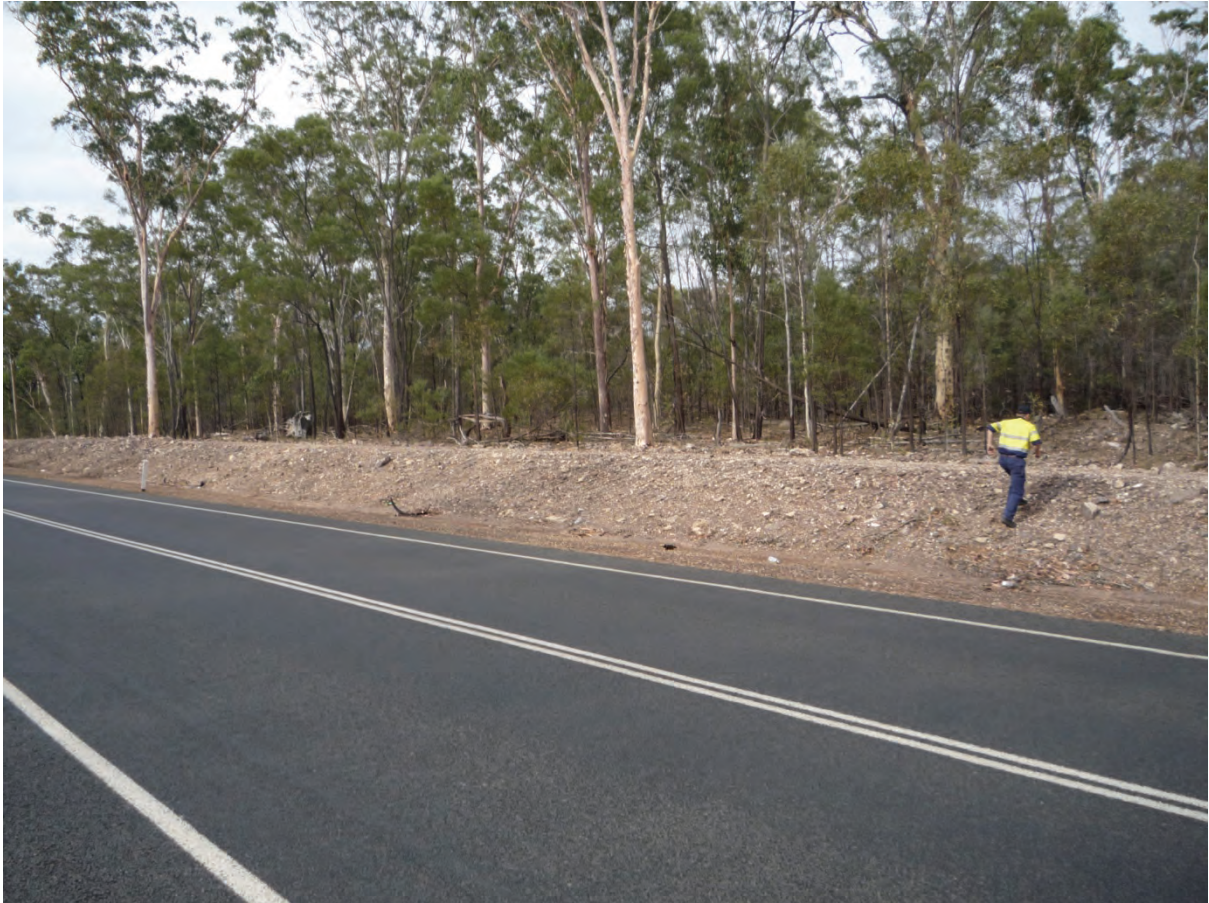
Figure 15: Road cutting, view to North

Description
SANDSTONE, medium to coarse grained, pale brown – pale grey – white, assessed moderately weathered and medium to high strength, defects < 200mm, joints, graded bedding, some cross bedding

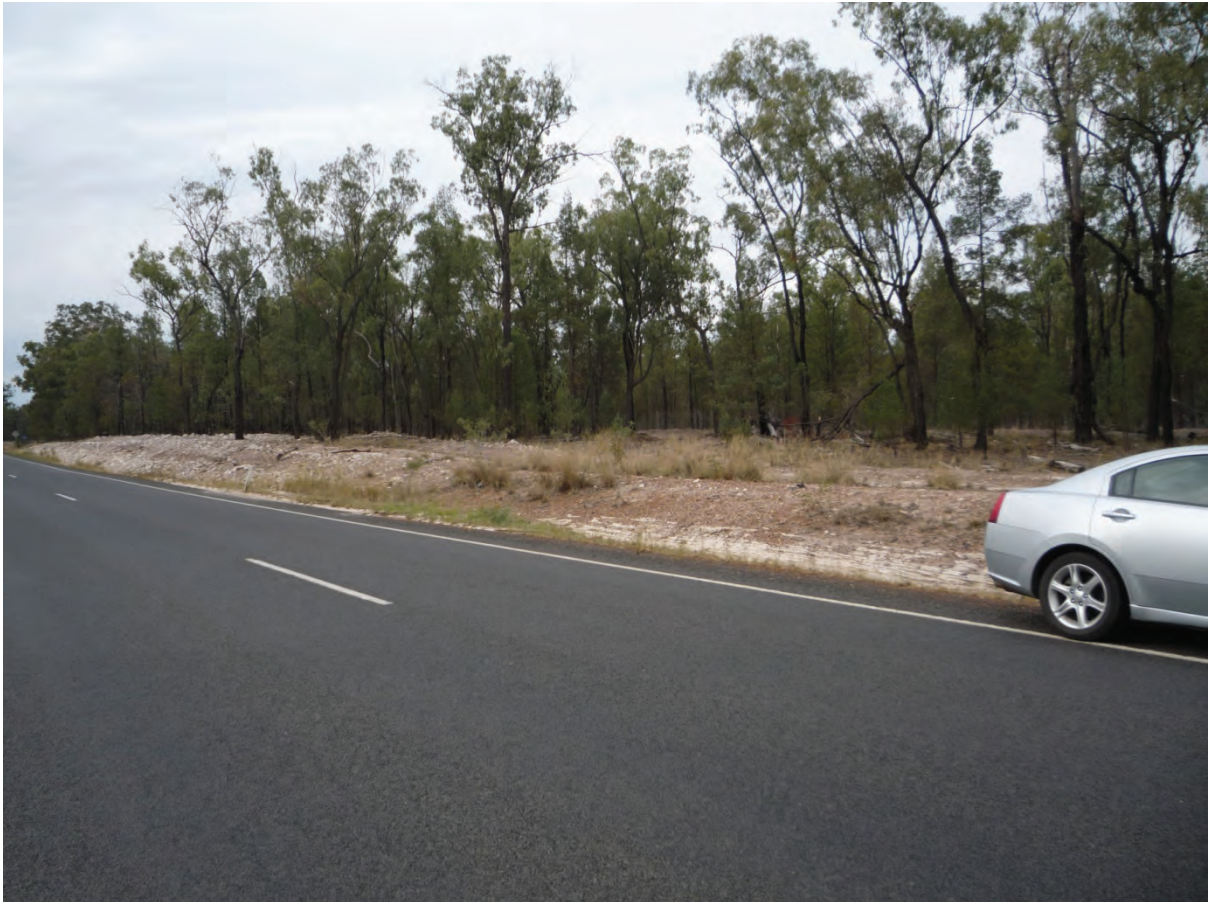
Figure 16: Road cutting, view to North

Description
SANDSTONE, medium to coarse grained, pale brown – pale grey – white, assessed moderately weathered, medium to high strength, defects < 200mm, joints, graded bedding, some cross bedding

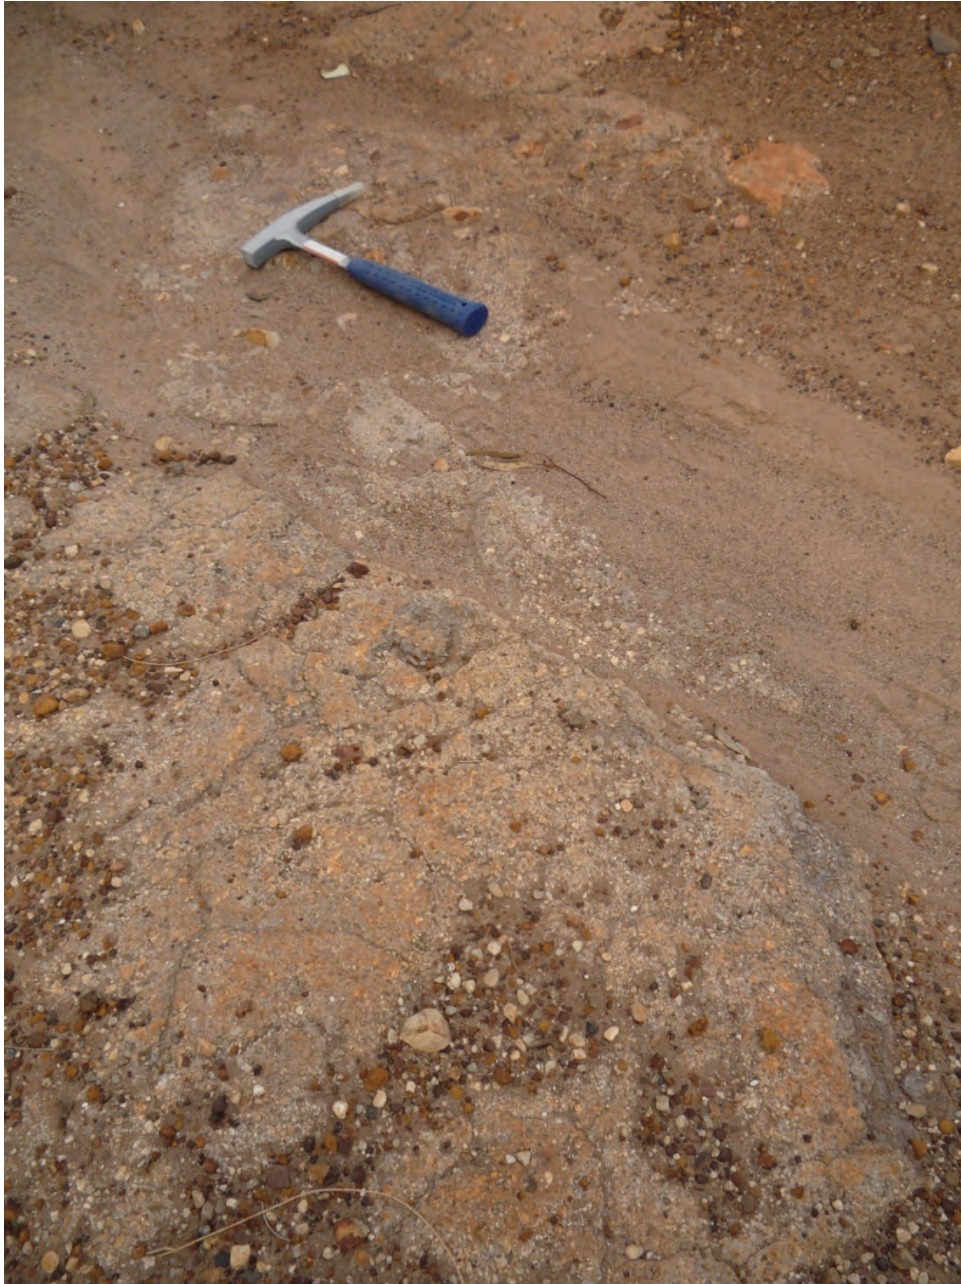
Figure 17: Road drain, view to South

Description
CONGLOMERATE, gravel and cobble clasts in medium to coarse grained sand matrix, pale grey and white with some orange ironstaining, assessed highly to moderately weathered and medium strength

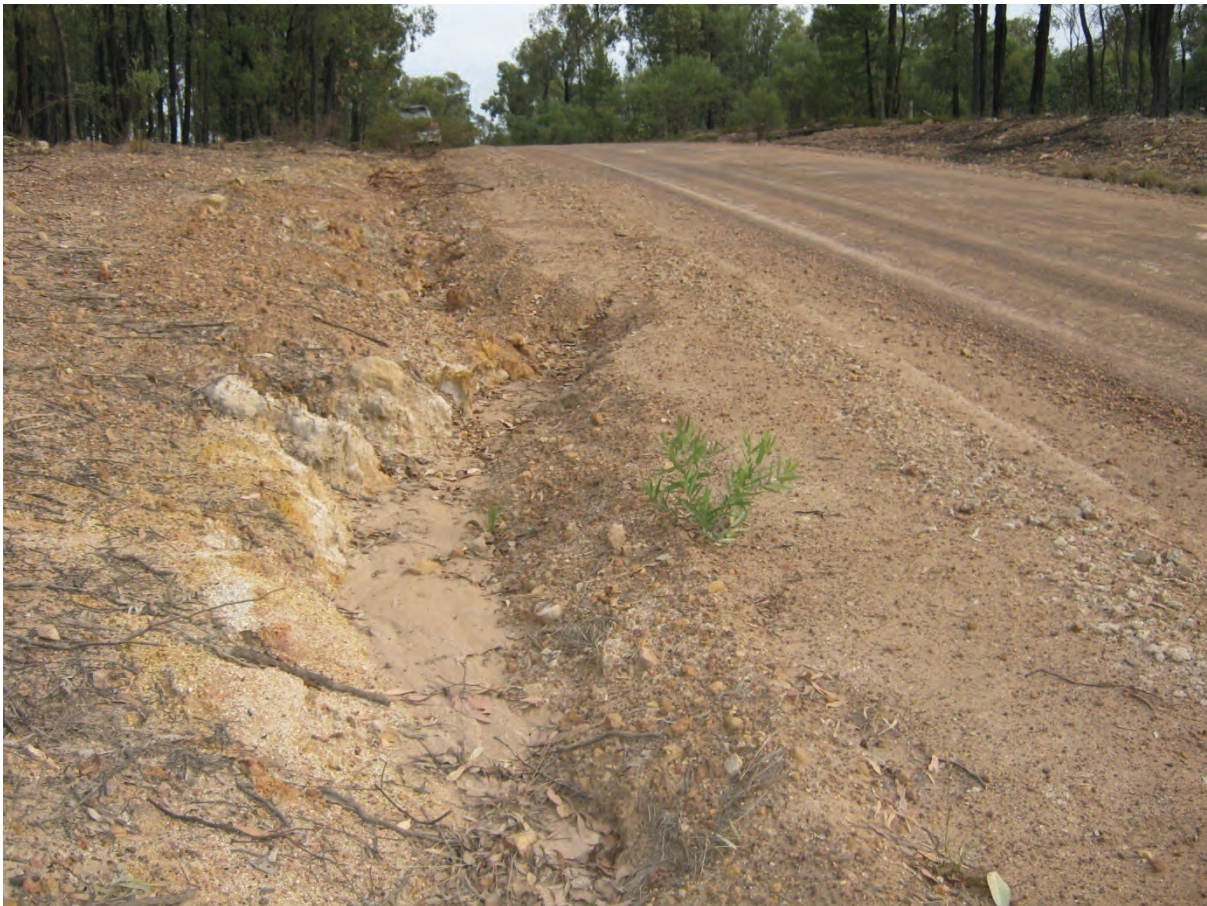
Figure 18: Road cutting, view to North – Northwest

Description
<p>Gravelly SAND, fine to coarse grained, pale brown – pale orange – pale grey – white, with ironstaining, fine to coarse grained gravel, some low plasticity clay</p> <p>With</p> <p>Interbedded SANDSTONE, medium to coarse grained, pale brown, some pale orange ironstaining, assessed highly weathered, very low to medium strength</p> <p>And</p> <p>CONGLOMERATE, fine to coarse gravel clasts and some cobbles in fine to coarse grained sand matrix, pale brown – pale orange ironstaining – pale grey, assessed highly weathered and very low to medium strength</p> <p>Defects in SANDSTONE are &lt;100mm; at least 3 sets of joints</p>

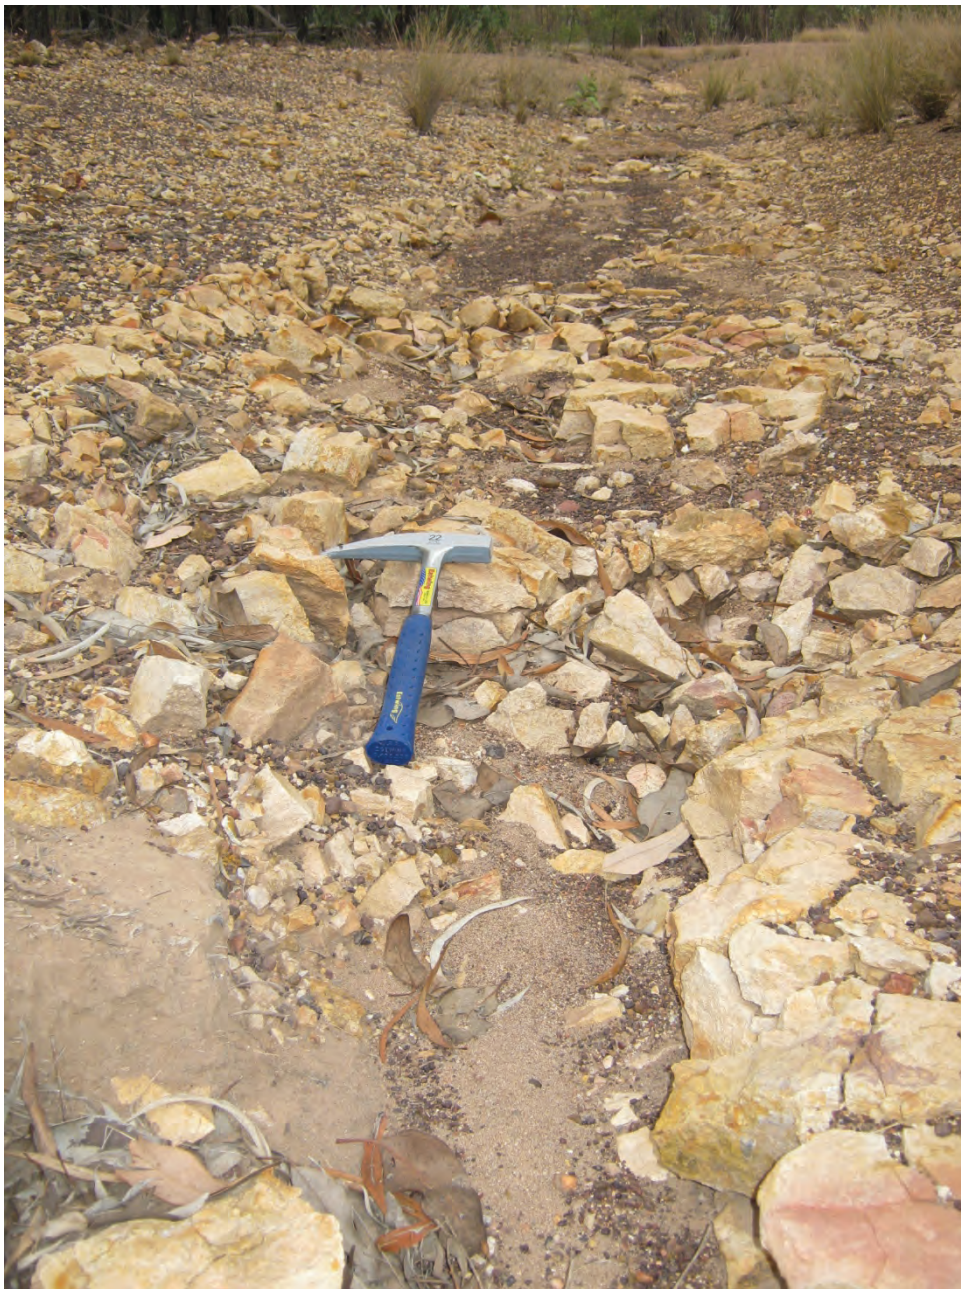
Figure 20: Road drain, view to Southwest

Description
SANDSTONE, medium to coarse grained with some fine grained gravel sized clasts, pale brown to pale grey, some ironstaining, assessed highly to moderately weathered and low to medium strength
