**GEOLOGY, LANDFORM AND SOILS  
STUDY  
ARROW ENERGY SURAT GAS PROJECT,  
SURAT BASIN, QUEENSLAND**

Report Date: 6 December 2011  
Project Ref: ENAUBRIS07040AC-  
9097\_GLS\_Rev4.docx

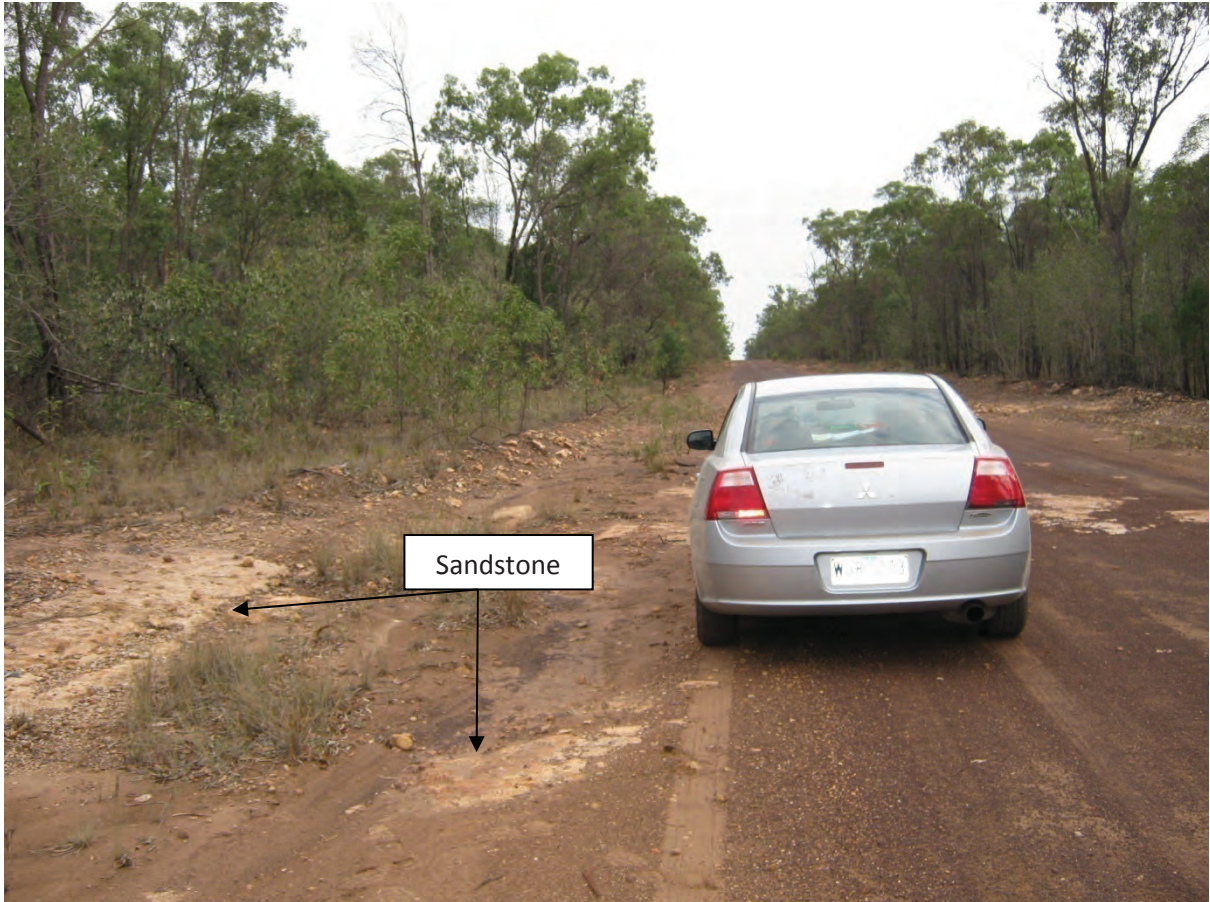
Figure 21: Road drain, view to North

Description
SANDSTONE, medium to coarse grained with some fine grained gravel sized clasts, pale brown to pale grey, some ironstaining, assessed highly to moderately weathered and low to medium strength

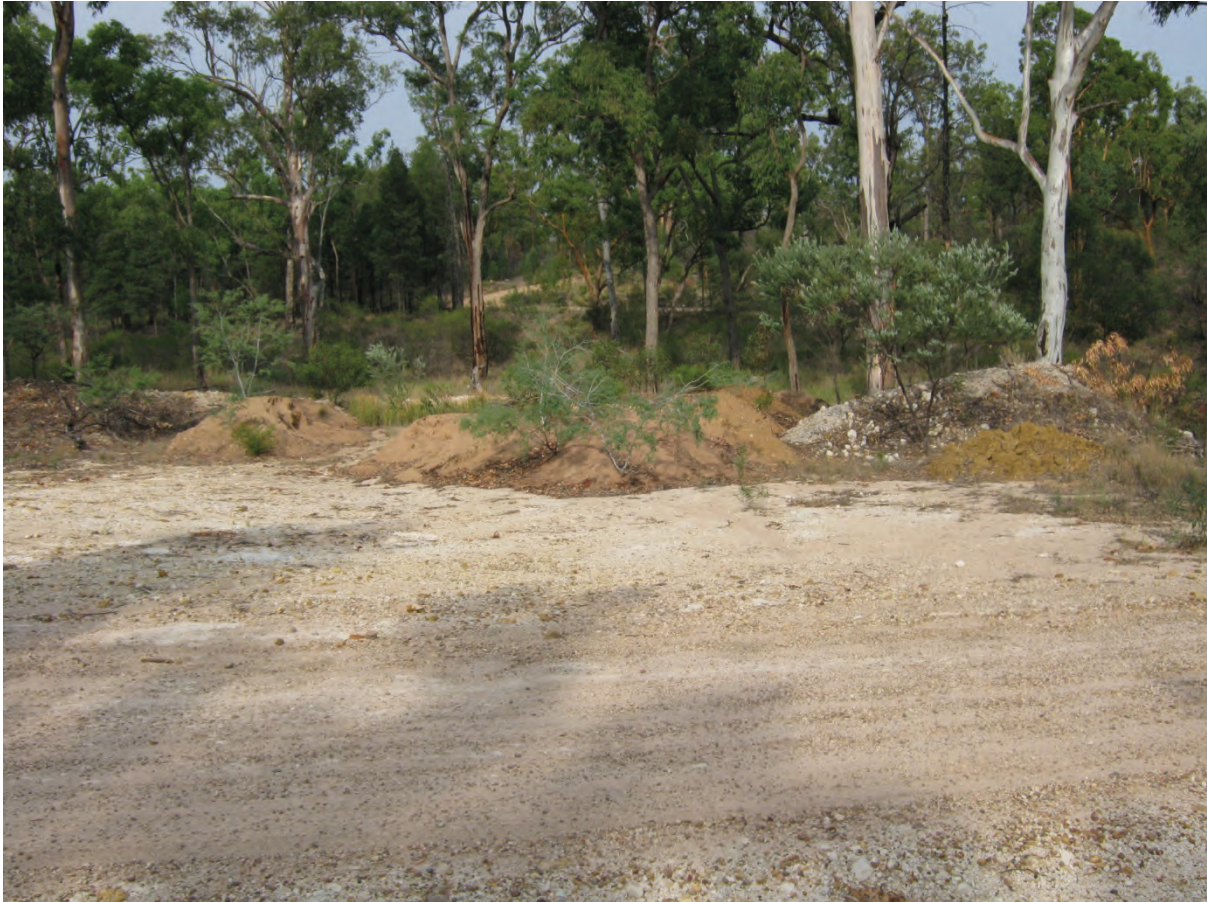
Figure 22: Borrow pit, view to West

Description
CONGLOMERATE, fine to medium gravel clasts in fine to medium grained sand matrix, pale grey and white with some ironstaining, assessed moderately weathered and medium to high strength, some honeycomb weathering

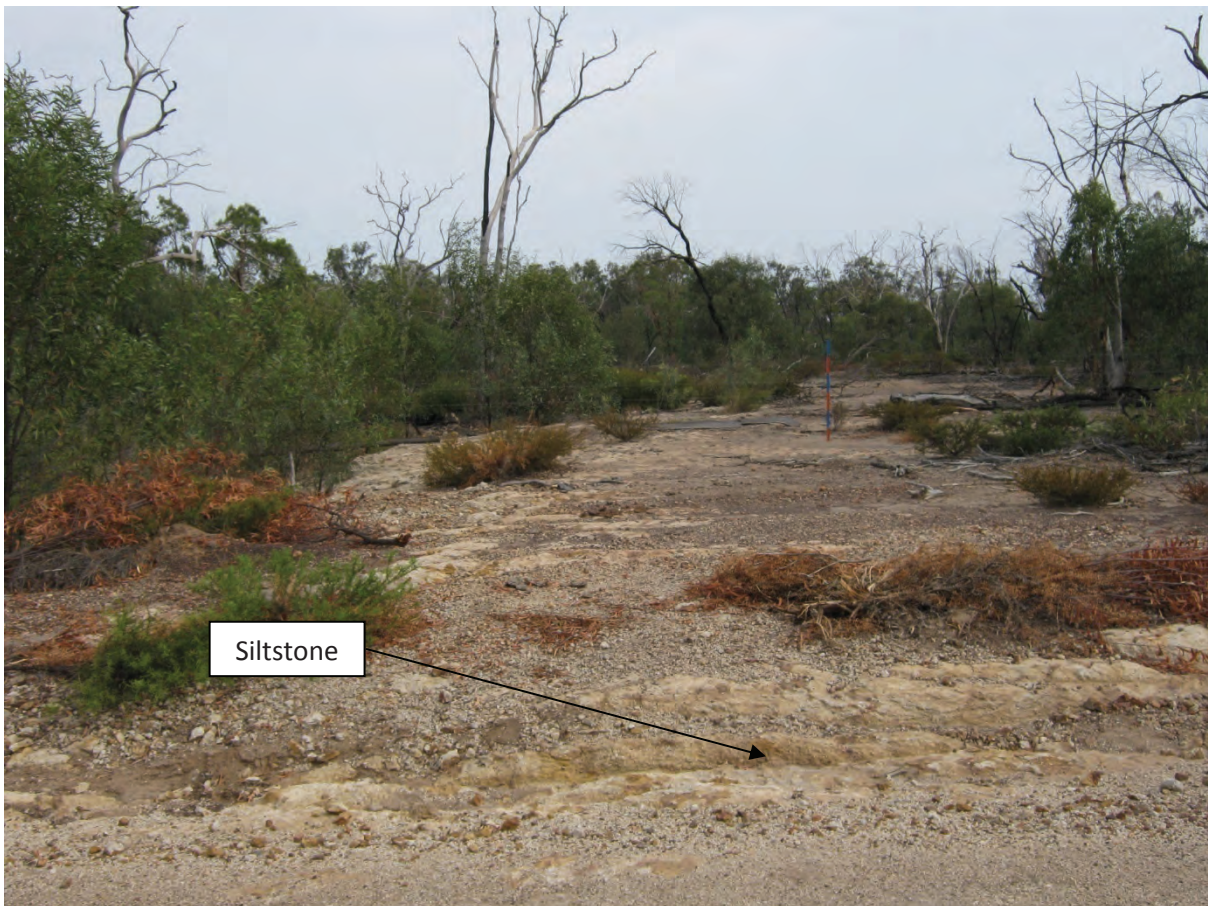
Figure 24: Road drain, view to West - Northwest

Description
SILTSTONE, pale grey to white with some ironstaining, assessed moderately to slightly weathered and medium to high strength, no signs of honeycomb weathering, defects <100mm; multiple sets  (Possible CLAYSTONE)

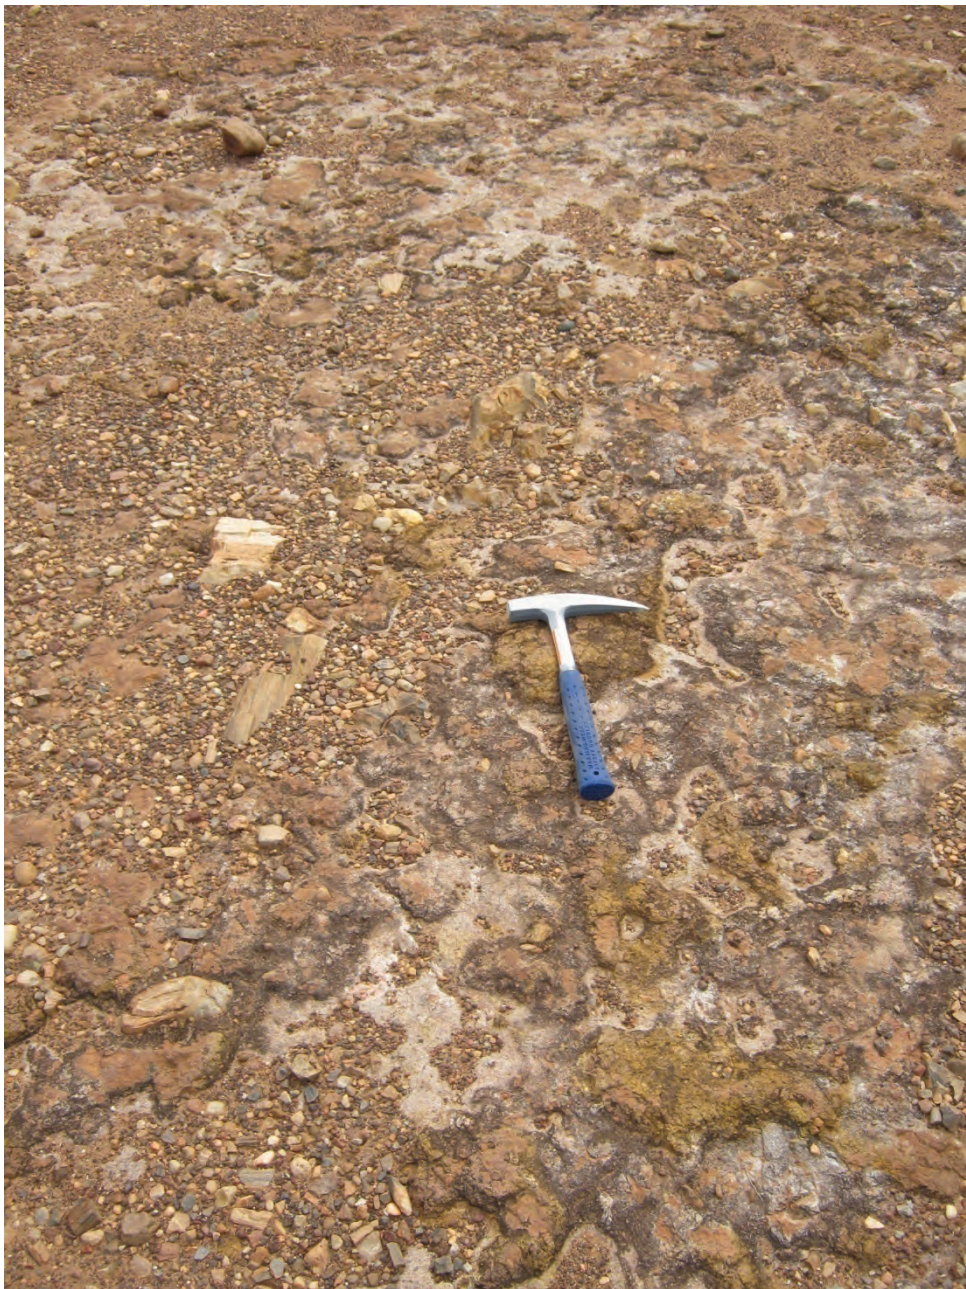
Figure 28: Road drain, view to Northeast

Description
CONGLOMERATE, medium to coarse gravel and cobble size clasts and petrified wood (extremely high strength) in fine to medium grained sand matrix, pale grey with some iron staining, assessed moderately to slightly weathered and high to very high strength

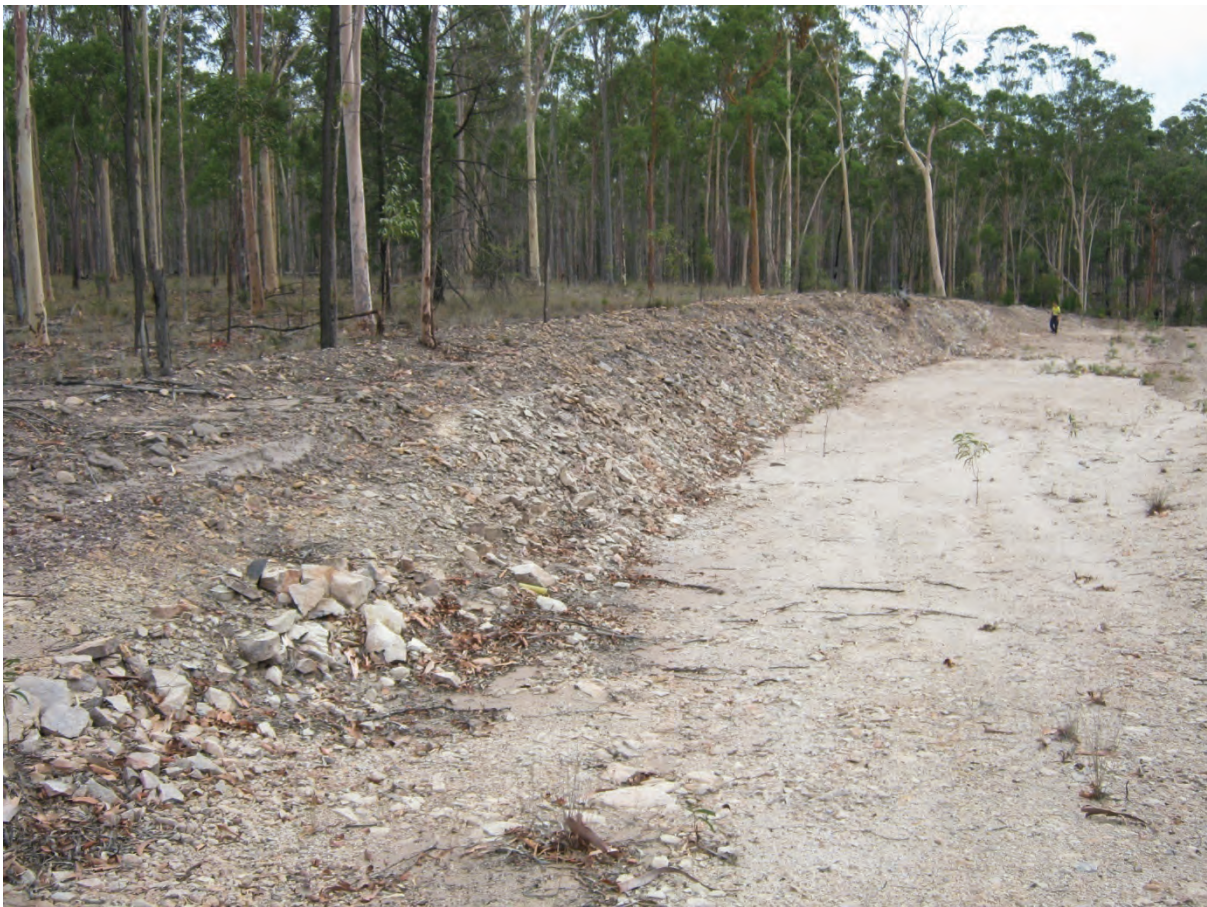
Figure 29: Road cutting, view to East

Description
Extremely weathered material comprising fine to medium grained SAND, pale brown to pale grey And Interbedded SANDSTONE, fine to coarse grained, pale brown, assessed highly weathered and low to medium strength, crossbedded

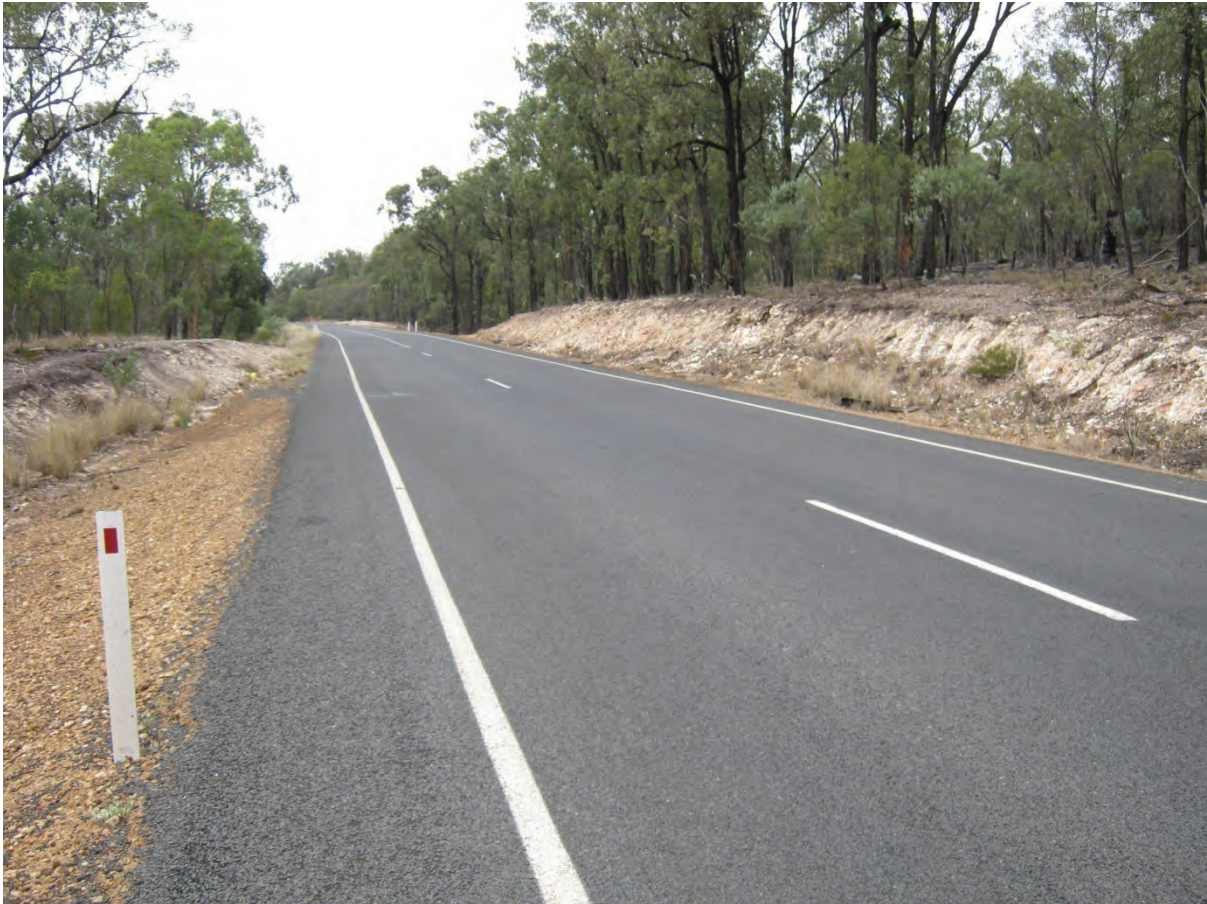
Figure 30: Road cutting, view to South

Description
Lithic SANDSTONE, medium to coarse grained with some fine grained gravel sized clasts, pale grey to white with some ironstaining, assessed highly weathered and very low to medium strength, some honeycomb weathering

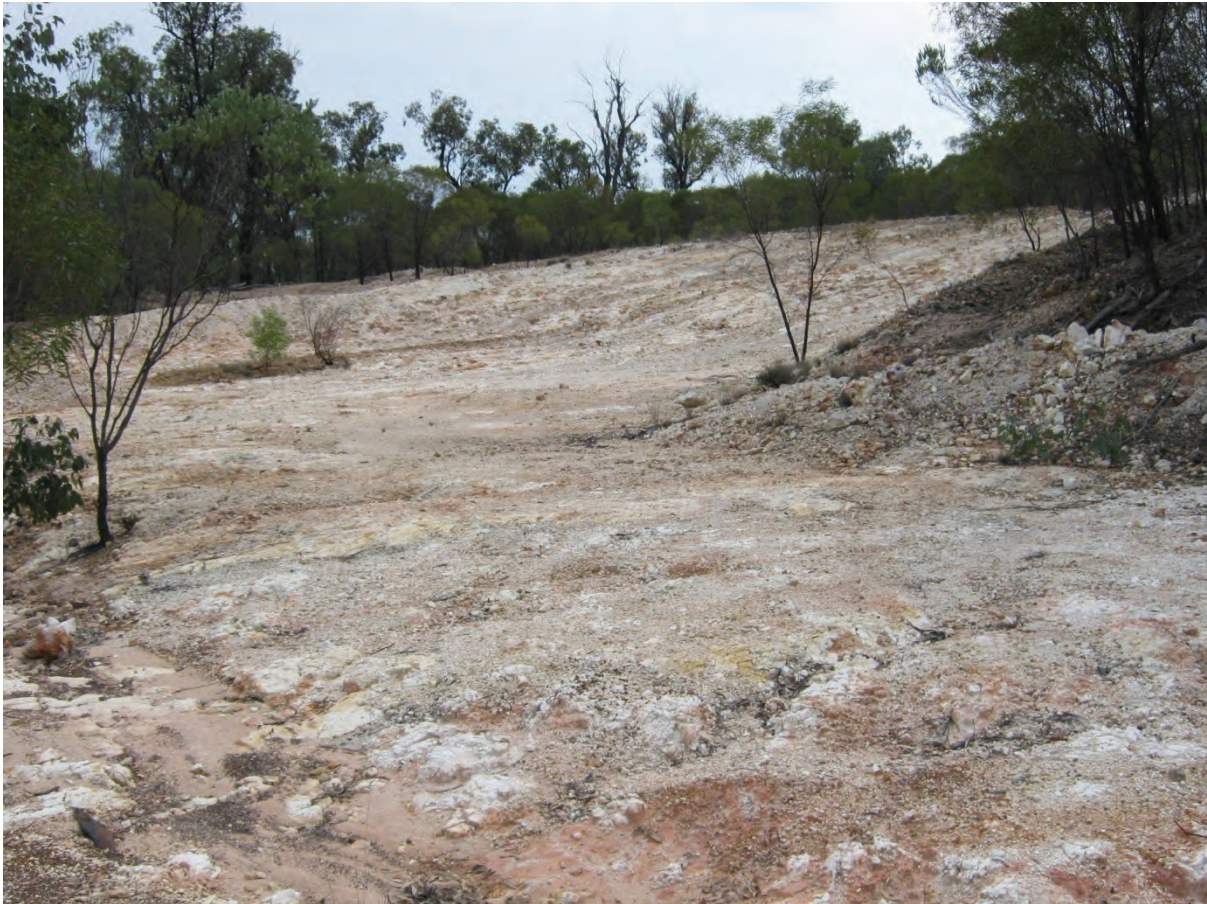
Figure 31: Borrow pit, view to North – Northeast

Description
Lithic SANDSTONE, medium to coarse grained with some fine grained gravel sized clasts, pale grey to white with some ironstaining, assessed highly weathered and very low to medium strength, some honeycomb weathering

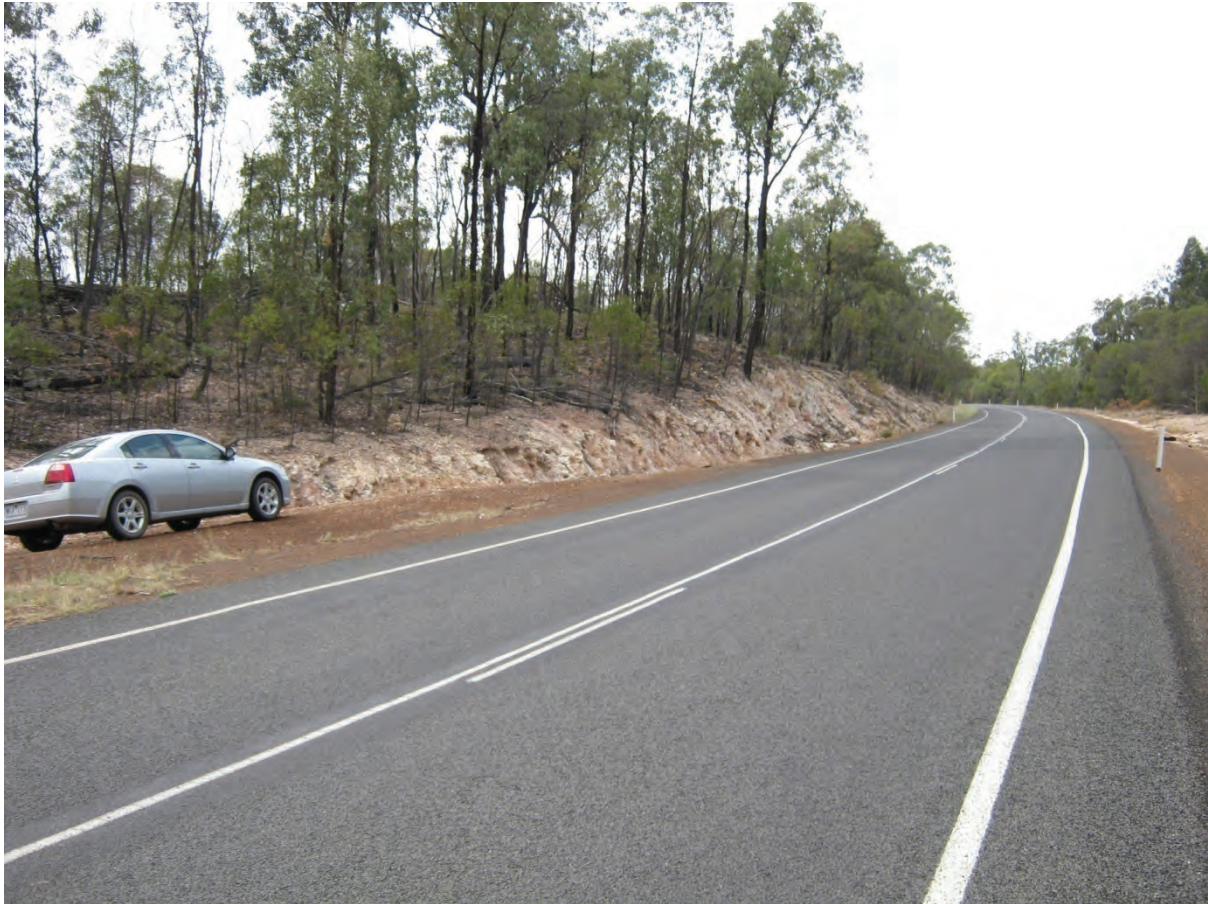
Figure 32: Road cutting, view to Southeast

Description
Lithic SANDSTONE, medium to coarse grained with some fine grained gravel sized clasts, pale grey to white with some ironstaining, assessed highly weathered and very low to medium strength, some honeycomb weathering

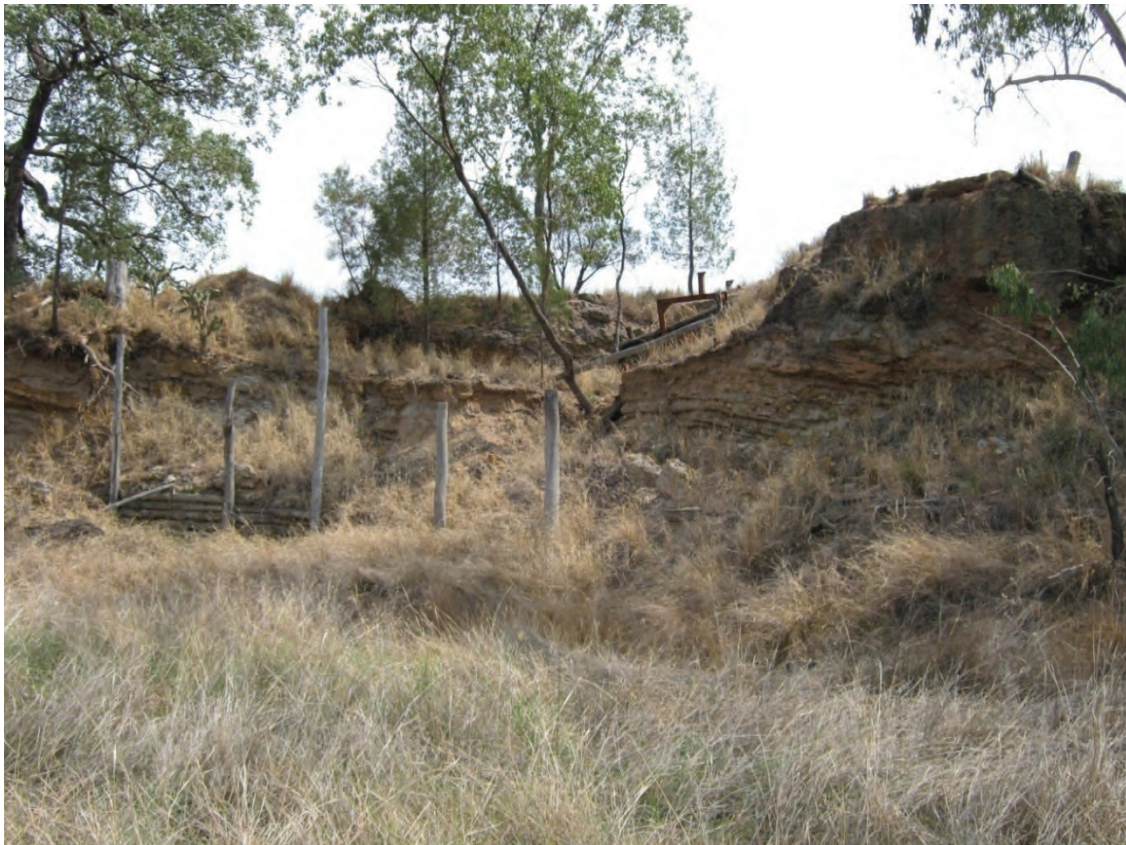
Figure 33: River channel, view to East

Description
<p>Extremely weathered material apparent as:</p> <p>Gravelly SAND, fine to coarse grained, pale brown – pale orange – pale grey – white, with ironstaining, fine to coarse grained gravel, some low plasticity clay</p> <p>With</p> <p>Interbedded SANDSTONE, medium to coarse grained, pale brown with some pale orange ironstaining, assessed highly weathered and very low to medium strength</p> <p>And</p> <p>CONGLOMERATE, fine to coarse gravel clasts and some cobbles in fine to coarse grained sand matrix, pale brown – pale orange (ironstaining) – pale grey, assessed highly weathered and very low to medium strength  Defects in SANDSTONE are &lt;100mm, at least 3 sets of joints</p>

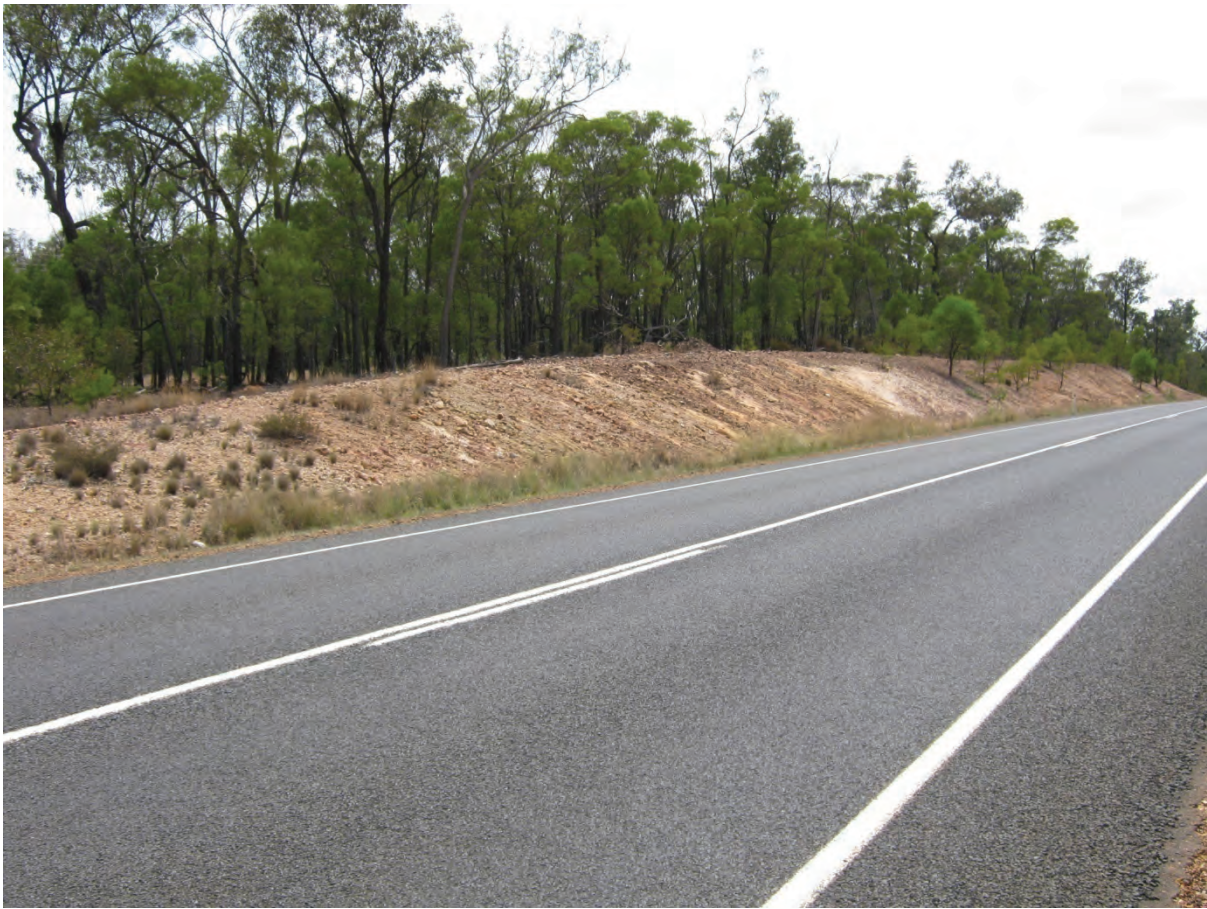
Figure 34: Road cutting, view to Northeast

Description
CONGLOMERATE, medium to coarse gravel, cobble and some boulder clasts in medium to coarse grained sand matrix, pale brown – pale orange – red – pale grey, assessed highly to moderately weathered and low to medium strength
Interbedded medium to coarse grained SANDSTONE horizons

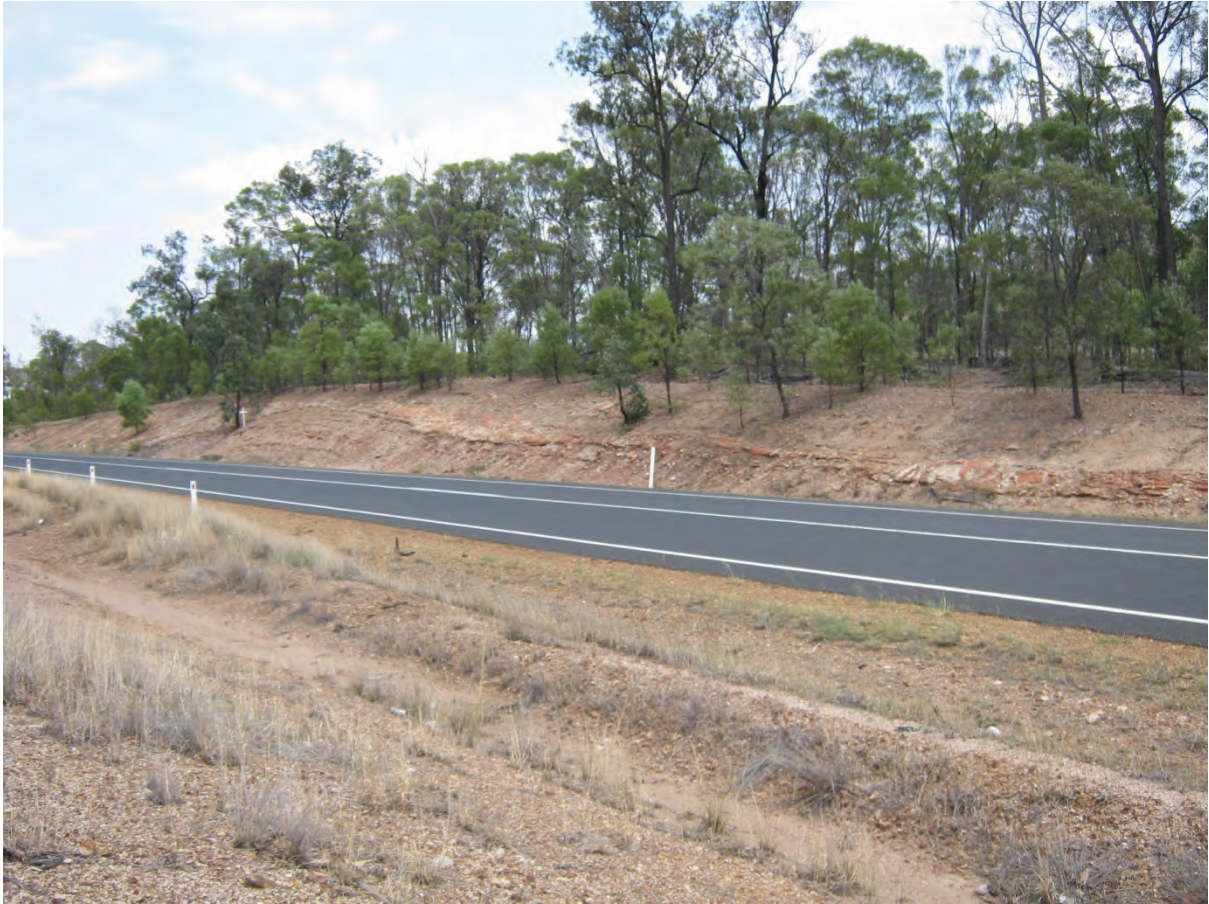
Figure 35: Road cutting, view to North

Description
SANDSTONE, medium to coarse grained with some fine grained gravel sized clasts, pale brown to pale grey with some ironstaining, assessed highly to moderately weathered and low to medium strength

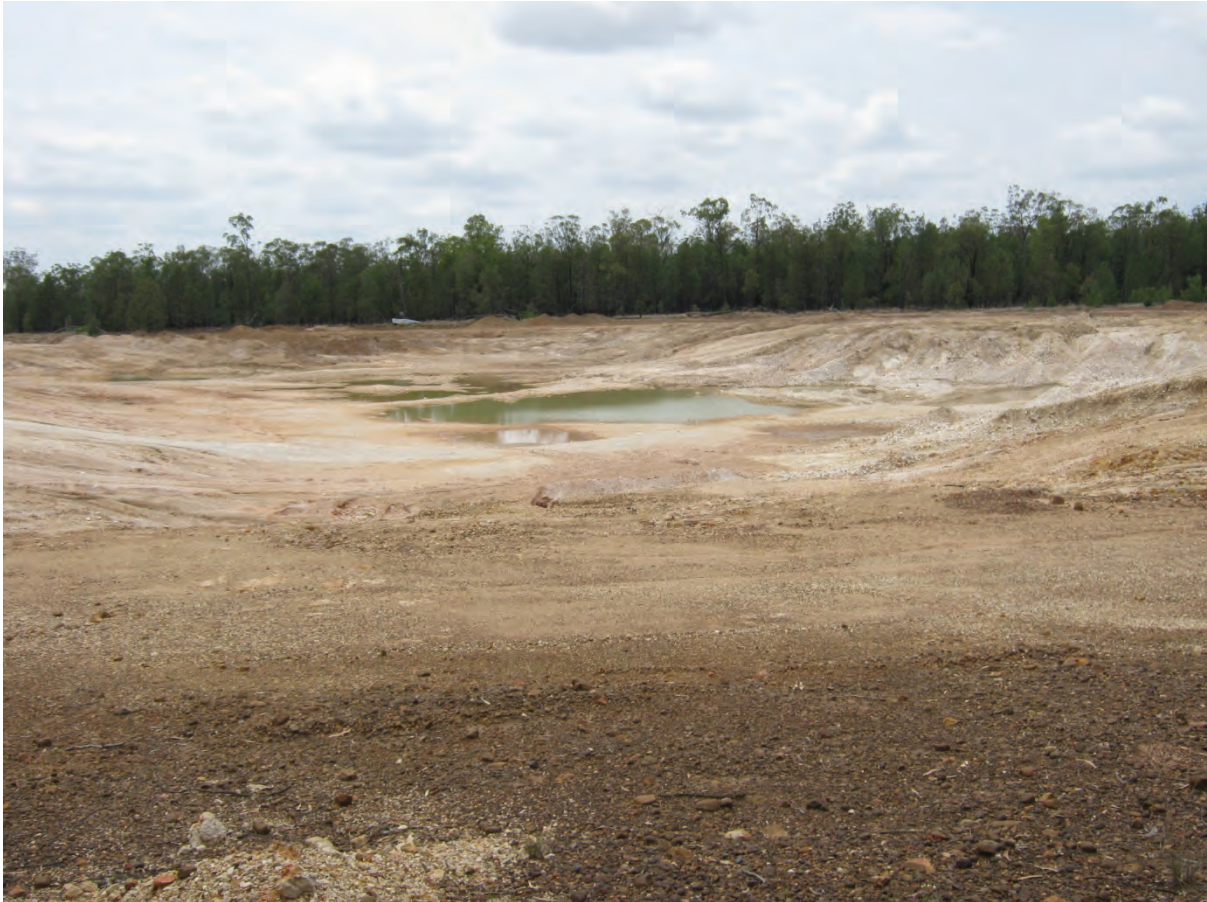
Figure 37: Borrow pit, view to Southeast

Description
SANDSTONE, medium to coarse grained, pale grey to white, assessed moderately to slightly weathered and medium to high strength

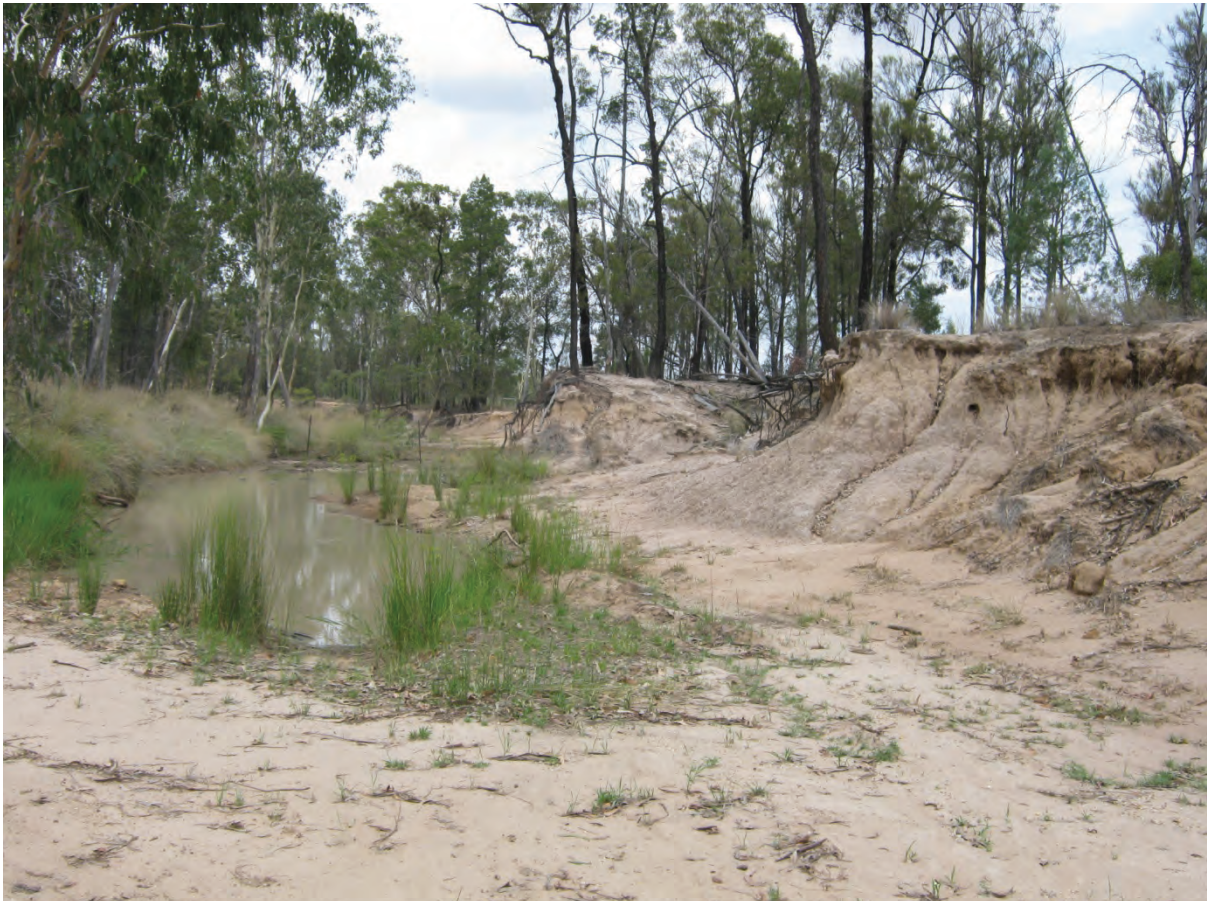
Figure 38: Creek bed, view to West

Description
No rock observed– alluvial profile

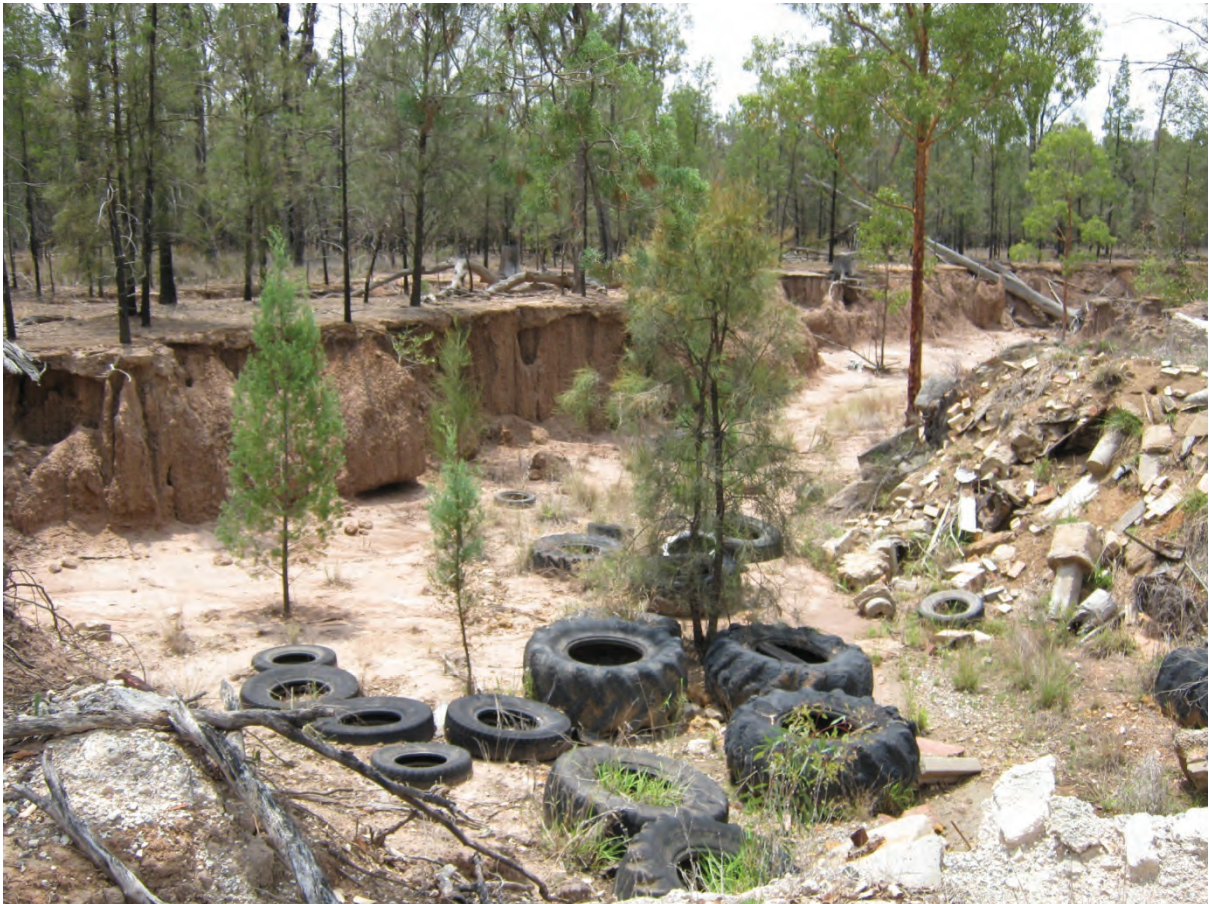
Figure 39: Gully, view to Northwest

Description
No rock observed – alluvial profile

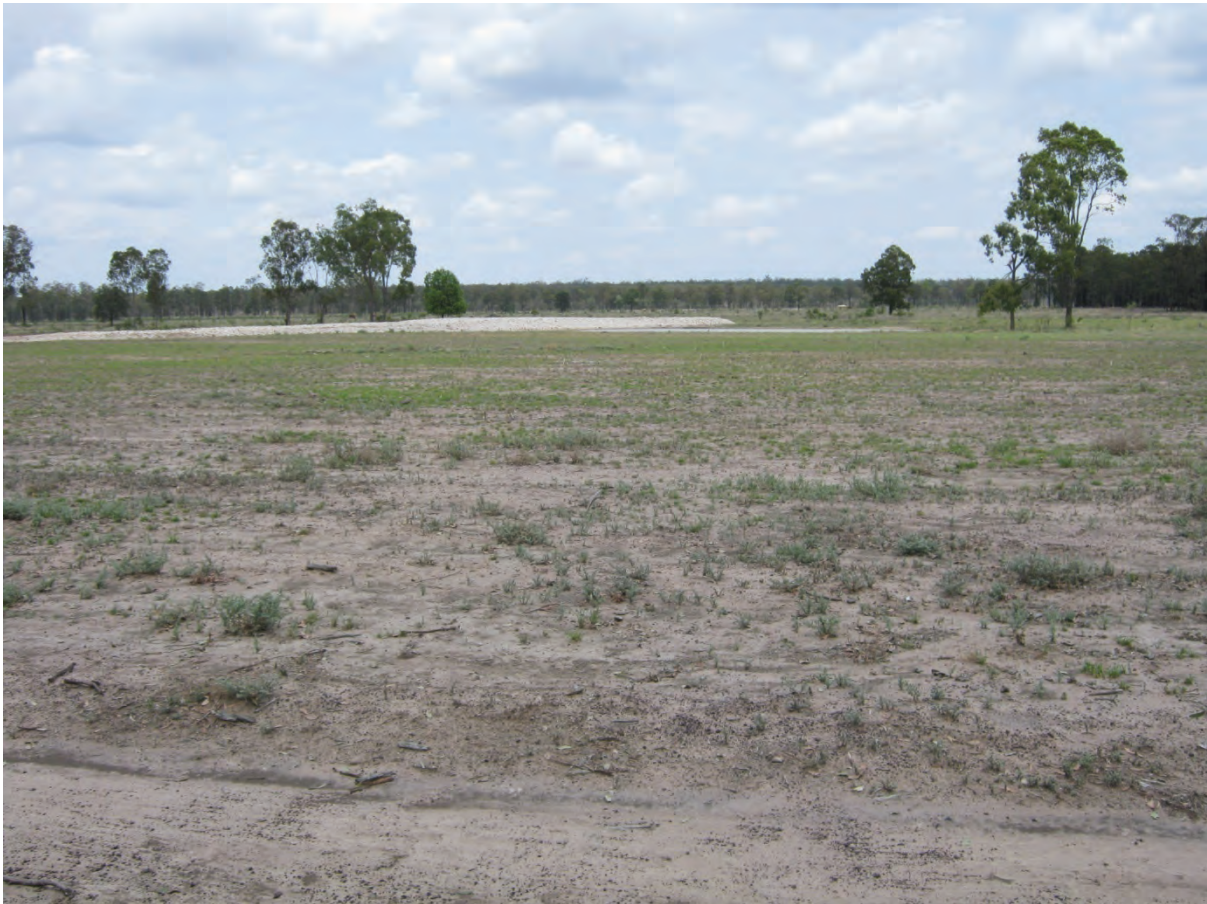
Figure 40: Landscape, view to Southwest

Description
Imported rock fill for bund

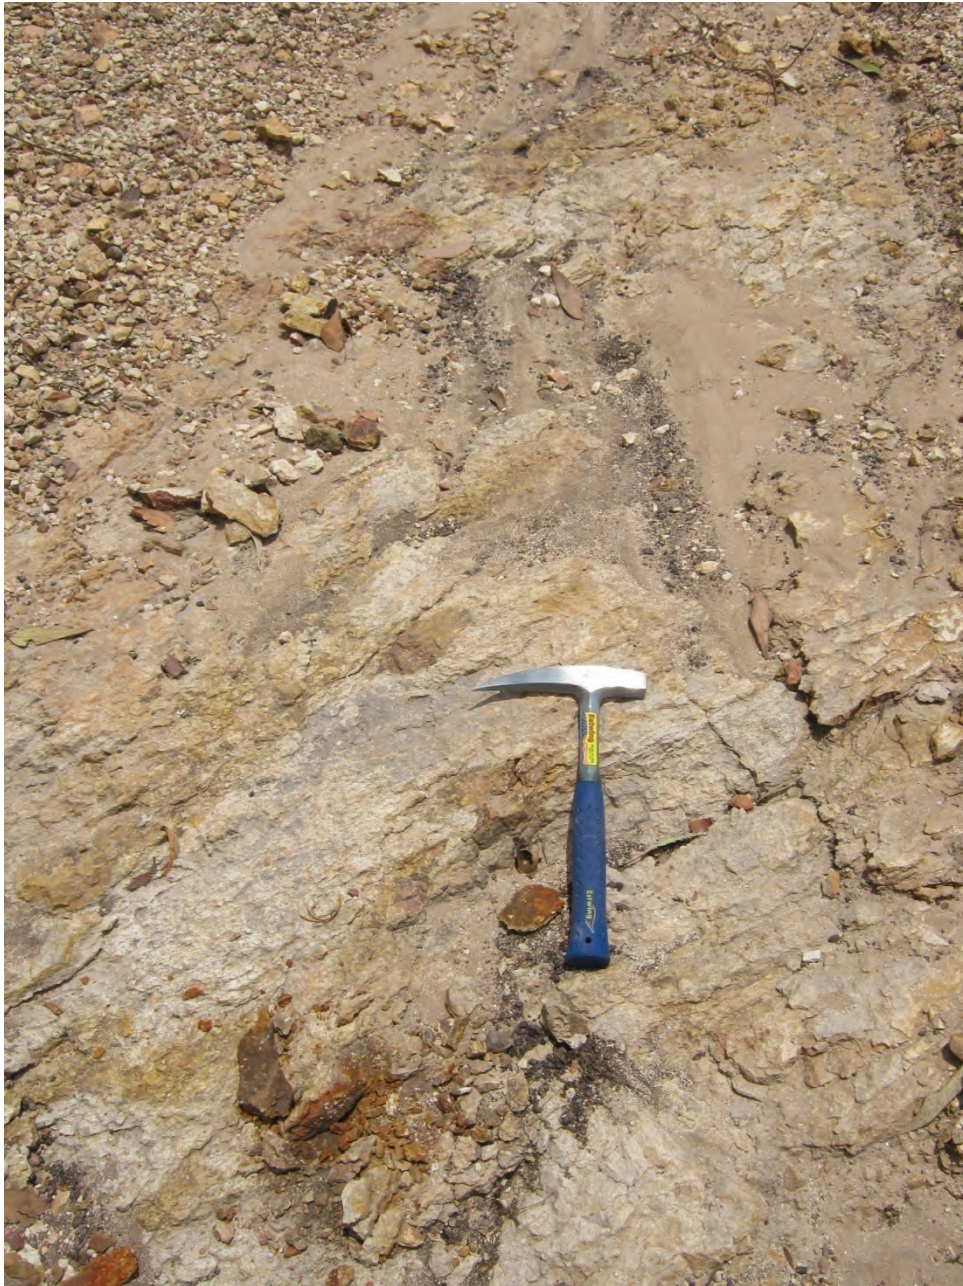
Figure 42: Road drain, view to Northwest

Description
SANDSTONE, medium to coarse grained, pale grey with some ironstaining, assessed highly to moderately weathered and low to medium strength, defects <100mm; at least 2 sets

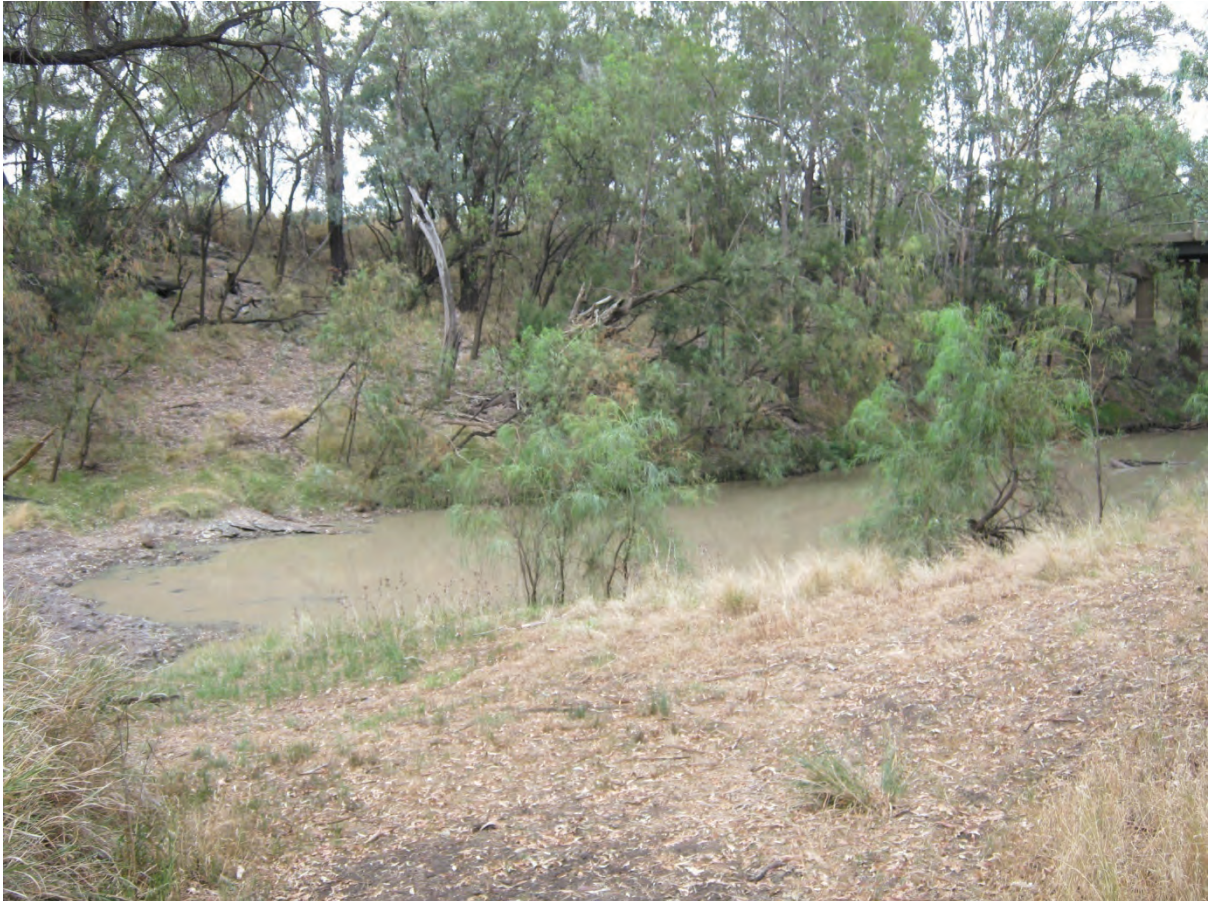
Figure 46: River embankment, view to South

Description
River embankment – 10m high (Possible sandstone)

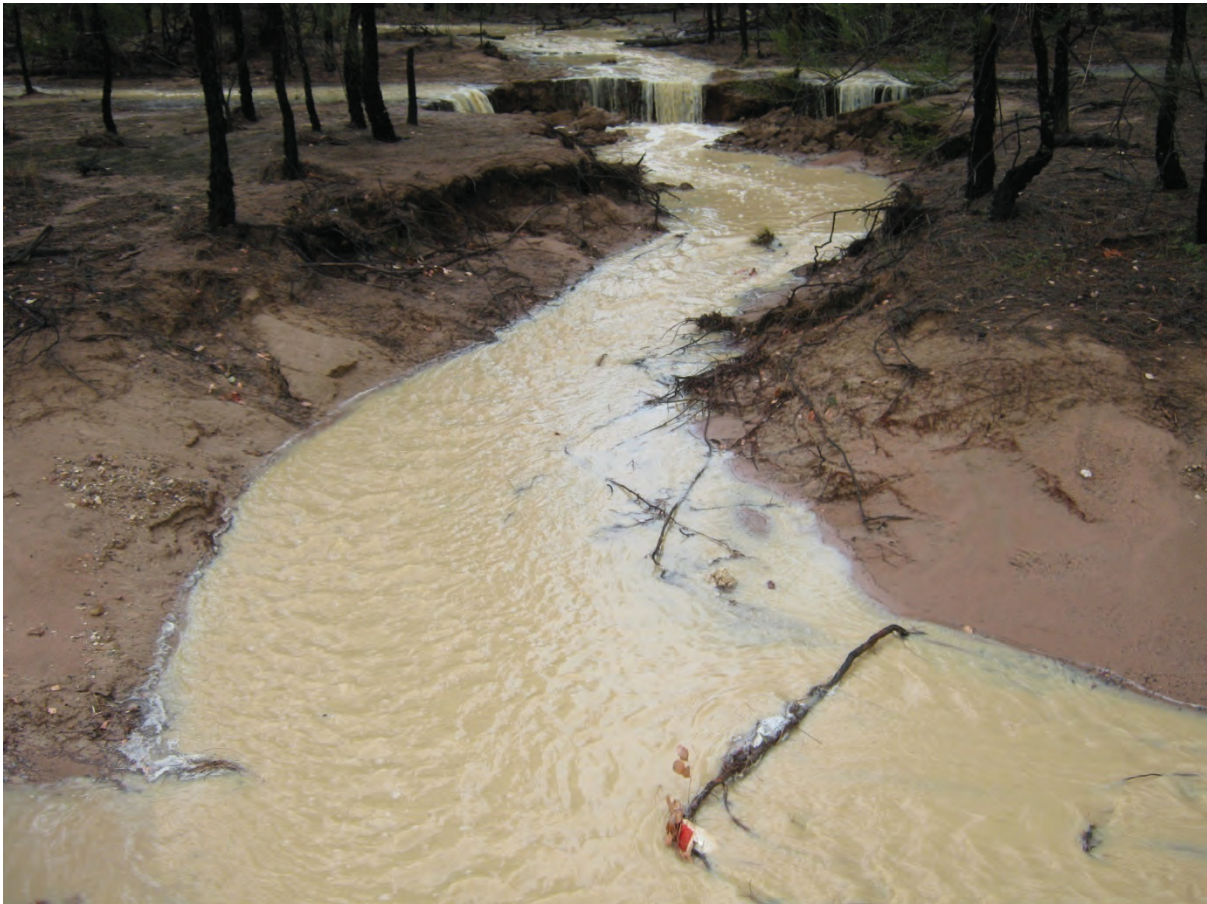
Figure 50: Storm water run-off, view to South

Location ID	Feature/Exposure Type	Location Co-ordinates		
		Zone	Easting	Northing
47	Landscape	56	0271590	7010330

Description
Surface run off after storm

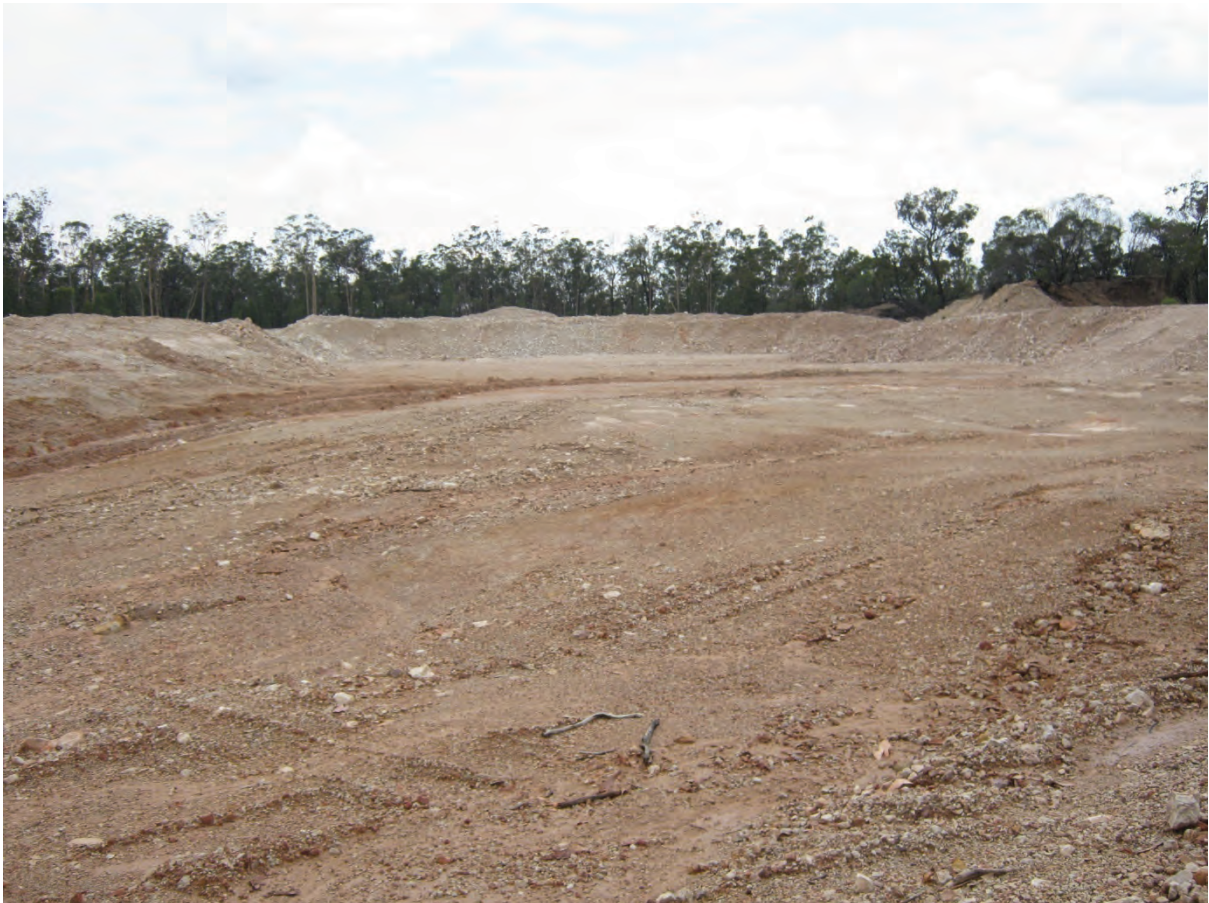
Figure 51: Borrow pit, view to South

Location ID	Feature/Exposure Type	Location Co-ordinates		
		Zone	Easting	Northing
48	Borrow Pit	56	0275741	7008569

Description
<p>SANDSTONE, fine to coarse grained, pale grey with some red ironstaining, assessed moderately weathered to fresh and medium to high strength, at least 3 joint sets</p> <p>Some interbedded SILTSTONE and CONGLOMERATE:</p> <p>SILTSTONE, pale grey to grey, assessed slightly weathered to fresh and medium strength</p> <p>CONGLOMERATE, fine to coarse gravel and some cobbles in fine to coarse grained sand matrix, pale grey – white – and some red, with some ironstaining</p>
