**GEOLOGY, LANDFORM AND SOILS  
STUDY  
ARROW ENERGY SURAT GAS PROJECT,  
SURAT BASIN, QUEENSLAND**

Report Date: 6 December 2011  
Project Ref: ENAUBRIS07040AC-  
9097\_GLS\_Rev4.docx

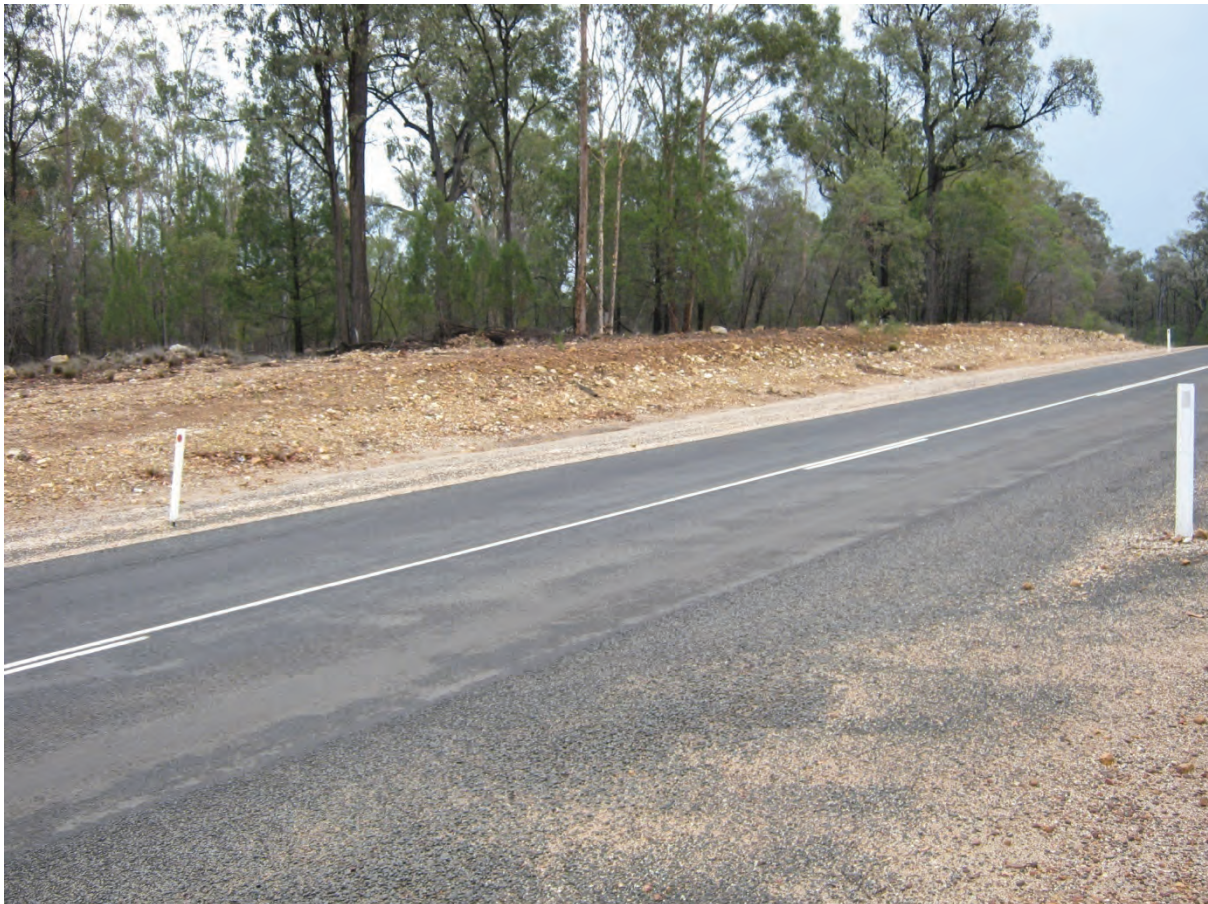
Figure 52: Landscape view to South – Southeast

Location ID	Feature/Exposure Type	Location Co-ordinates		
		Zone	Easting	Northing
49	Landscape	56	0275889	7008766

Description
<p>Cutting above Location 48</p> <p>SANDSTONE, fine to coarse grained, pale grey with some red ironstaining, assessed moderately weathered to fresh and medium to high strength, at least 3 joint sets</p> <p>Some interbedded SILTSTONE and CONGLOMERATE:</p> <p>SILTSTONE, pale grey to grey, assessed slightly weathered to fresh and medium strength</p> <p>CONGLOMERATE, fine to coarse gravel and some cobbles in fine to coarse grained sand matrix, pale grey – white – and some red, with some ironstaining</p>

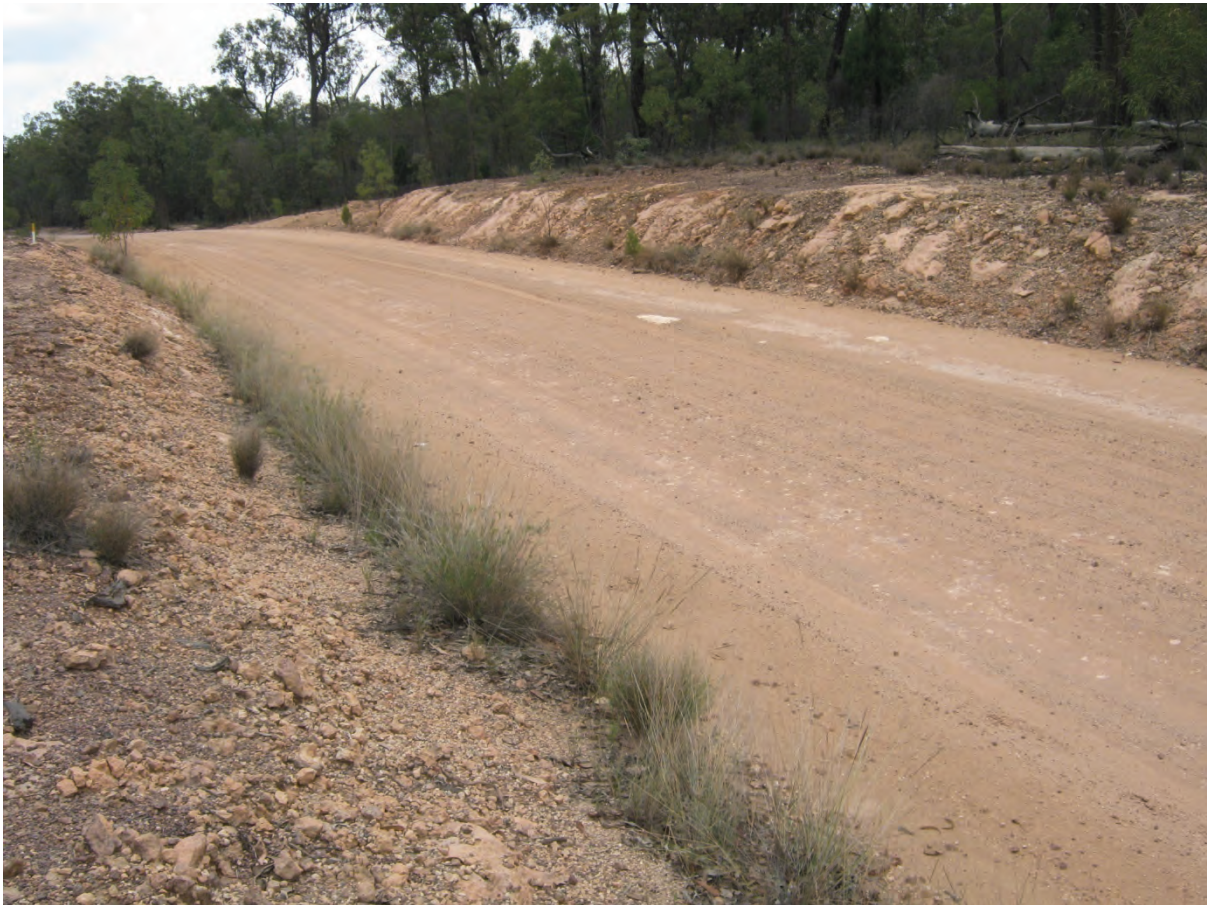
Figure 54: Road cutting, view to West

Location ID	Feature/Exposure Type	Location Co-ordinates		
		Zone	Easting	Northing
51	Road Cutting	56	0280495	7009229

Description
SANDSTONE, fine to medium grained, pale brown – pale grey – pale orange, assessed moderately to slightly weathered and medium to high strength, massive

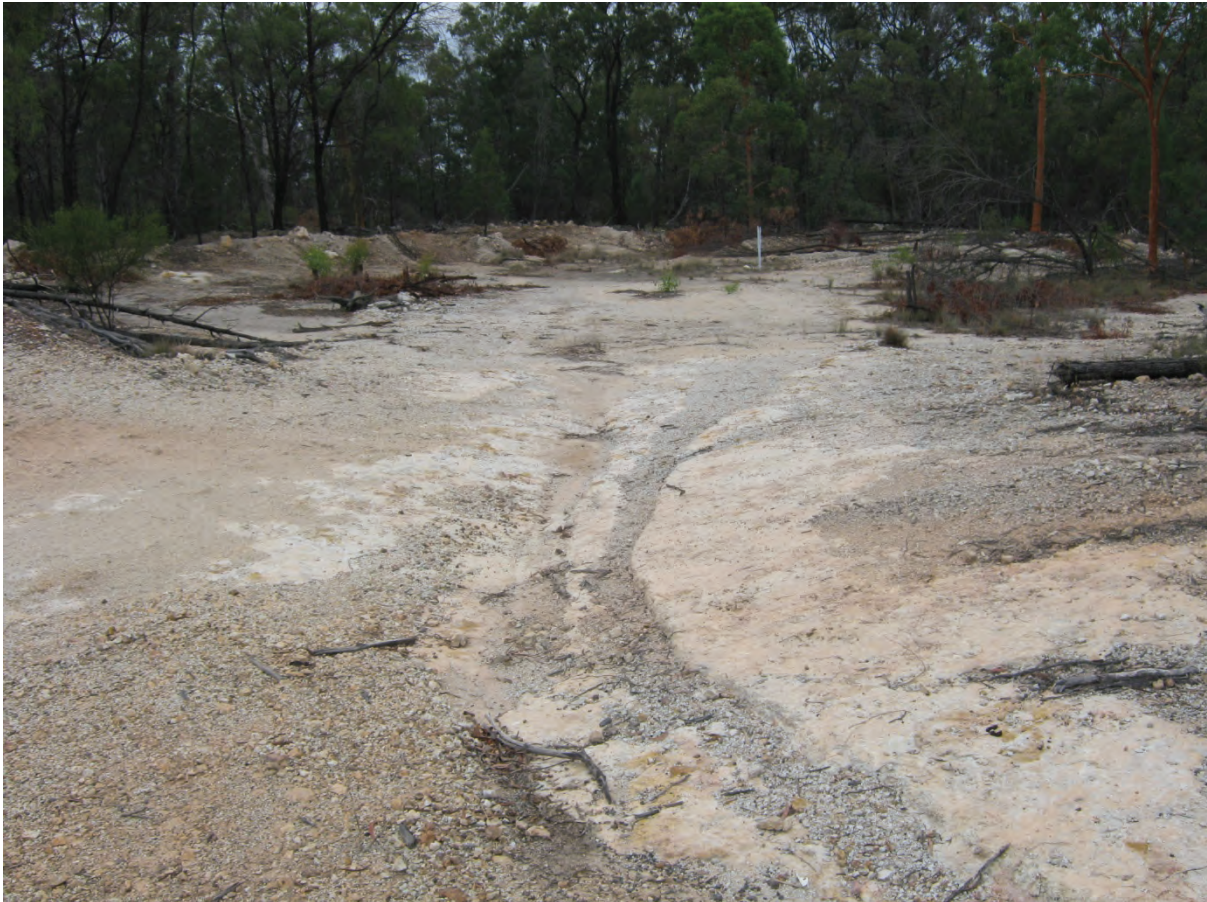
Figure 56: Road cutting and borrow pit, view to North – Northwest

Location ID	Feature/Exposure Type	Location Co-ordinates		
		Zone	Easting	Northing
53	Road Cutting and Borrow Pit	56	0283201	7012557

Description
SANDSTONE, fine to coarse grained, pale grey with some red ironstaining, assessed moderately weathered to fresh and medium to high strength, at least 3 joint sets

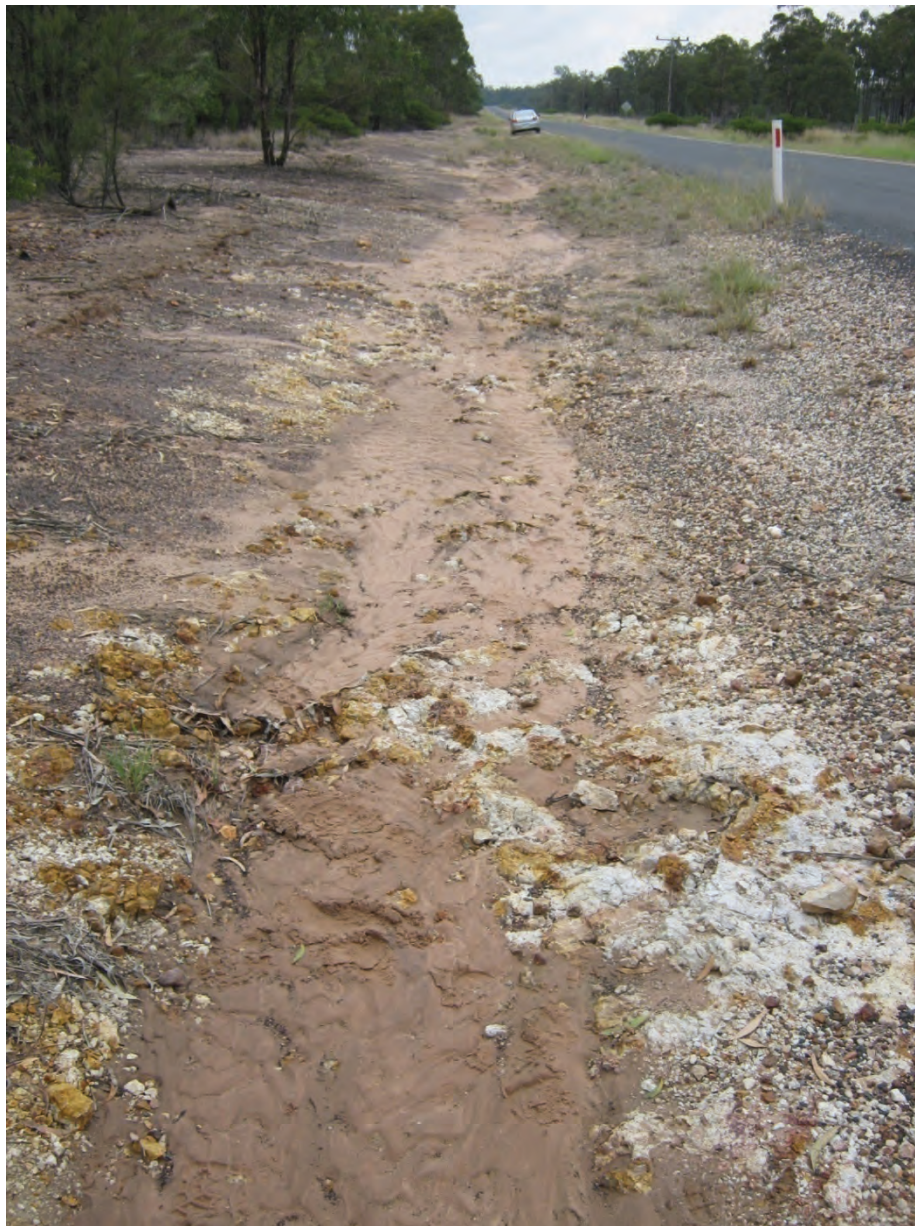
Figure 59: Road drain, view to West - Southwest

Location ID	Feature/Exposure Type	Location Co-ordinates		
		Zone	Easting	Northing
56	Road Drain	56	0286298	7014104

Description
SANDSTONE, fine to medium grained, white – pale grey with some ironstaining, assessed highly weathered and low strength
Some interbedded SILTSTONE (possible CLAYSTONE), pale brown – pale grey, assessed highly weathered and very low to low strength

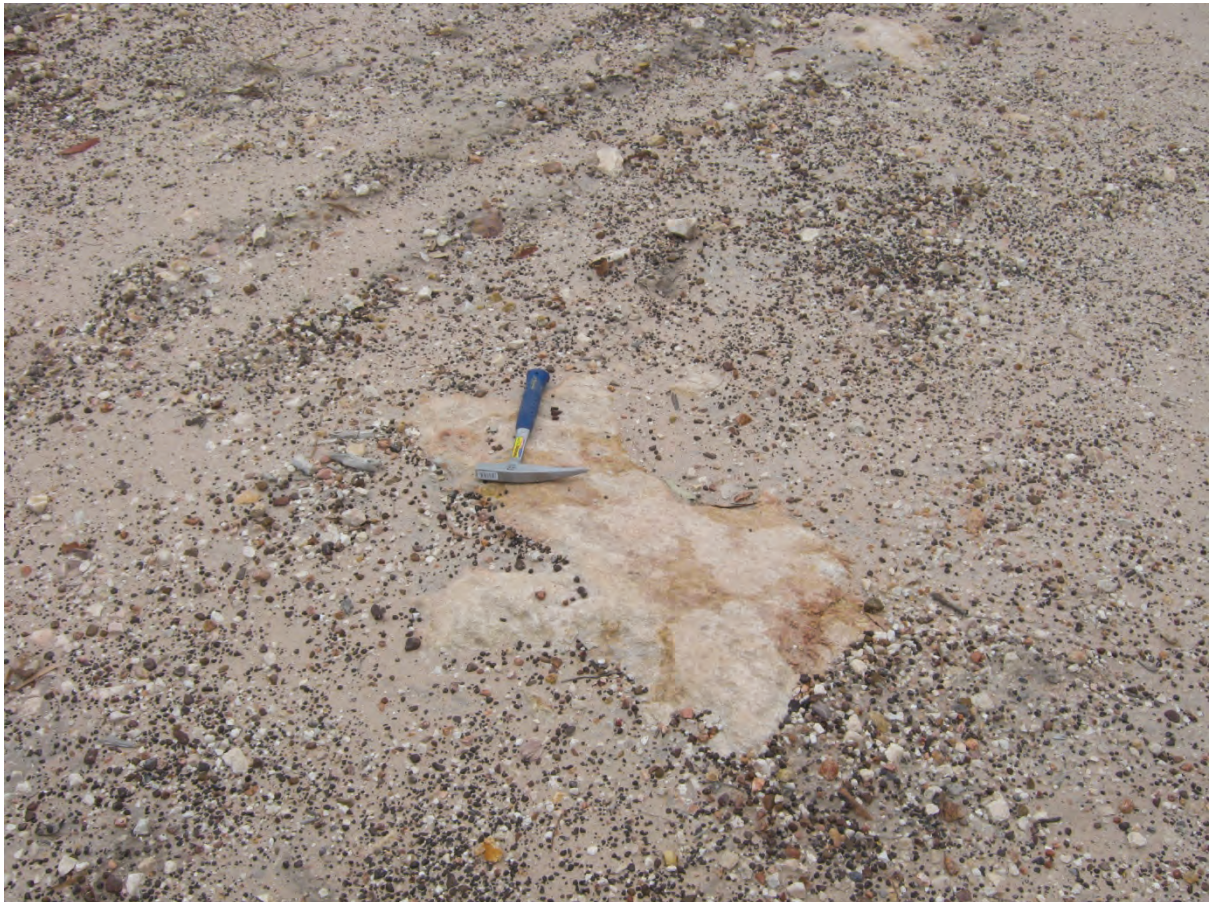
Figure 60: Road cutting view to Northwest

Location ID	Feature/Exposure Type	Location Co-ordinates		
		Zone	Easting	Northing
57	Road Cutting	56	0286086	7012128

Description
SANDSTONE, fine to medium grained, pale brown – pale grey – pale orange, assessed moderately to slightly weathered and medium to high strength, massive

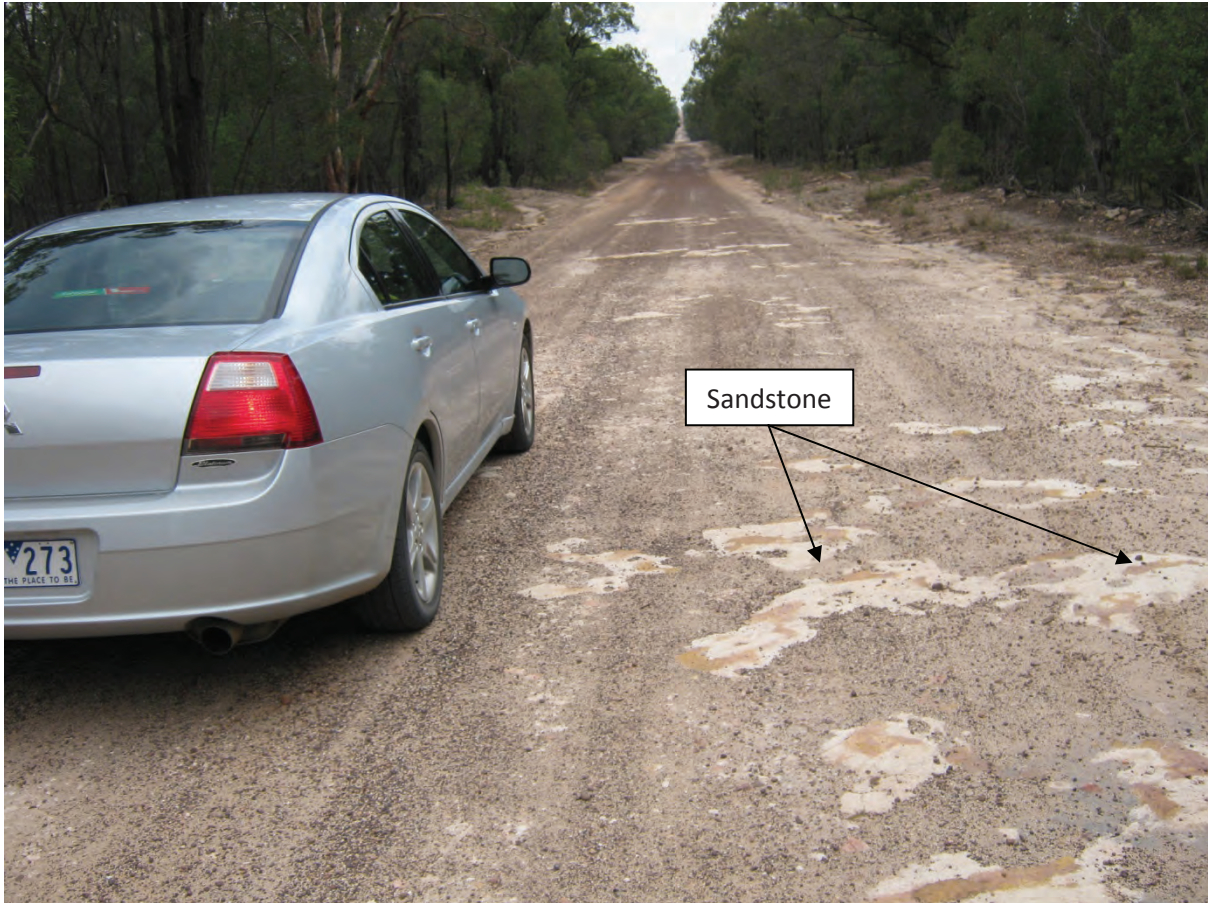
Figure 61: Road, view to South

Location ID	Feature/Exposure Type	Location Co-ordinates		
		Zone	Easting	Northing
58	Road	56	0286165	7010037

Description
SANDSTONE, fine to medium grained, pale brown – pale grey – pale orange, assessed moderately to slightly weathered and medium to high strength, massive

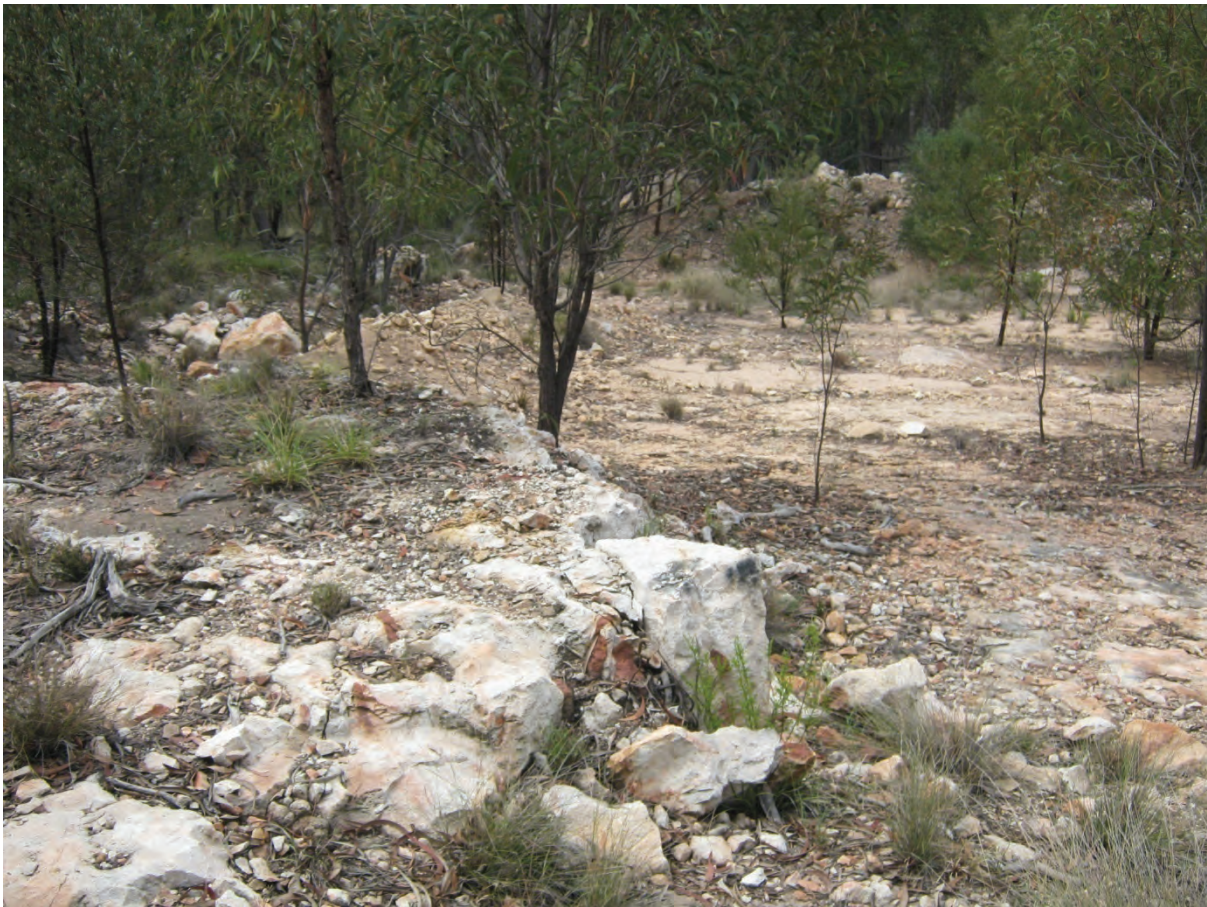
Figure 62: Borrow pit, view to Northeast

Location ID	Feature/Exposure Type	Location Co-ordinates		
		Zone	Easting	Northing
59	Borrow Pit	56	0285738	7006185

Description
<p>SANDSTONE, fine to medium grained, pale brown – pale grey – pale orange, assessed moderately to slightly weathered and medium to high strength, massive</p> <p>With some CONGLOMERATE, fine to coarse gravel and some cobbles in fine to coarse grained sand matrix, pale grey – white – and some red, with some ironstaining</p>

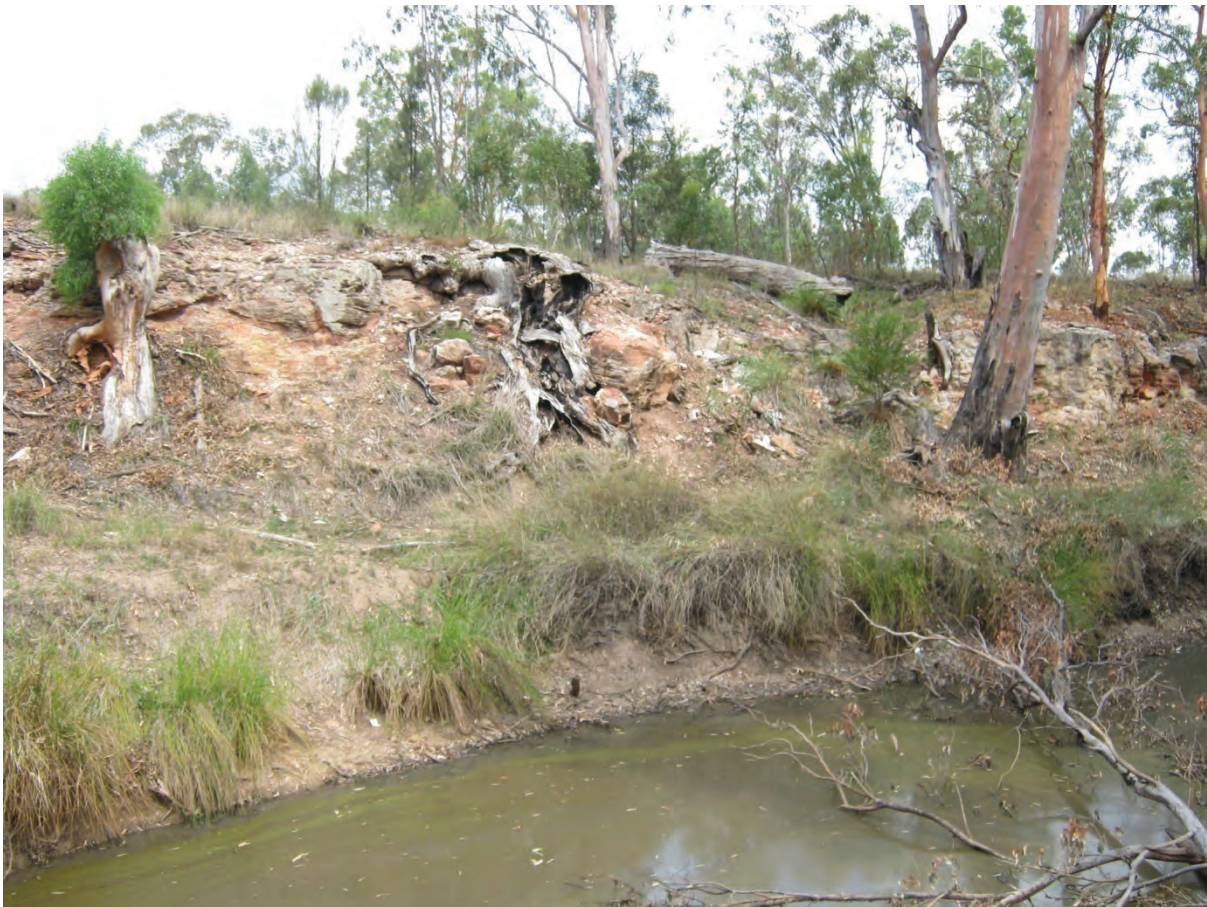
Figure 63: Creek embankment, view to East

Location ID	Feature/Exposure Type	Location Co-ordinates		
		Zone	Easting	Northing
60	Creek	56	0288215	7003989

Description
SANDSTONE, medium to coarse grained, pale brown – orange – red, assessed highly to slightly weathered and low to high strength, cross bedding, some honeycomb weathering, SANDSTONE only present on east side of creek

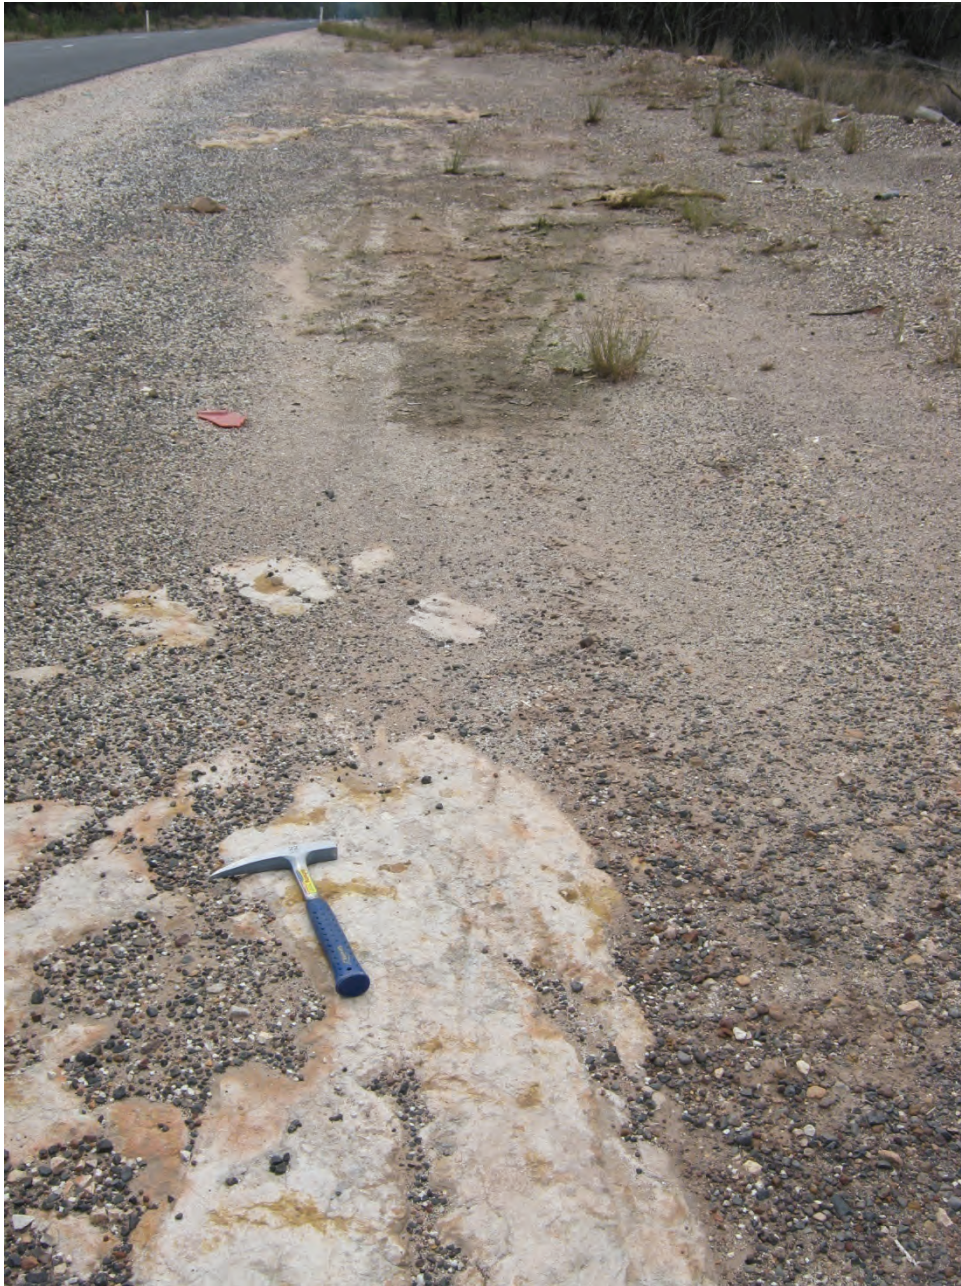
Figure 64: Road cutting, view to Northwest

Location ID	Feature/Exposure Type	Location Co-ordinates		
		Zone	Easting	Northing
61	Road	56	0290434	7003475

Description
SANDSTONE, medium to coarse grained, pale brown – orange – red, assessed highly to slightly weathered and low to high strength, cross bedding, some honeycomb weathering

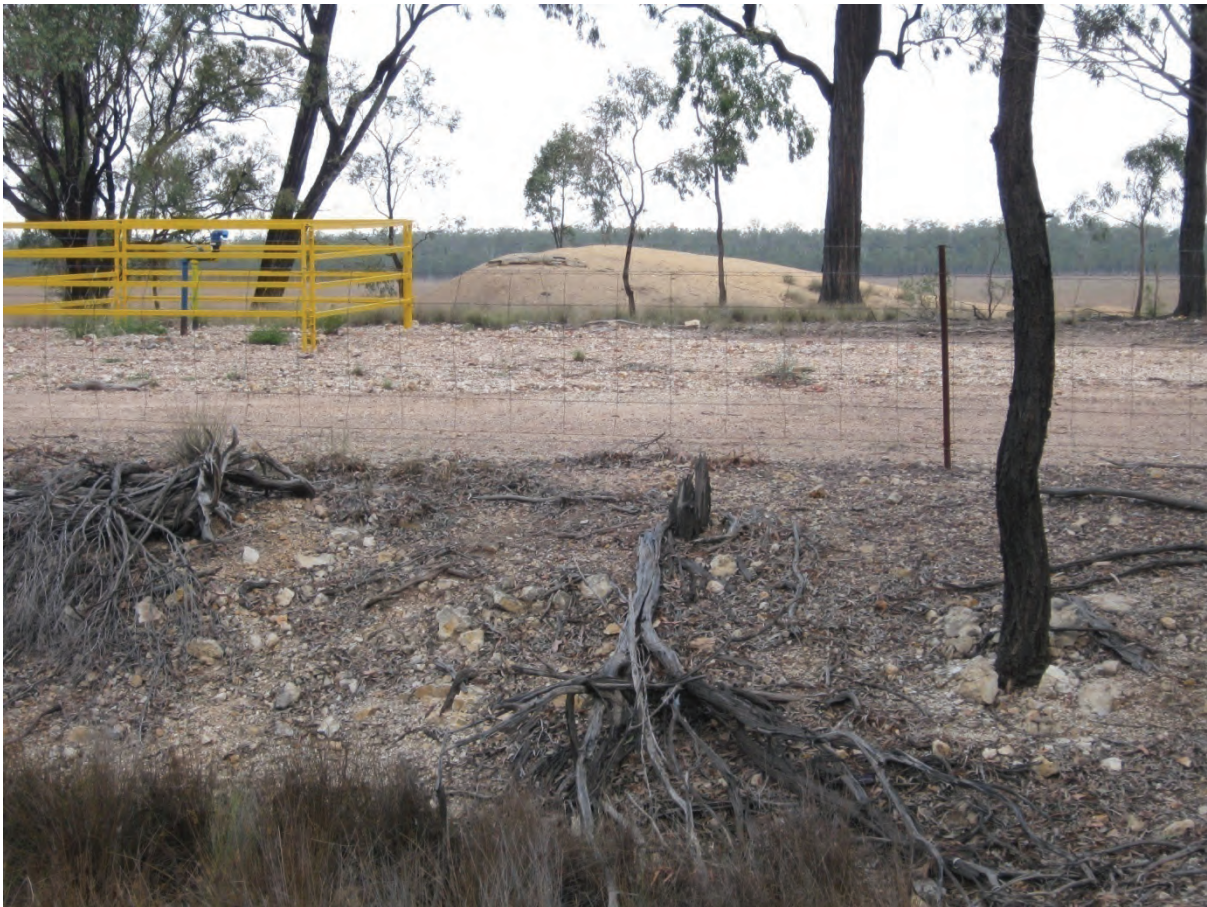
Figure 74: Borrow pit, view to East

Location ID	Feature/Exposure Type	Location Co-ordinates		
		Zone	Easting	Northing
71	Borrow Pit	56	0316803	6957245

Description
SANDSTONE, fine to medium grained, pale brown – pale grey, some ironstaining, bedding mm scale, assessed moderately to slightly weathered, high strength, at least 3 joint sets
Some SILTSTONE, coarse grained, pale grey and brown

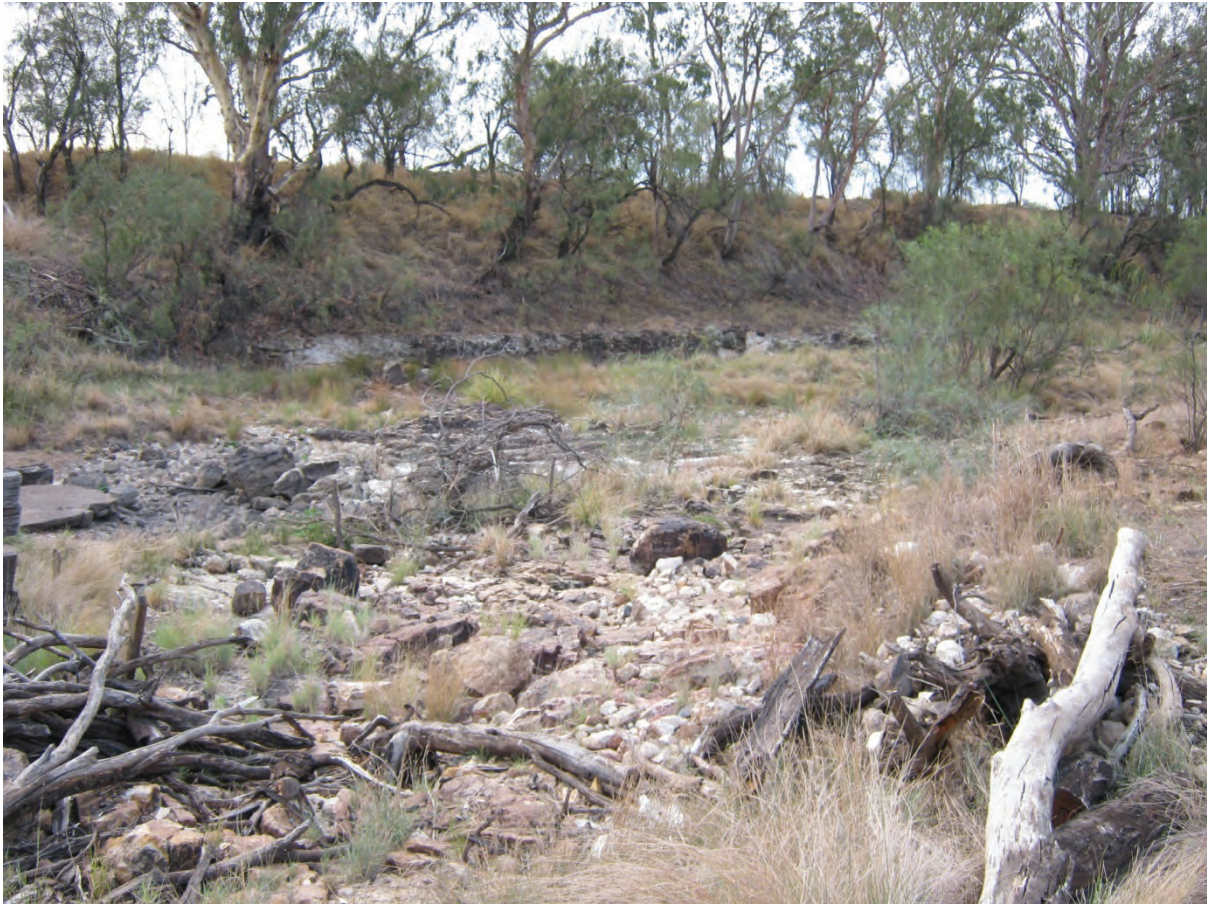
Figure 75: Road cutting, view to Northwest

Location ID	Feature/Exposure Type	Location Co-ordinates		
		Zone	Easting	Northing
72	Creek	56	0322741	6953200

Description
SANDSTONE, fine to medium grained, pale brown – pale grey, some ironstaining, bedding mm scale, assessed moderately to slightly weathered and high strength, at least 3 joint sets

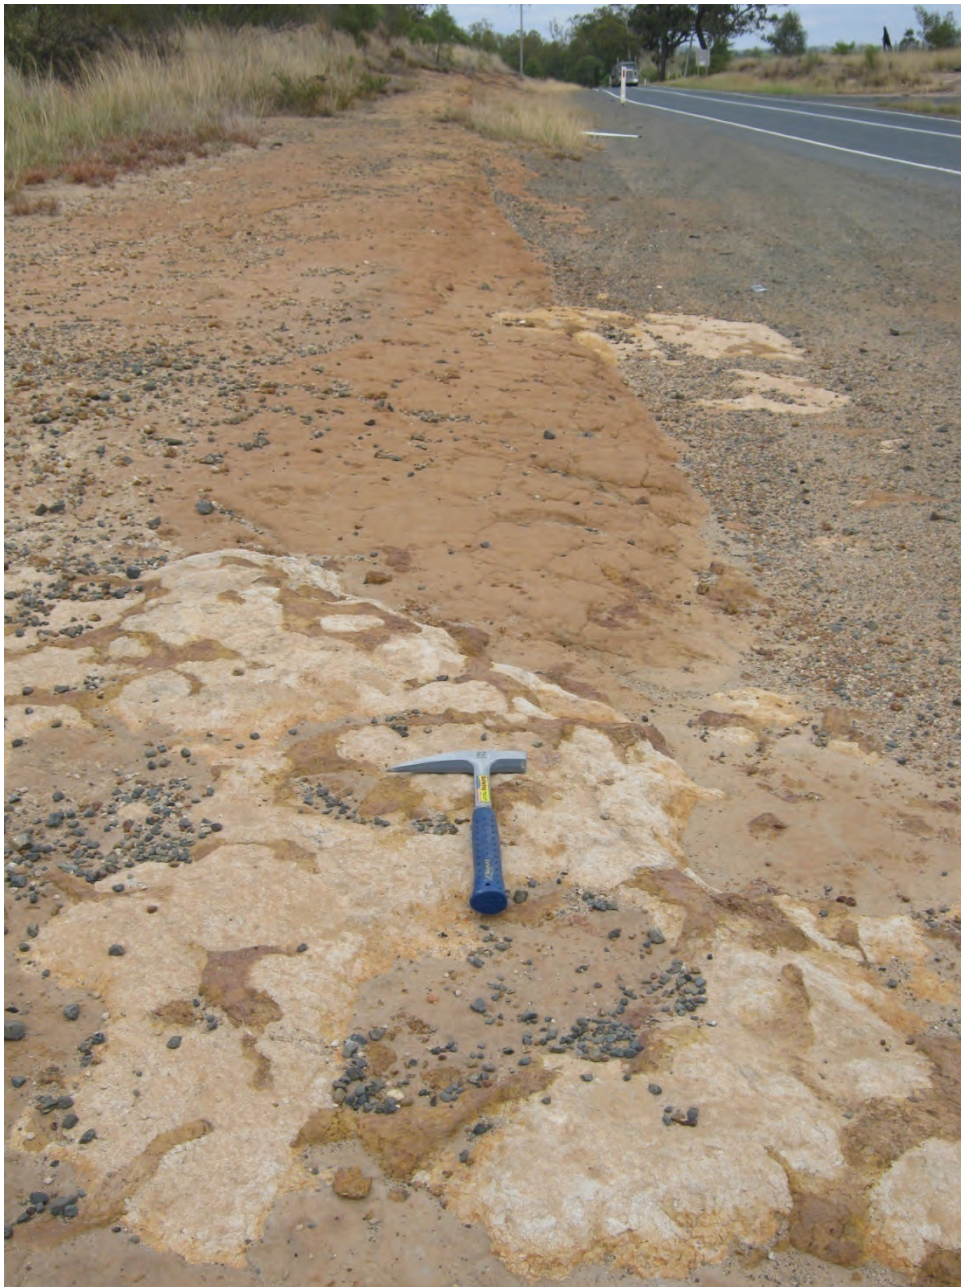
Figure 82: Road cutting, view to West

Description
SANDSTONE, medium to coarse grained, pale grey – pale brown with some ironstaining, assessed highly weathered and low strength

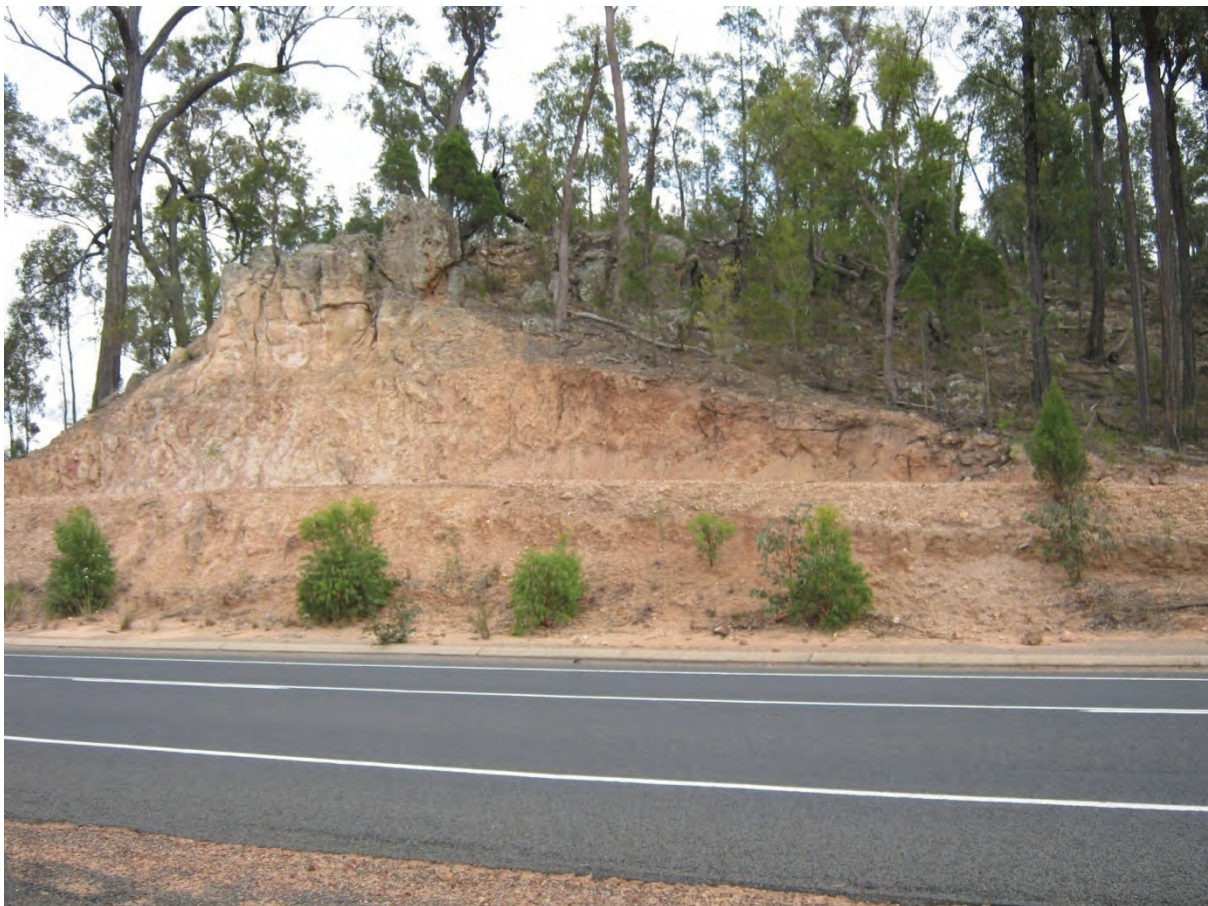
Figure 83: Road cutting, view to North - Northwest

Location ID	Feature/Exposure Type	Location Co-ordinates		
		Zone	Easting	Northing
80 a	Road Cutting	56	0309560	6903955

Description
North – South trending ridgelines approximately 50m wide (East – West)
SANDSTONE, medium to coarse grained, orange – pale brown – pale grey, some red, some ironstaining, assessed highly to slightly weathered and low to high strength, bedding apparent at >200mm spacing

Along the western flanks of the Kumbarilla Ridge, resistant sandstone has formed distinct ridges and swarms of jumpups. These ridges and individual hills can rise approximately 40 m to 100 m above the surrounding slopes (see Appendix B, Figures 83, 87 and 88). The valley floor is generally covered by the thick Brigalow clays. Pockets of melonhole and crabhole gilgai occur. Some gilgai have been levelled for agriculture, but many remain. Adjacent to the major watercourses, sandy alluvium has been deposited over the floodplain areas. Linear relict fans, terraces and levees composed of reworked alluvium indicate the dynamicism and downcutting of the watercourses in recent geological times (Thwaites and Macnish, 1991). Occasional low, elongated relict dune ridges may also be found on the valley floor.

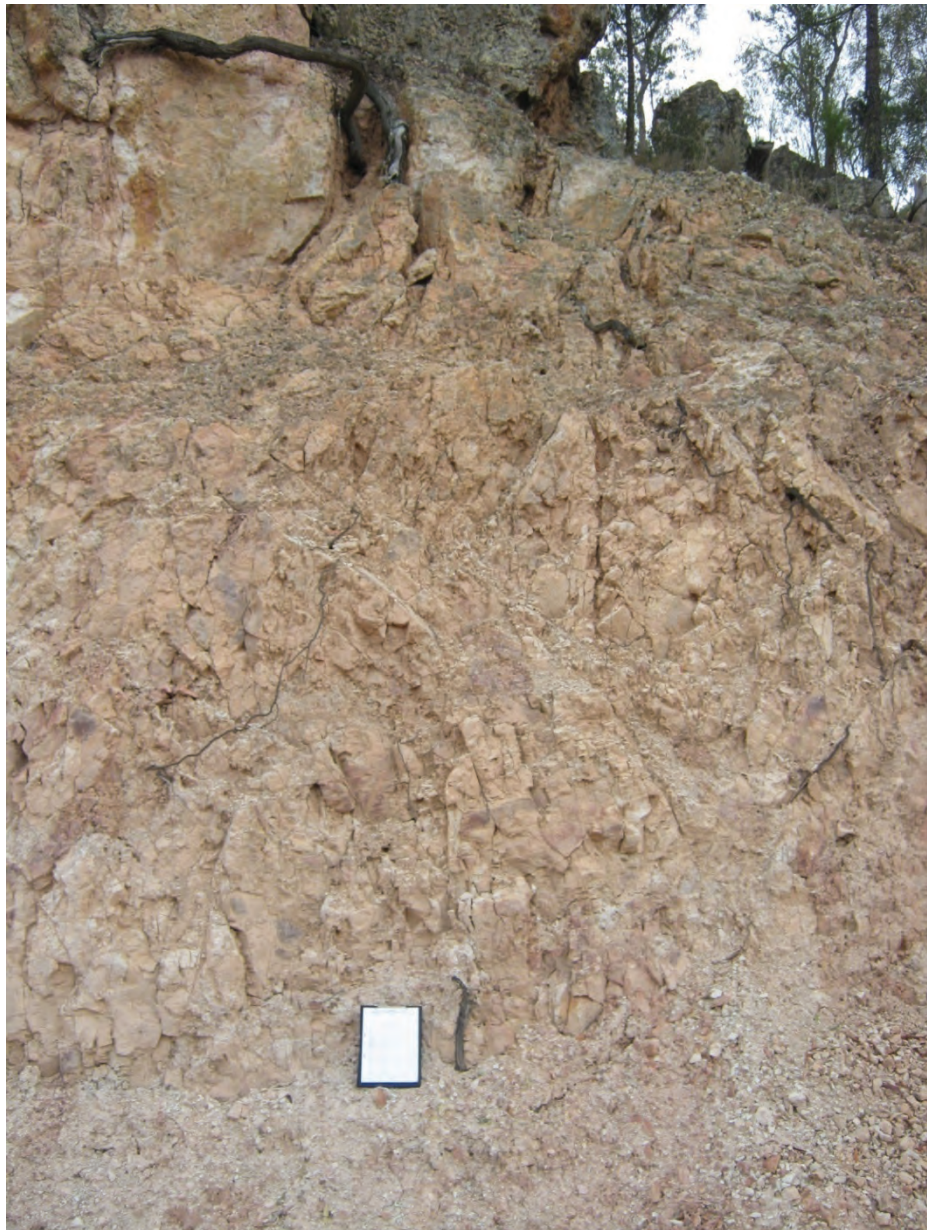
Figure 84: Road cutting, view to North

Location ID	Feature/Exposure Type	Location Co-ordinates		
		Zone	Easting	Northing
80 b	Road Cutting	56	0309505	6903982

Description
SANDSTONE, medium to coarse grained, orange – pale brown – pale grey, some red, some ironstaining, assessed highly to slightly weathered and low to high strength, bedding apparent at >200mm spacing

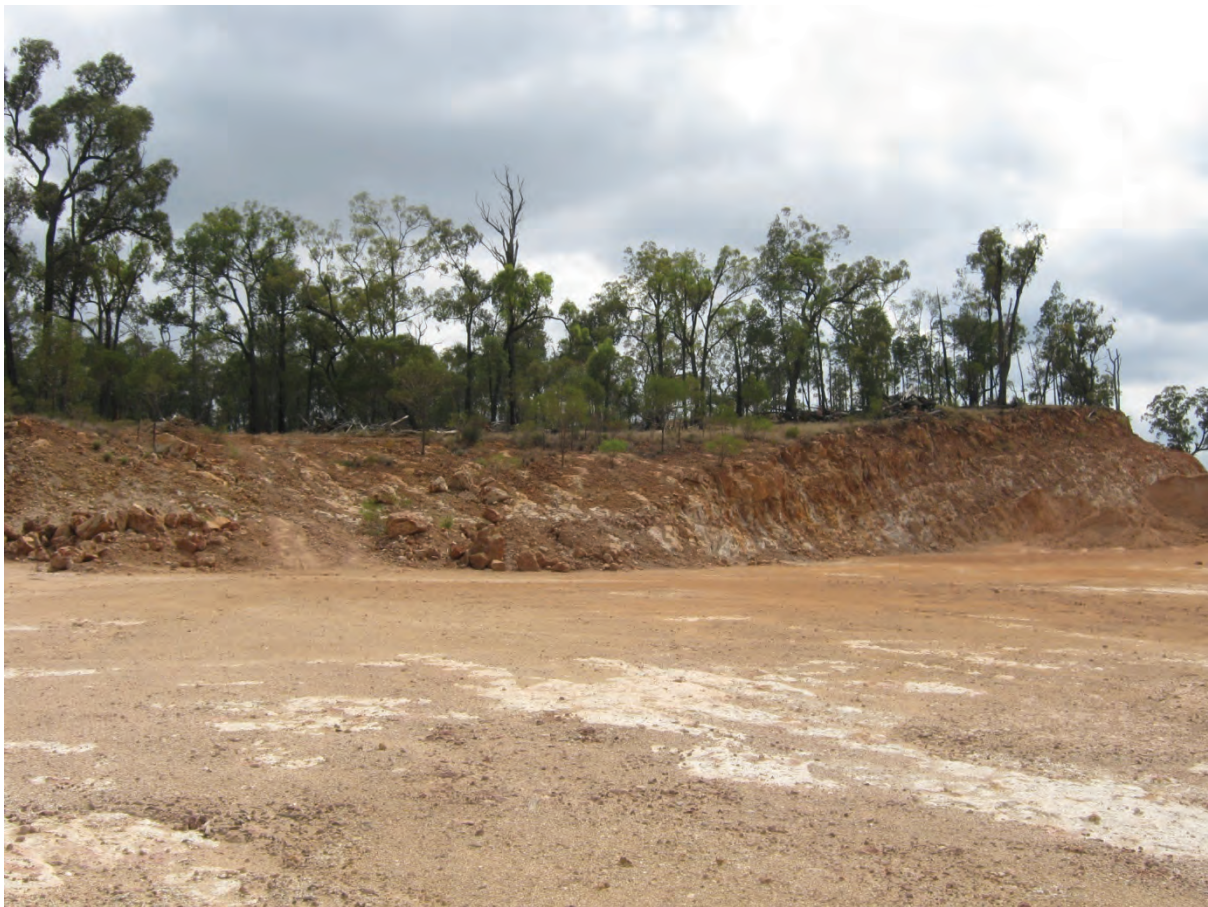
Figure 85: Borrow pit, view to Southeast

Location ID	Feature/Exposure Type	Location Co-ordinates		
		Zone	Easting	Northing
80 c	Borrow Pit	56	0309505	6903982

Description
SANDSTONE, medium to coarse grained, orange – pale brown – pale grey, some red, some ironstaining, assessed highly to slightly weathered and low to high strength, bedding apparent at >200mm spacing
CONGLOMERATE, fine to coarse gravel, cobble and some boulder sized clasts in a fine to coarse sand sized matrix, pale orange – orange – red - pale brown, assessed highly to slightly weathered and low to high strength

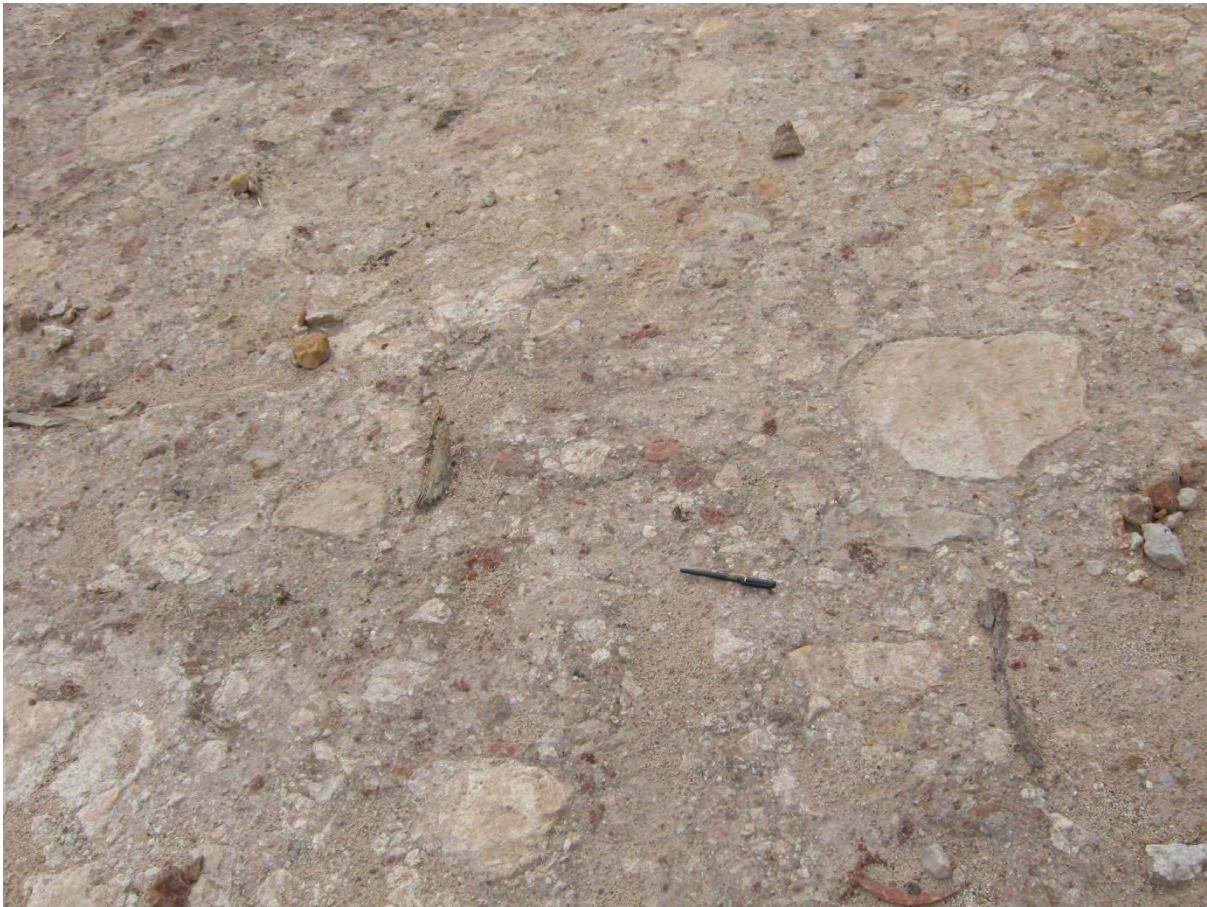
Figure 86: Breccia, view to South East

Location ID	Feature/Exposure Type	Location Co-ordinates		
		Zone	Easting	Northing
80 c	Borrow Pit	56	0309505	6903982

Description
BRECCIA, fine to coarse gravel, cobble and boulder sized, sub angular to angular clasts in fine to coarse sand sized matrix, dark grey – grey – some red – some pale grey, assessed moderately to slightly weathered and high strength

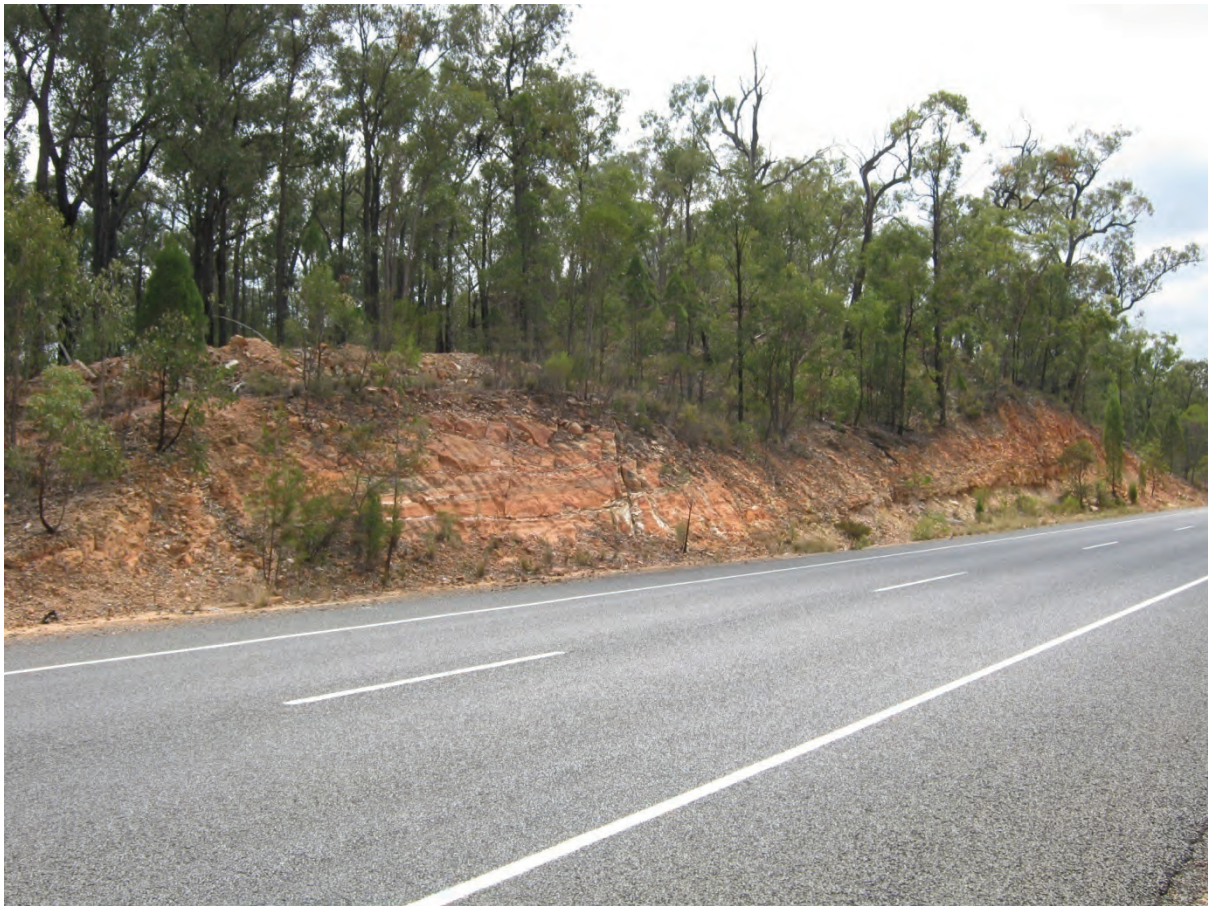
Figure 87: Road cutting, view to Northeast

Description
<p>SANDSTONE, coarse grained, red – orange – pale grey with orange and red ironstaining, assessed highly to moderately weathered and low to medium strength, some honeycomb weathering, cross bedding observed – cm scale</p> <p>Some interbedded SANDSTONE and SILTSTONE</p> <p>SILTSTONE, red – brown – orange with orange and red ironstaining, assessed highly to moderately weathered, very low to low strength, bedding planar and &lt; cm scale</p>

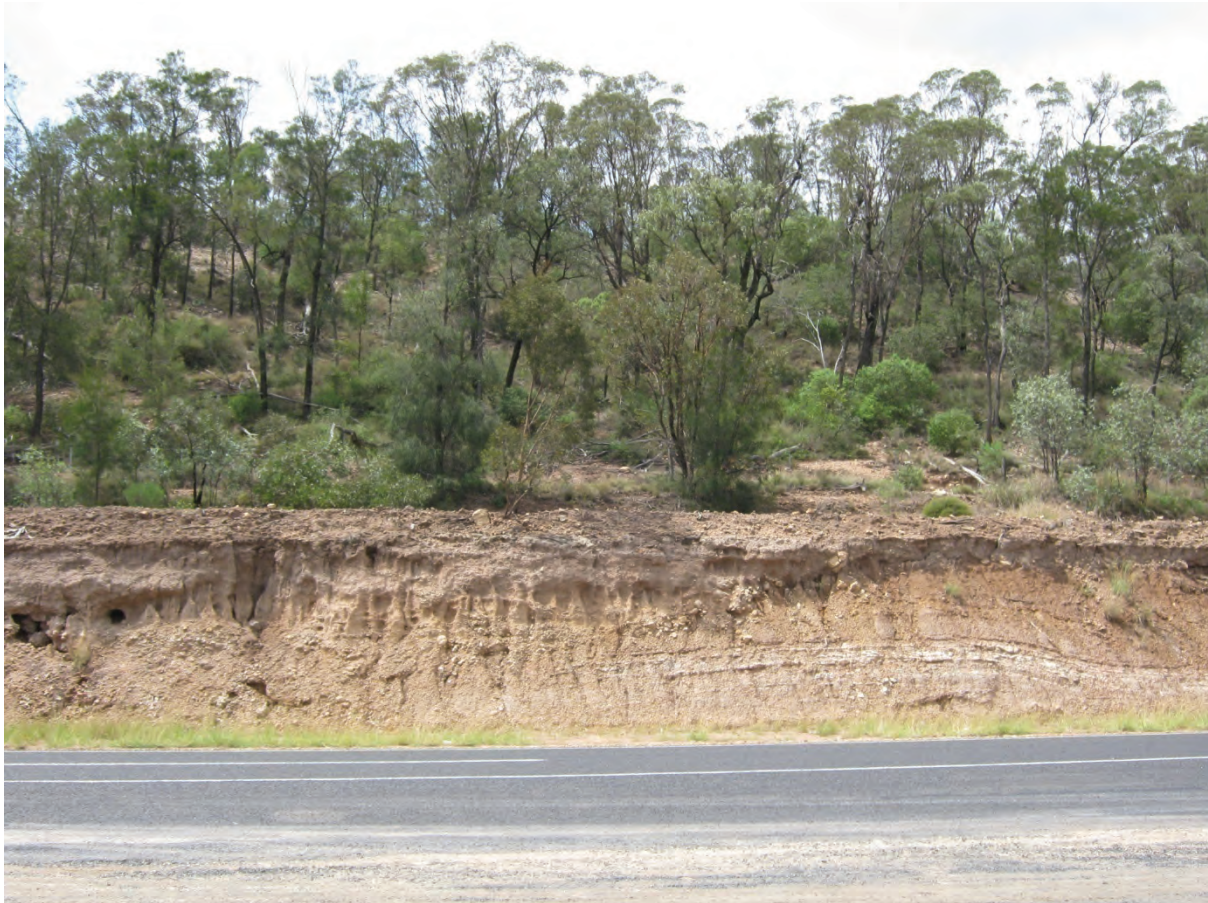
Figure 89: Road cutting, view to Southeast

Location ID	Feature/Exposure Type	Location Co-ordinates		
		Zone	Easting	Northing
83	Road Cutting	56	0205456	6896910

Description
<p>SANDSTONE, fine to medium grained, some coarse grained, pale grey – pale brown – white, some orange ironstaining, assessed highly weathered and low strength, bedding apparent and generally &lt;200mm</p> <p>Extremely weathered material overlying weathered rock, apparent as Clayey SAND, fine to coarse grained, pale grey to orange – brown, low plasticity clay, some fine grained gravel</p> <p>Some Colluvium, apparent as Sandy GRAVEL, fine to coarse grained, pale grey – brown – orange, fine to coarse grained sand, some low plasticity clay, some cobbles, trace boulders</p>
