**GEOLOGY, LANDFORM AND SOILS  
STUDY  
ARROW ENERGY SURAT GAS PROJECT,  
SURAT BASIN, QUEENSLAND**

Report Date: 6 December 2011  
Project Ref: ENAUBRIS07040AC-  
9097\_GLS\_Rev4.docx

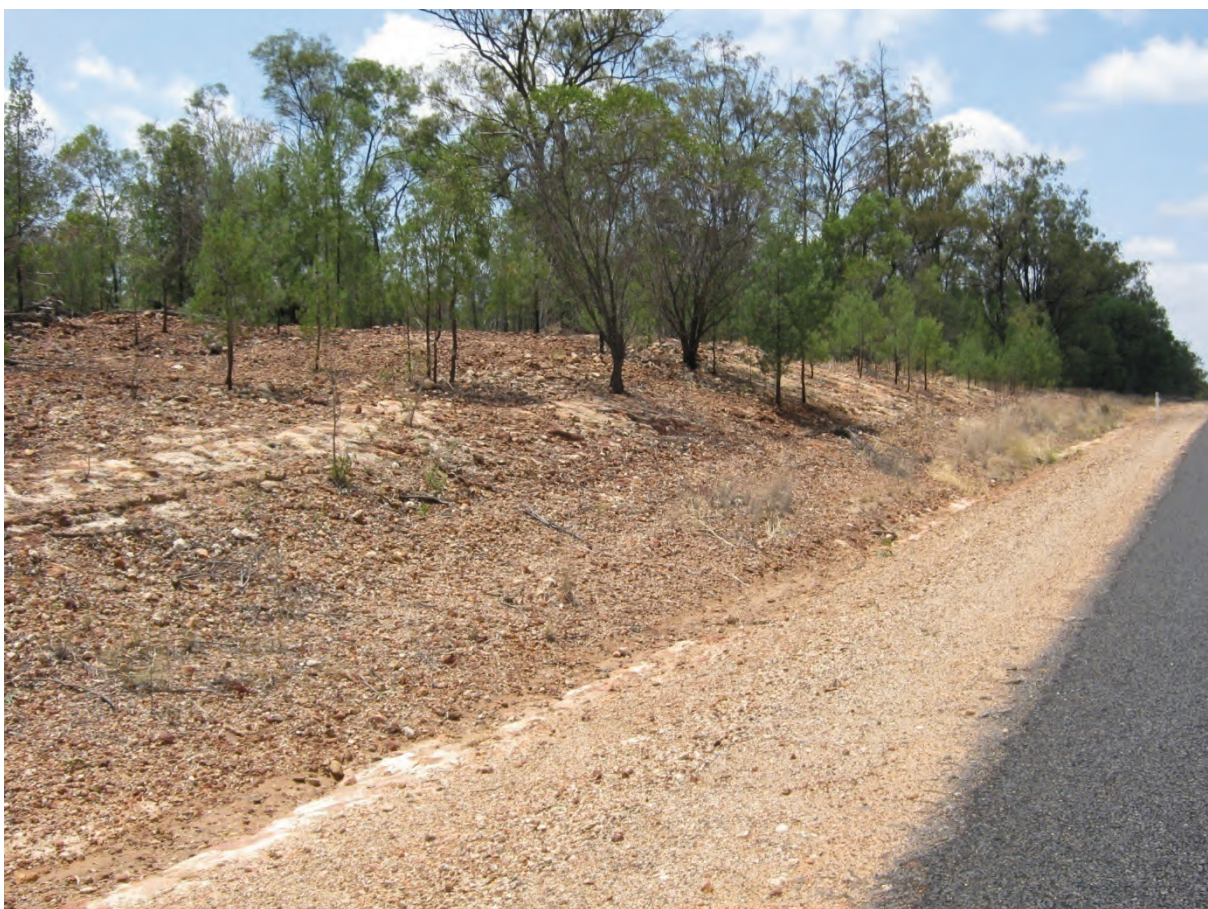
Figure 93: Road cutting, view to Southeast

Description
SANDSTONE, fine to coarse grained, pale grey – pale brown – orange – red, with orange and red ironstaining, assessed highly to moderately weathered and low to high strength, at least 3 joint sets, 300mm – 500mm spacing
Some CONGLOMERATE, fine to coarse gravel, some cobbles in fine to coarse sand matrix, pale grey – white – orange – red, with orange and red ironstaining, assessed highly to slightly weathered and low to medium strength

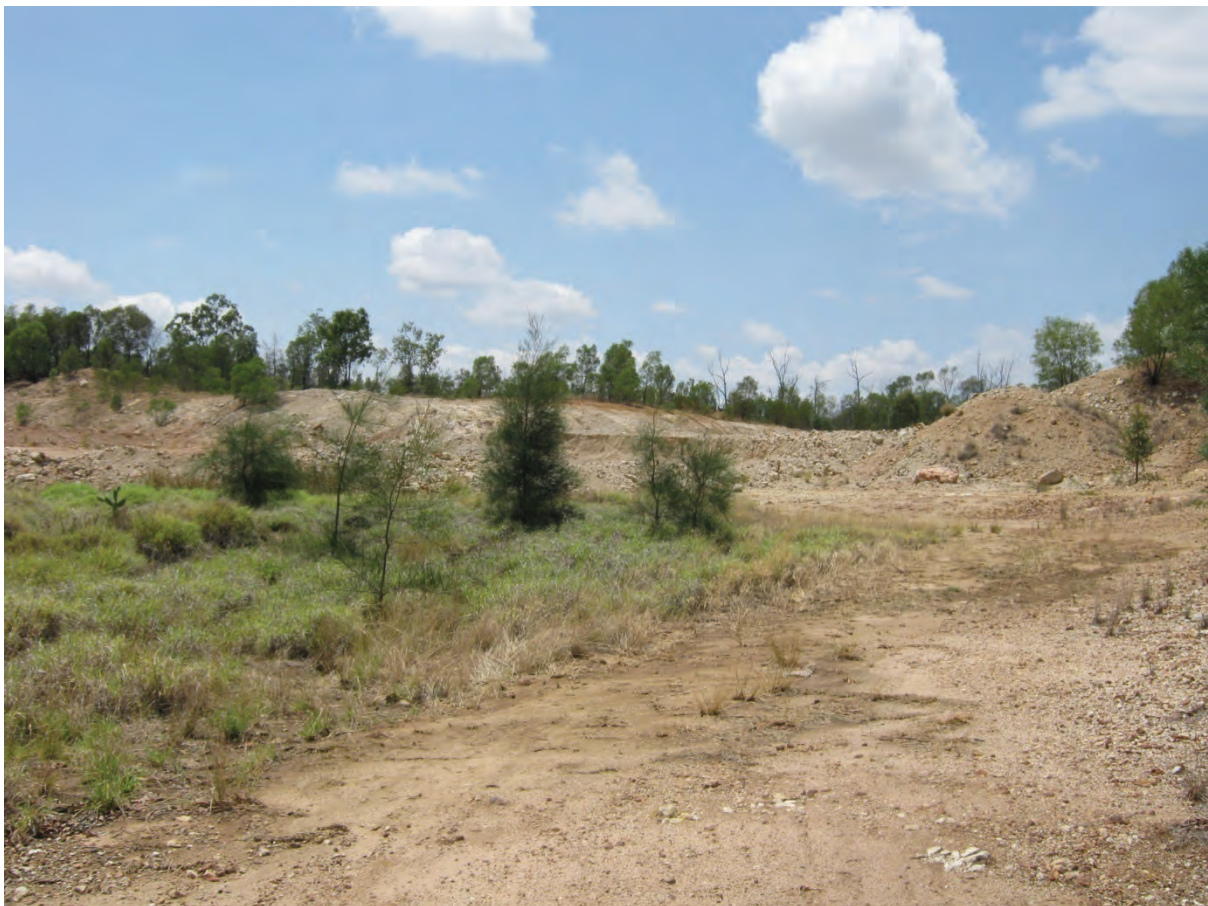
Figure 94: Borrow pit, view to Southeast

Description
<p>SANDSTONE, fine to coarse grained, pale grey – pale brown – orange – red, with orange and red ironstaining, assessed highly to moderately weathered and low to high strength, at least 3 joint sets, 300mm – 500mm spacing</p> <p>Some CONGLOMERATE, fine to coarse gravel, some cobbles in fine to coarse sand matrix, pale grey – white – orange – red, with orange and red ironstaining, assessed highly to slightly weathered and low to medium strength</p>

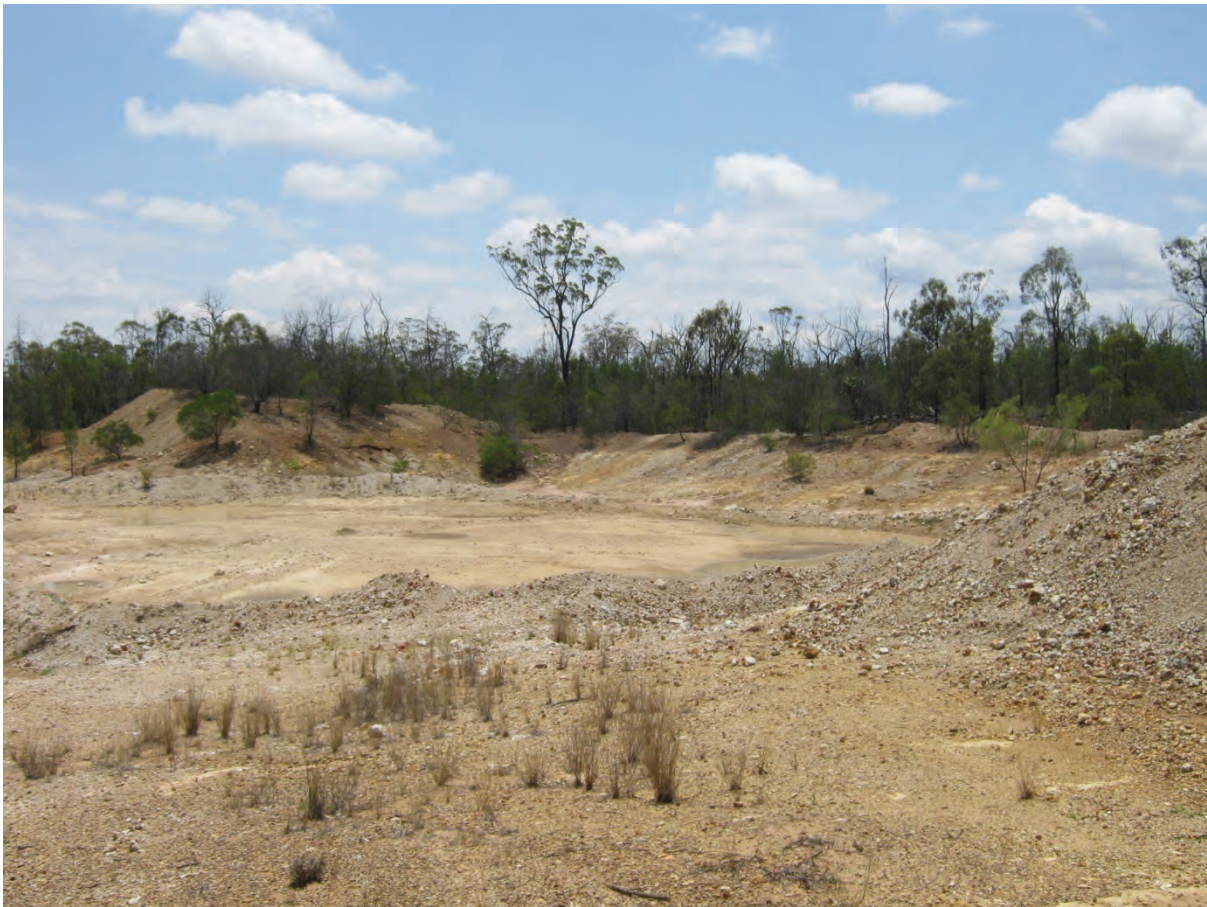
Figure 95: Borrow pit, view to Northeast

Description
<p>SANDSTONE, fine to medium grained, pale grey, with orange and red ironstaining, assessed highly to moderately weathered and low to high strength, at least 3 joint sets, 300mm – 500mm spacing</p> <p>Some CONGLOMERATE, fine to coarse gravel, some cobbles in fine to coarse sand matrix, pale grey – white – orange – red, with orange and red ironstaining, assessed highly to slightly weathered and low to medium strength</p>

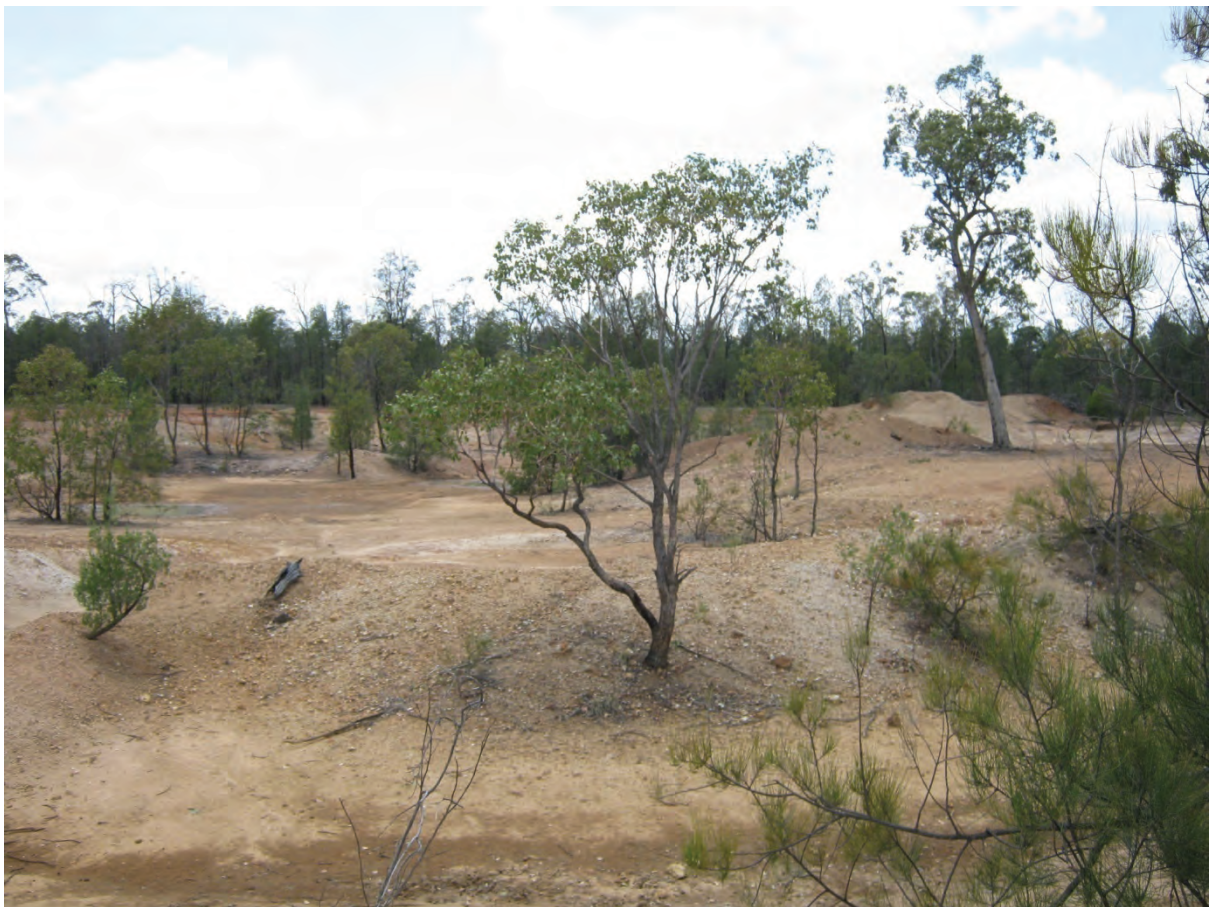
Figure 96: Borrow pit, view to East - Northeast

Description
<p>SANDSTONE, fine to medium grained, pale grey, with orange and red ironstaining, assessed highly to moderately weathered and low to high strength, at least 3 joint sets, 300mm – 500mm spacing</p> <p>Some CONGLOMERATE, fine to coarse gravel, some cobbles in fine to coarse sand matrix, pale grey – white – orange – red, with orange and red ironstaining, assessed highly to slightly weathered and low to medium strength</p>

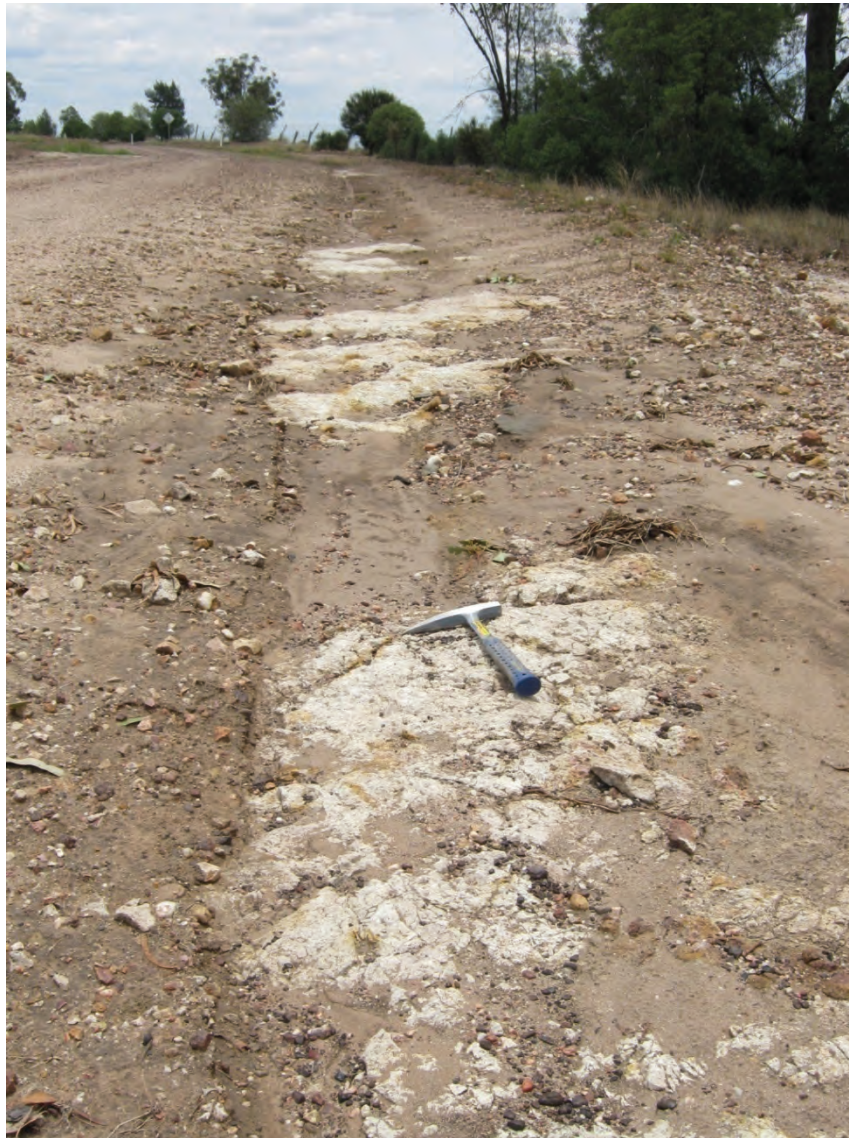
Figure 100: Road drain view to North – Northwest

Description
<p>CONGLOMERATE, fine to medium sized gravel, sub rounded to rounded, in fine grained sand sized matrix, some medium to coarse sand sized clasts, pale grey with some orange ironstaining, assessed highly to moderately weathered and very low to medium strength</p> <p>SANDSTONE, fine to medium grained, pale grey – white, assessed highly to moderately weathered and low to medium strength</p> <p>SANDSTONE is dominant lithology, some interbedding, contains some fine grained gravel</p>

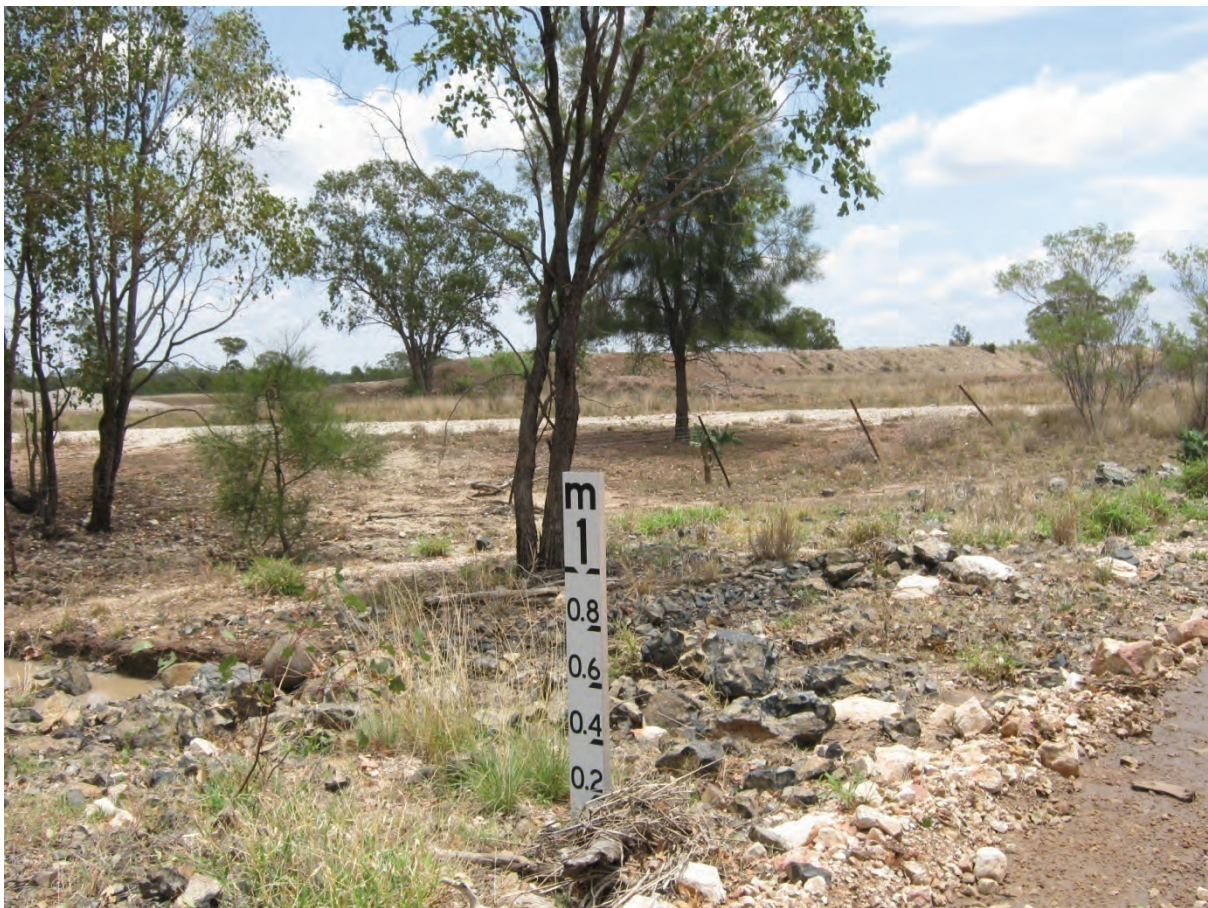
Figure 101: Borrow pit, view to Northwest

Description
<p>CONGLOMERATE, fine to medium sized gravel, sub rounded to rounded, in fine grained sand sized matrix, some medium to coarse sand sized clasts, pale grey with some orange ironstaining, assessed highly to moderately weathered and very low to medium strength</p> <p>SANDSTONE, fine to medium grained, pale grey – white, assessed highly to moderately weathered and low to medium strength</p> <p>SANDSTONE is dominant lithology, some interbedding, contains some fine grained gravel</p>

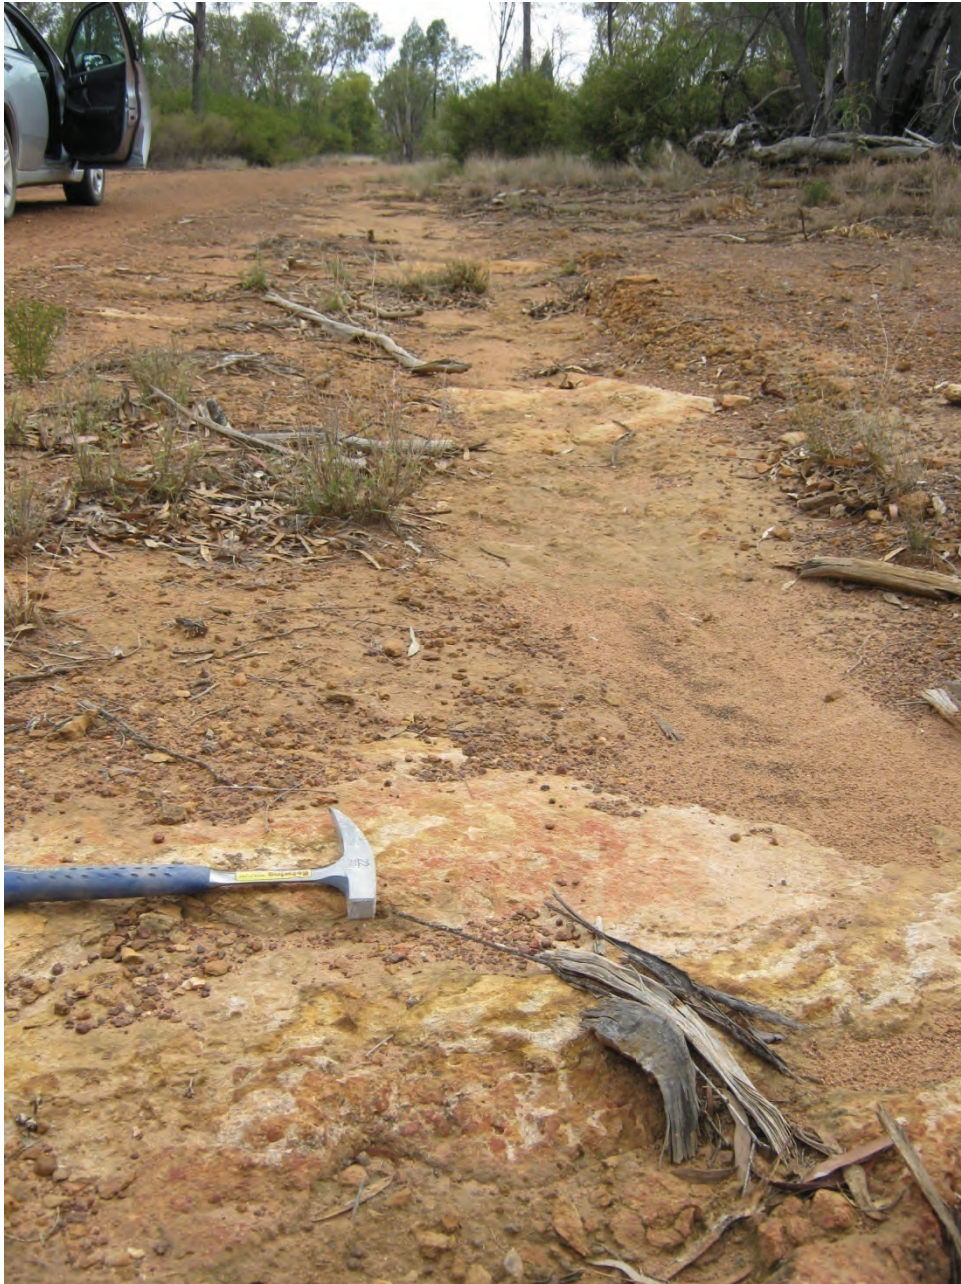
Figure 104: Rock outcrop, view to South

Description
SANDSTONE, medium to coarse grained, pale brown – pale grey –some red, some orange ironstaining, assessed moderately weathered and medium to high strength

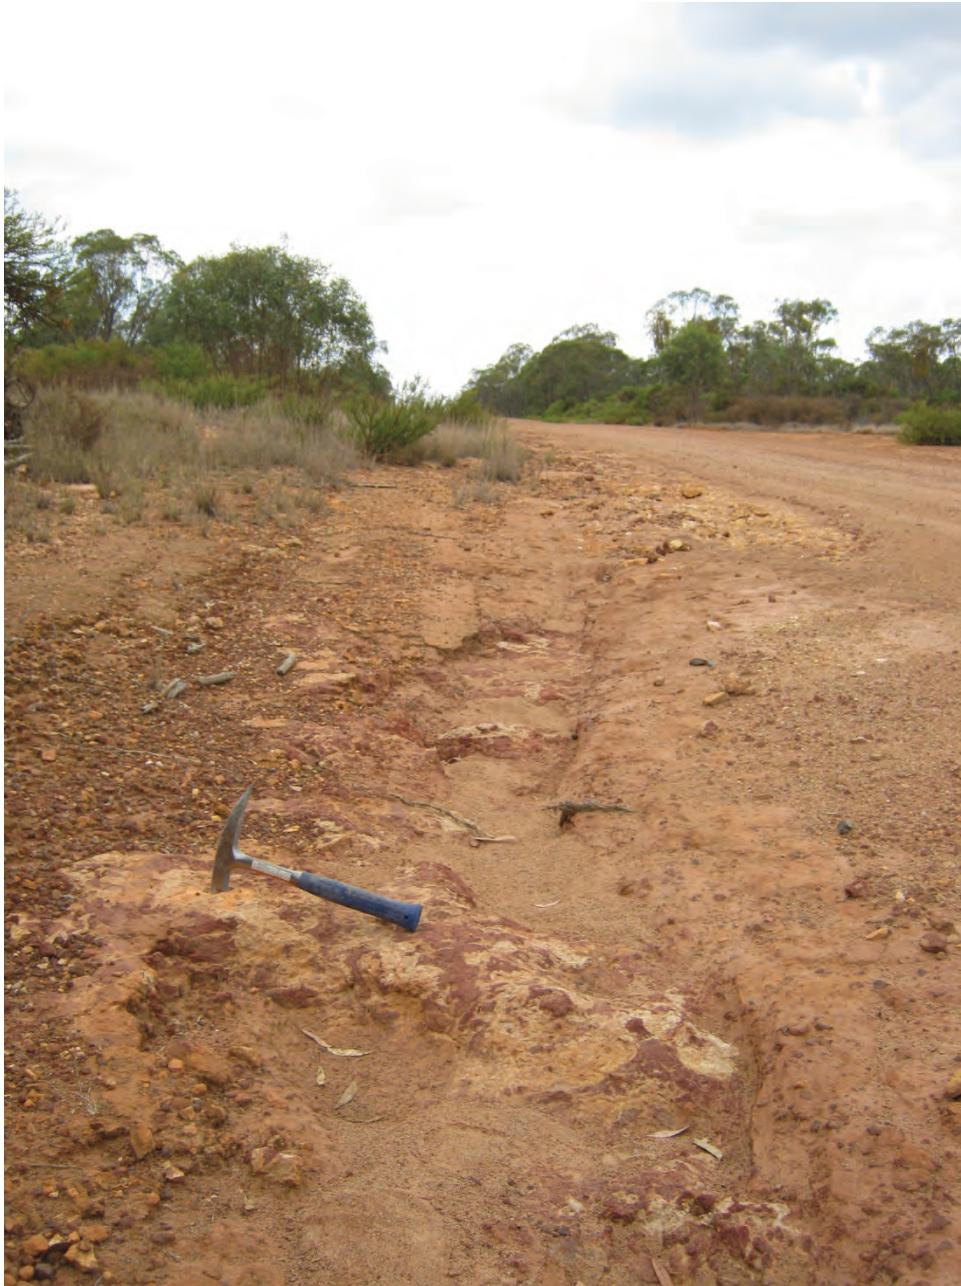
Figure 105: Rock outcrop, view to South

Description
SANDSTONE, medium to coarse grained, pale brown – pale grey –some red, some orange ironstaining, assessed moderately weathered and medium to high strength, includes some fine clasts

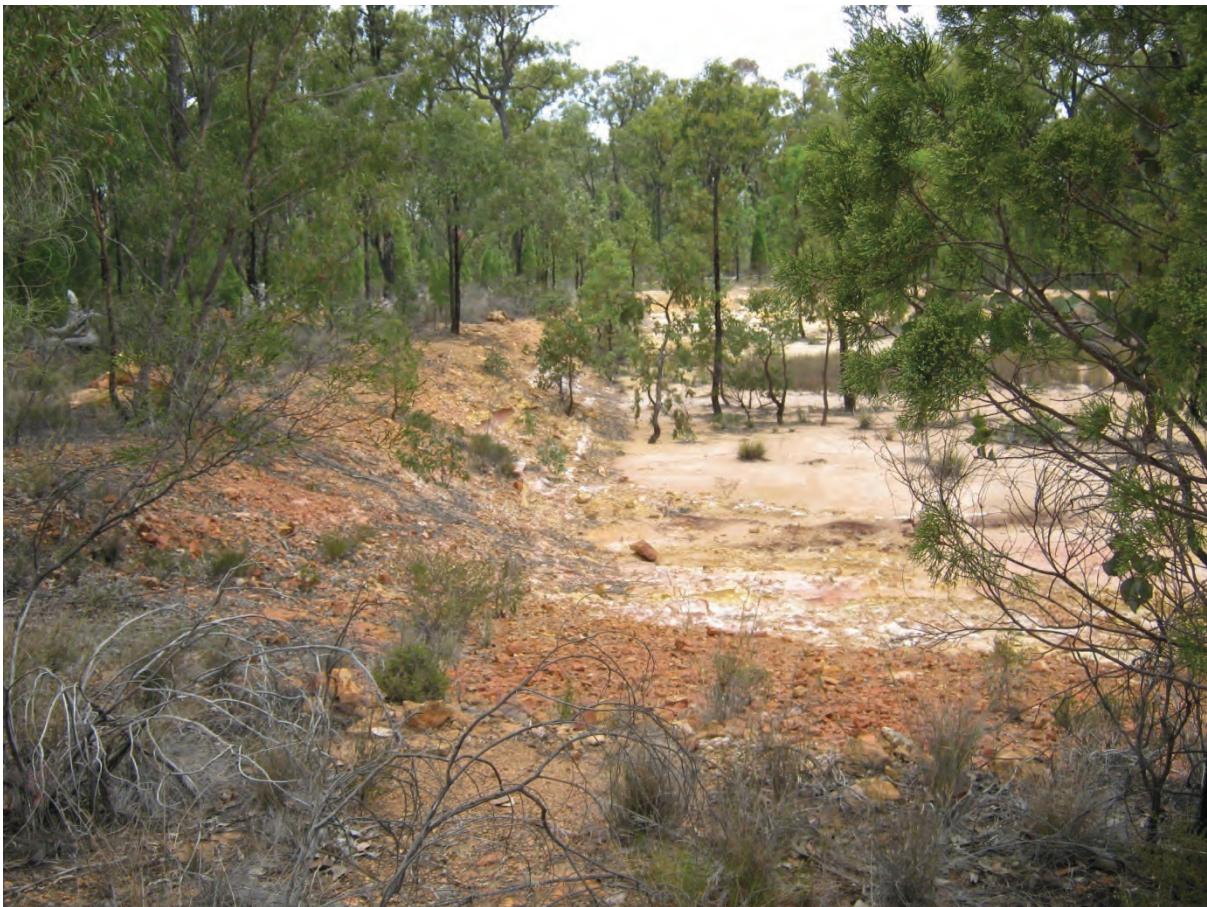
Figure 107: Borrow pit, view to West

Description
<p>SANDSTONE, medium to coarse grained, pale brown – pale grey –some red, some orange ironstaining, assessed highly to moderately weathered and low to medium strength</p> <p>Some interbedded CONGLOMERATE, fine to coarse gravel, some cobble, some boulder sized clasts, all sub rounded to rounded, in fine to coarse sand sized matrix, pale grey – white – pale brown, some orange and red ironstaining, assessed moderately to slightly weathered and medium to high strength</p>

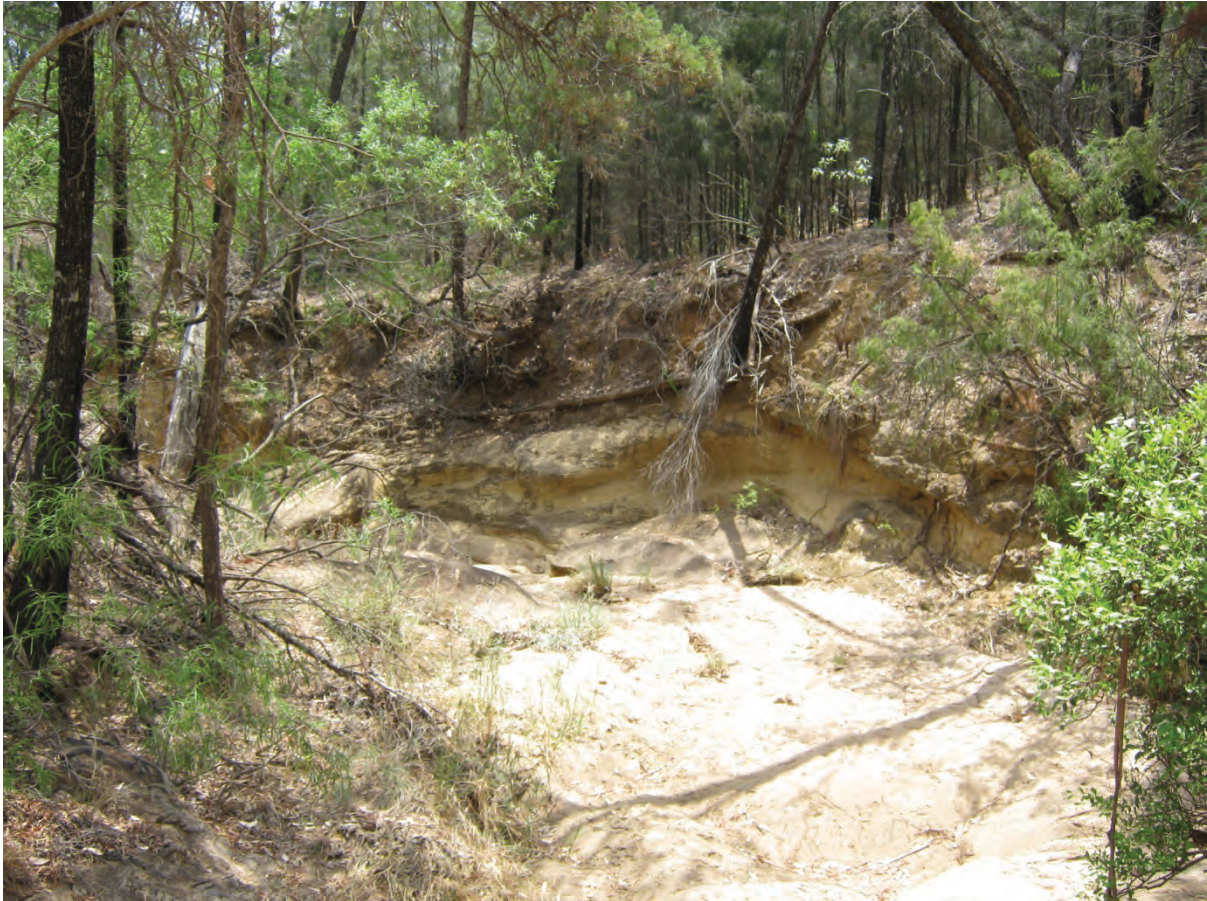
Figure 111: Creek, view to West

Description
SANDSTONE, medium to coarse grained, pale brown, assessed moderately to slightly weathered and medium to high strength, bedding 10mm – 200mm, no joints observed

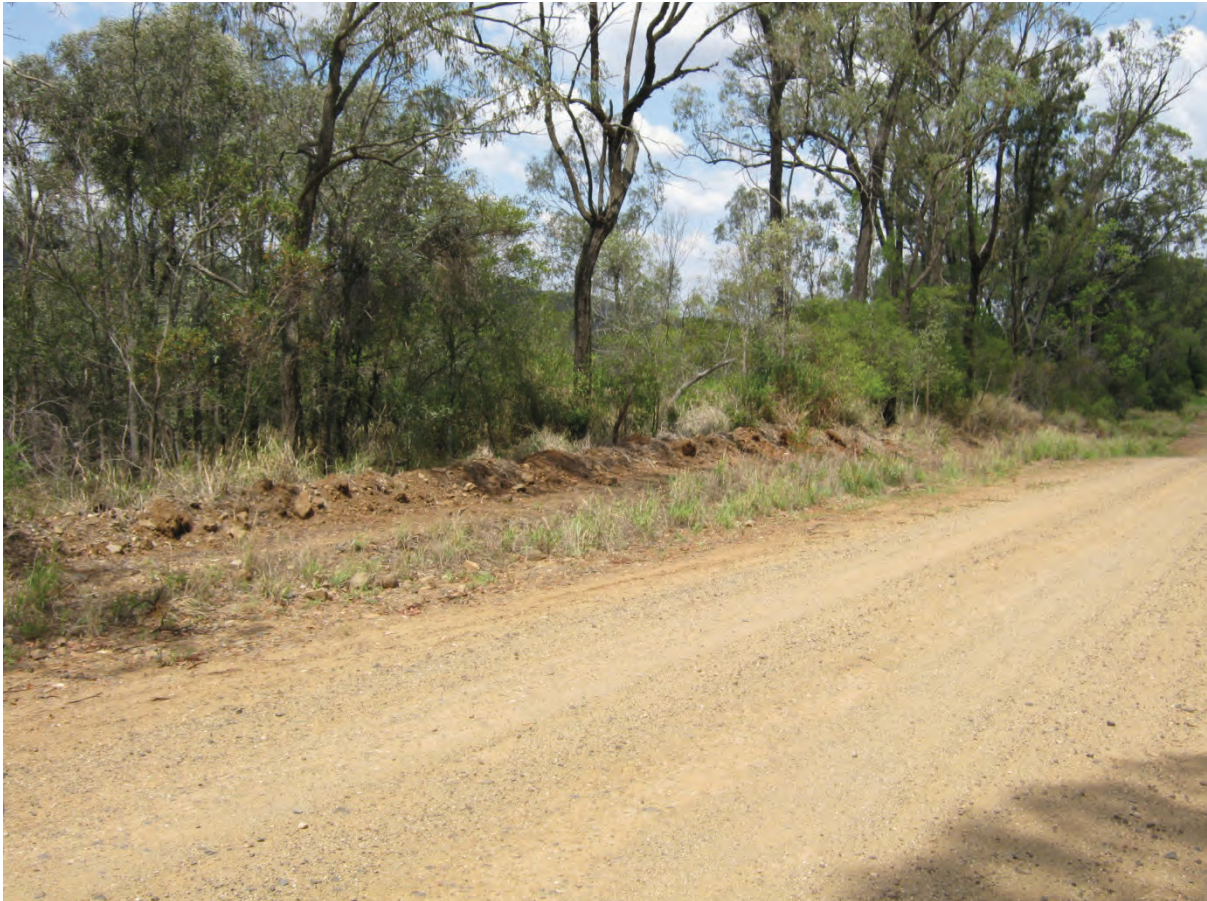
Figure 116: Road cutting, view to East

Description
Basalt cobbles and boulders in soil matrix

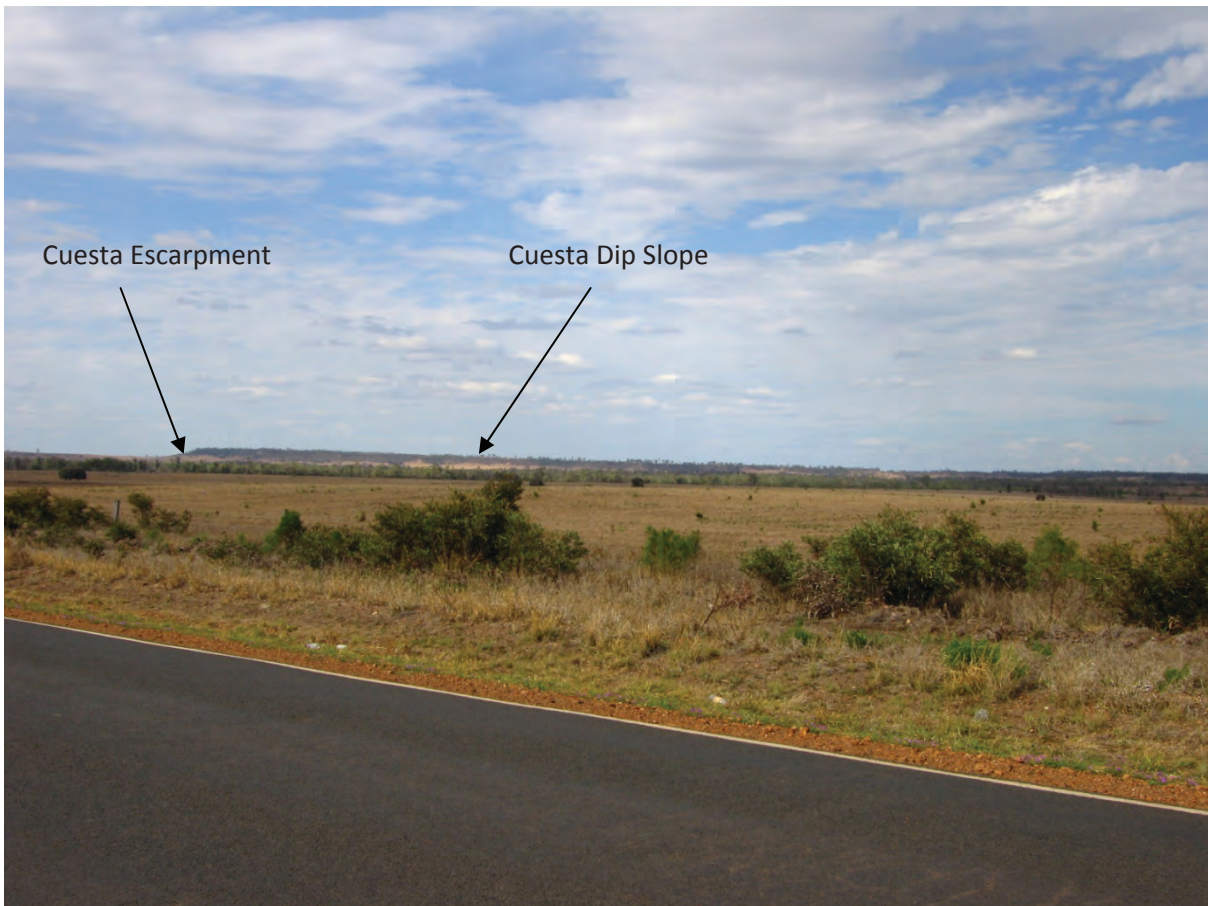
Figure 117

Description
Cuesta (background) with a plateau-like appearance due to the shallow dip of the strata

Cuestas are formed by the erosion of gently tilted sedimentary rocks: the dip slope parallel to the dip of the strata and the steep escarpment representing the eroded face. In the study area, the dip is sufficiently shallow that the cuestas take a plateau-like appearance (see Appendix B, Figure 117). These features may be found in the north of the study area, where resistant laterised sandstones cap the dip-slopes.

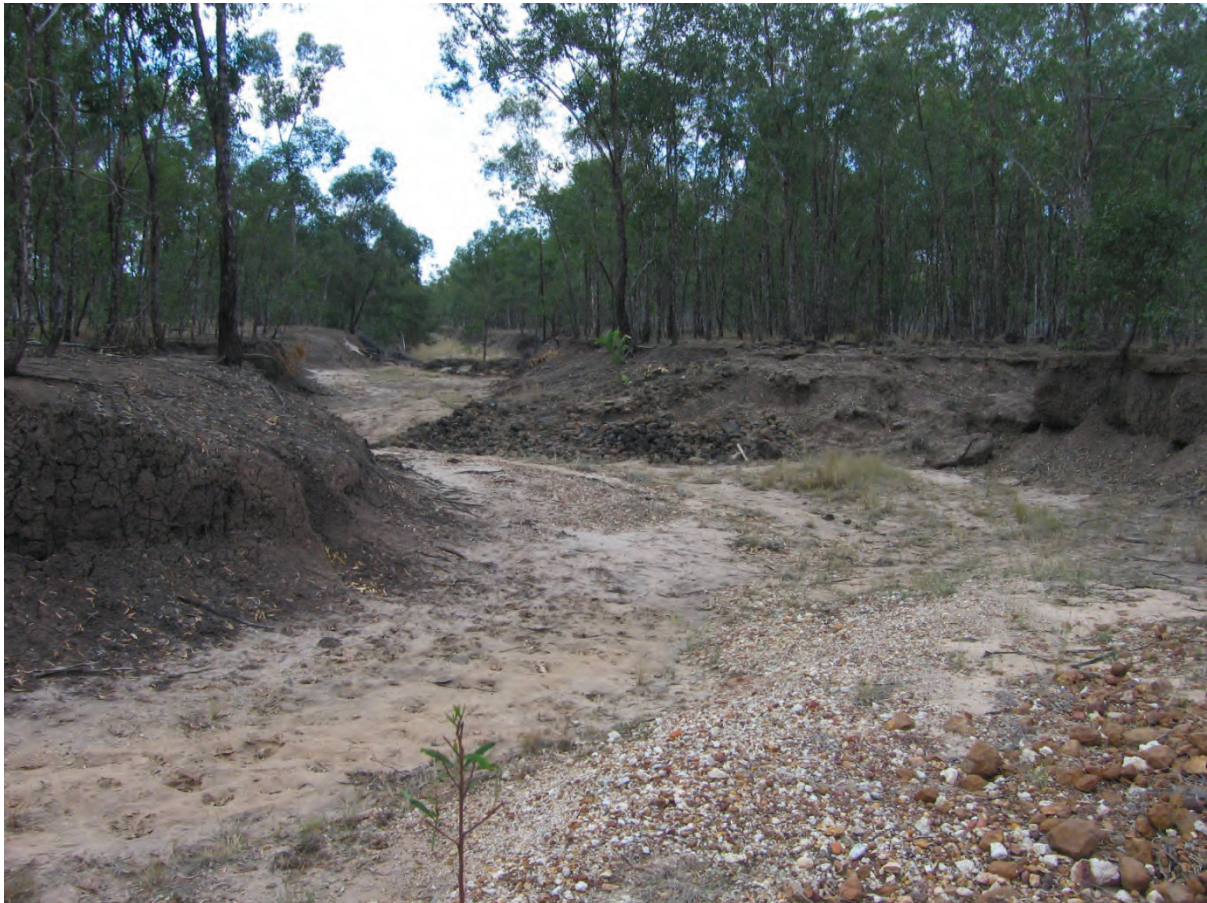
Figure 319

Description
Creek incision exposing dispersive Vertosol profiles.

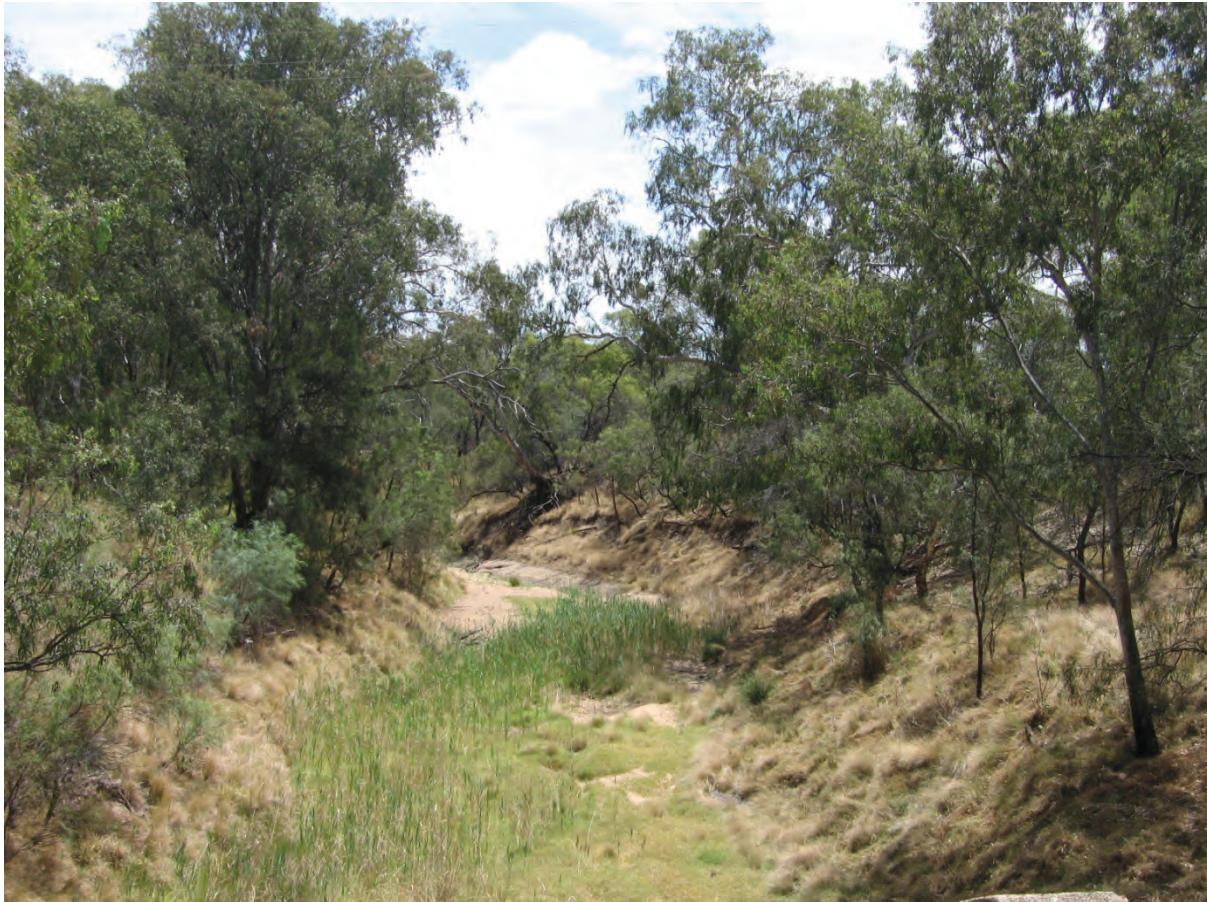
Figure 420

Description
Incised Condamine River with sandy alluvium base

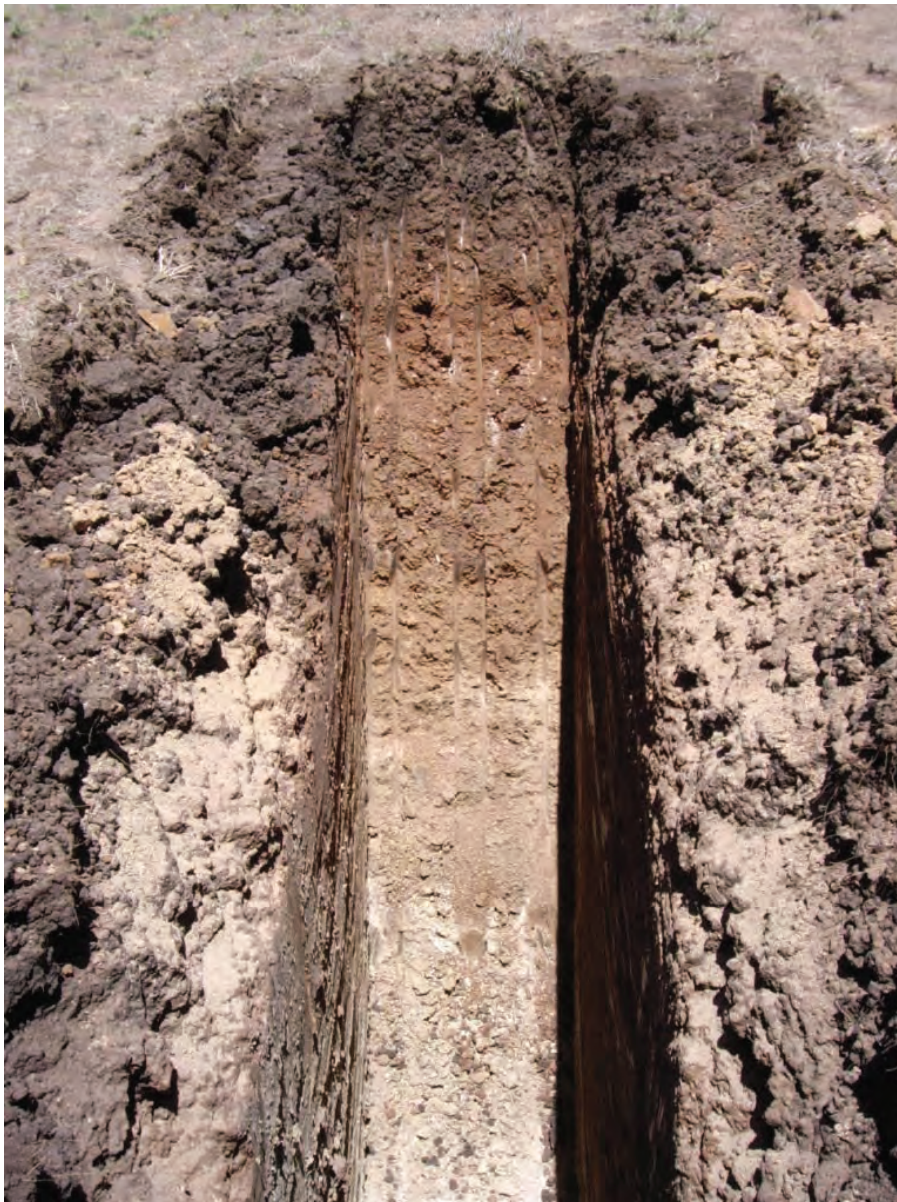
Figure 521

Description
Test pit excavation exposing Brown Dermosol soil profile (TU IIIId; Cheshire LRA soil type)

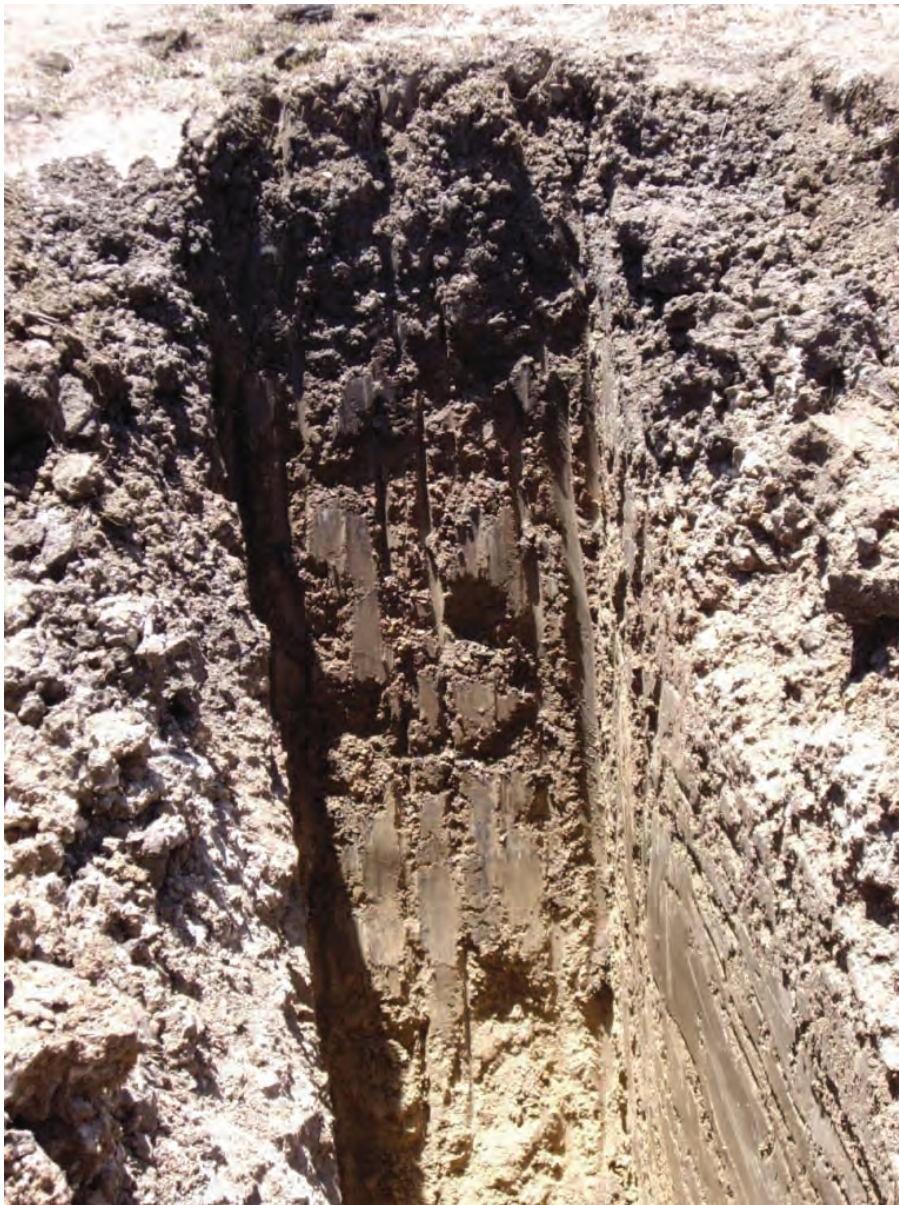
Figure 622

Description
Test pit excavation exposing Brown Dermosol soil profile (TU Va; Kinnoul LRA soil type)

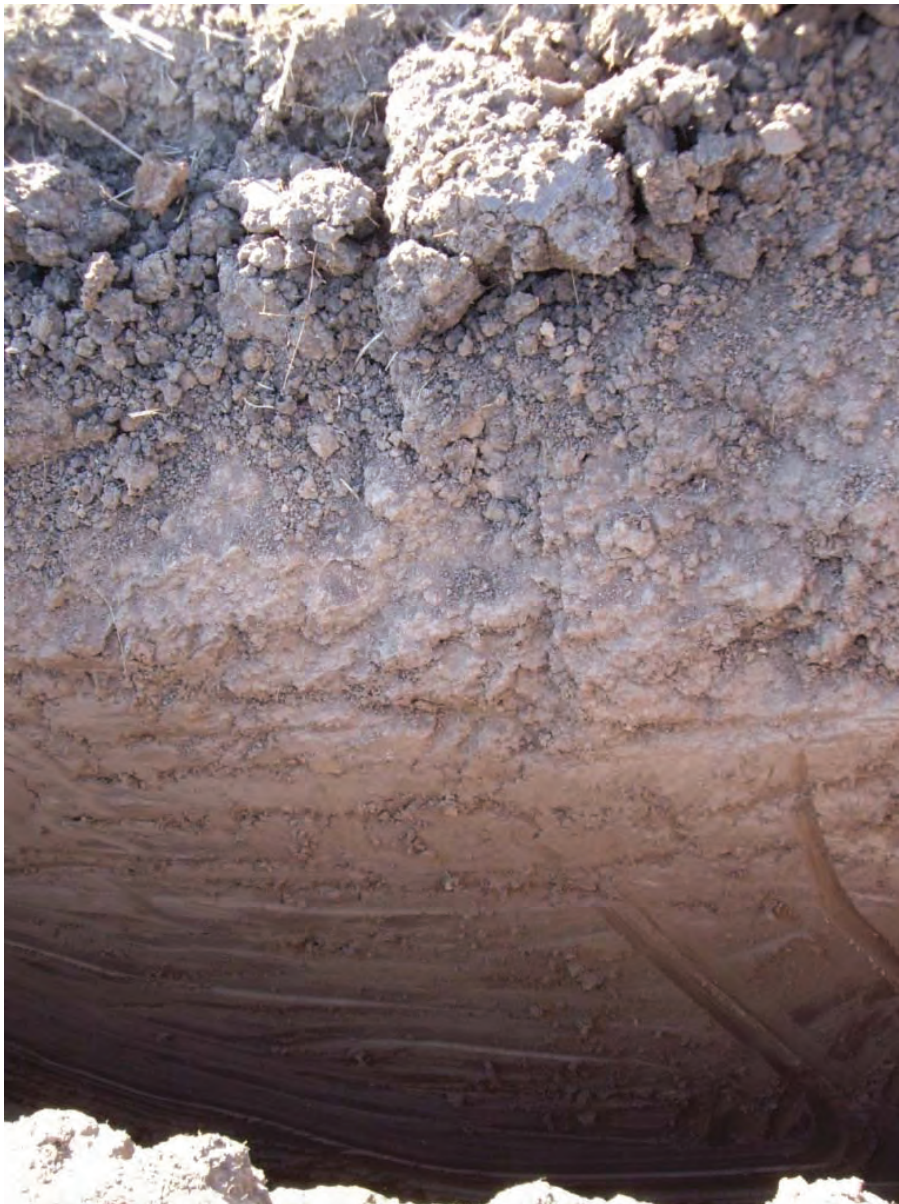
Figure 723

Description
Test pit excavation exposing Brown Sodosol soil profile (TU Ila; Taurus LRA soil type)

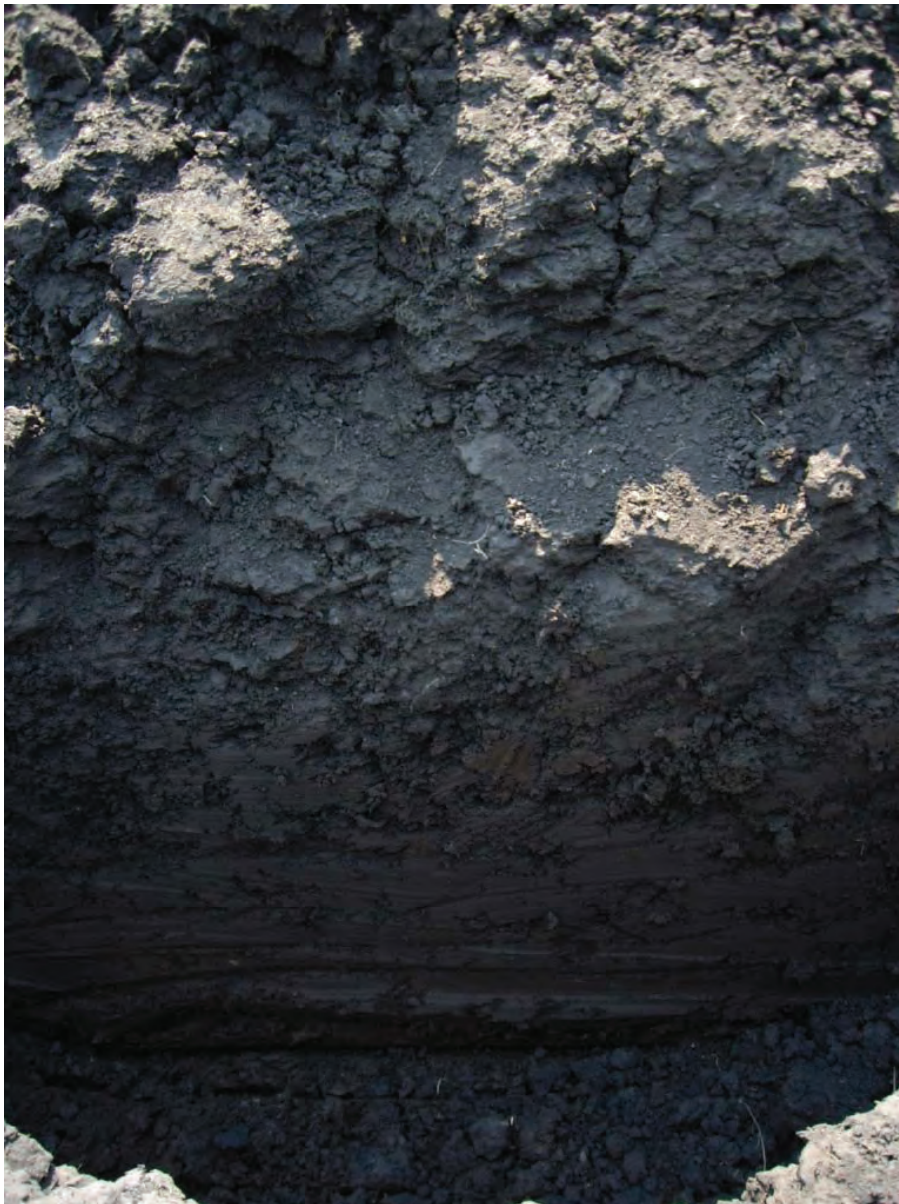
Figure 824

Description
Test pit excavation exposing Grey Vertosol soil profile (TU IIIb; Tara LRA soil type)

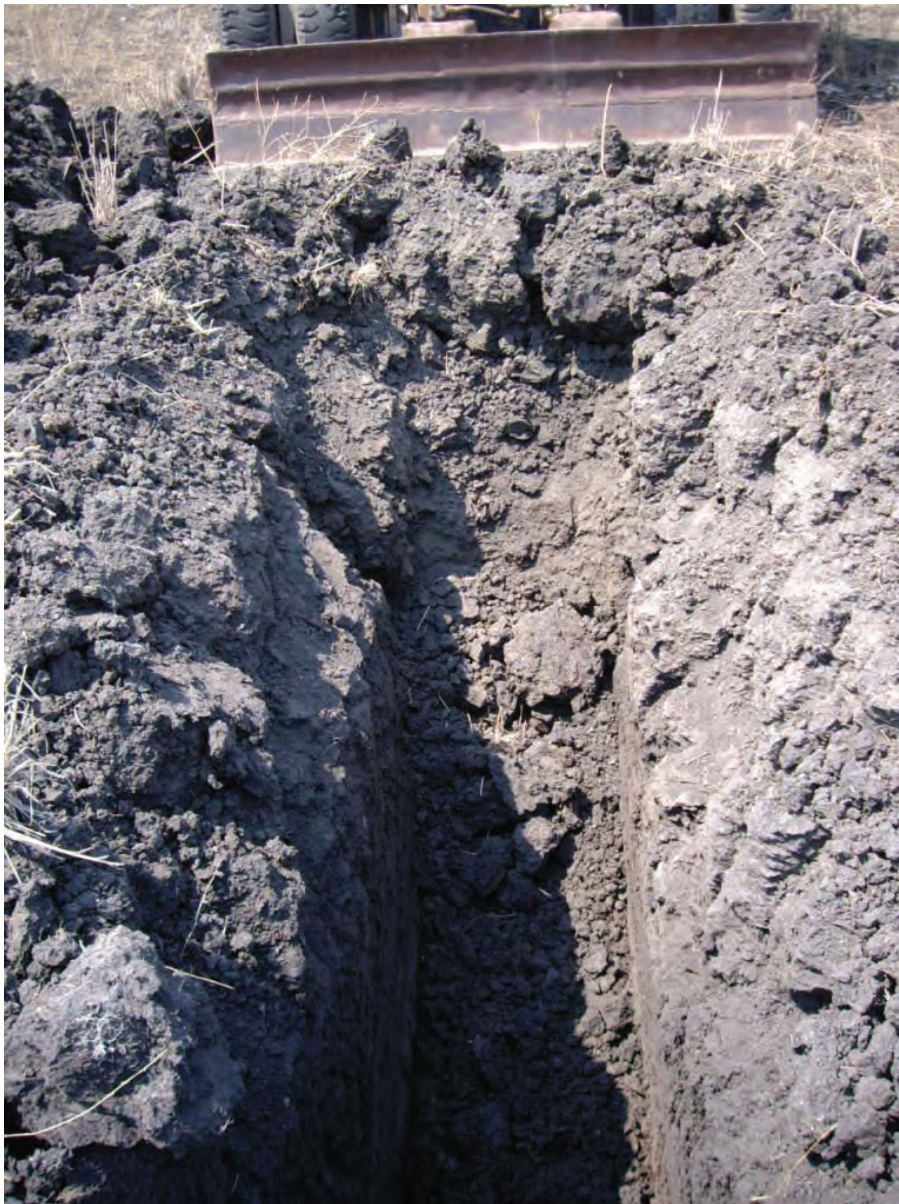
Figure 925

Description
Test pit excavation exposing Grey Vertosol soil profile (TU 1a; Condamine LRA soil type)
