**GEOLOGY, LANDFORM AND SOILS  
STUDY  
ARROW ENERGY SURAT GAS PROJECT,  
SURAT BASIN, QUEENSLAND**

Report Date: 6 December 2011  
Project Ref: ENAUBRIS07040AC-  
9097\_GLS\_Rev4.docx

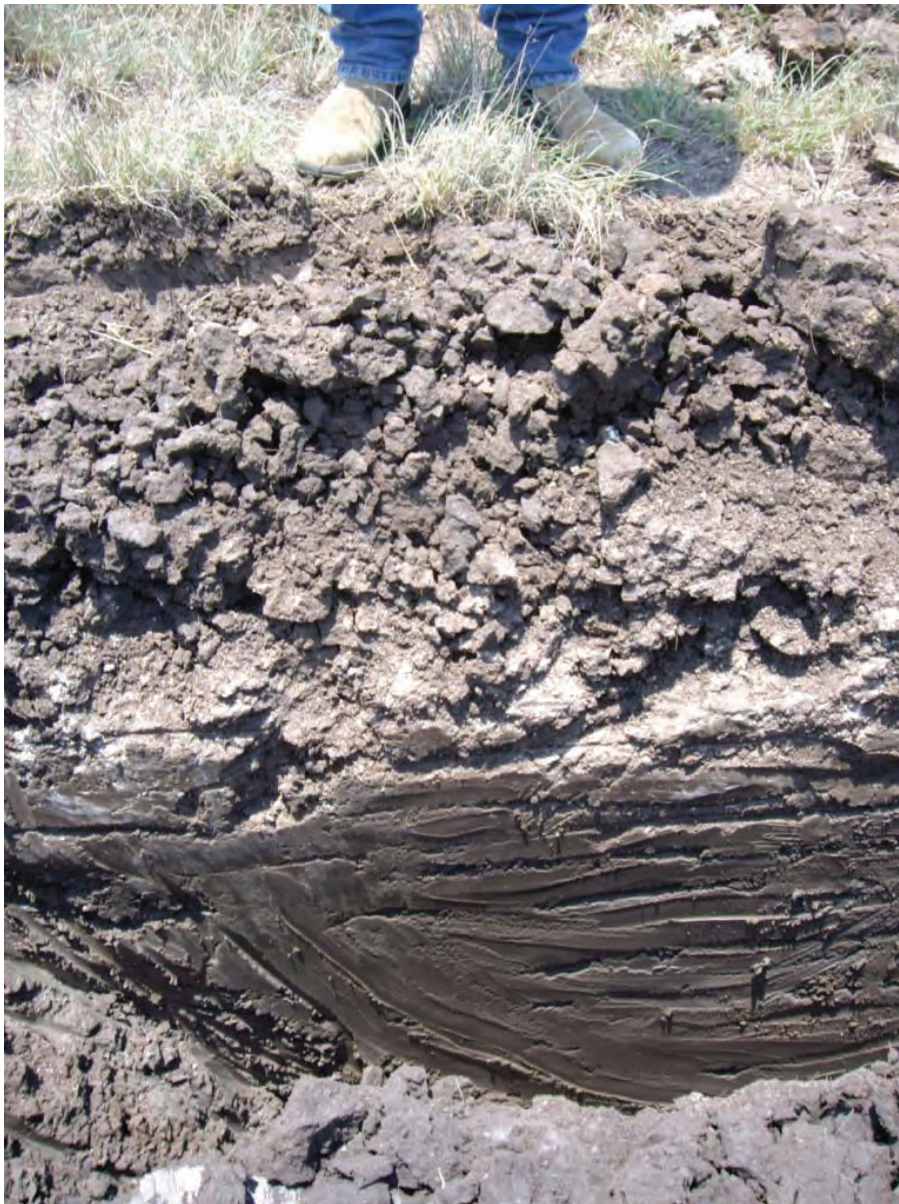
Figure 1026

Description
Test pit excavation exposing Grey Vertosol soil profile (TU IVb; Kupunn LRA soil type)

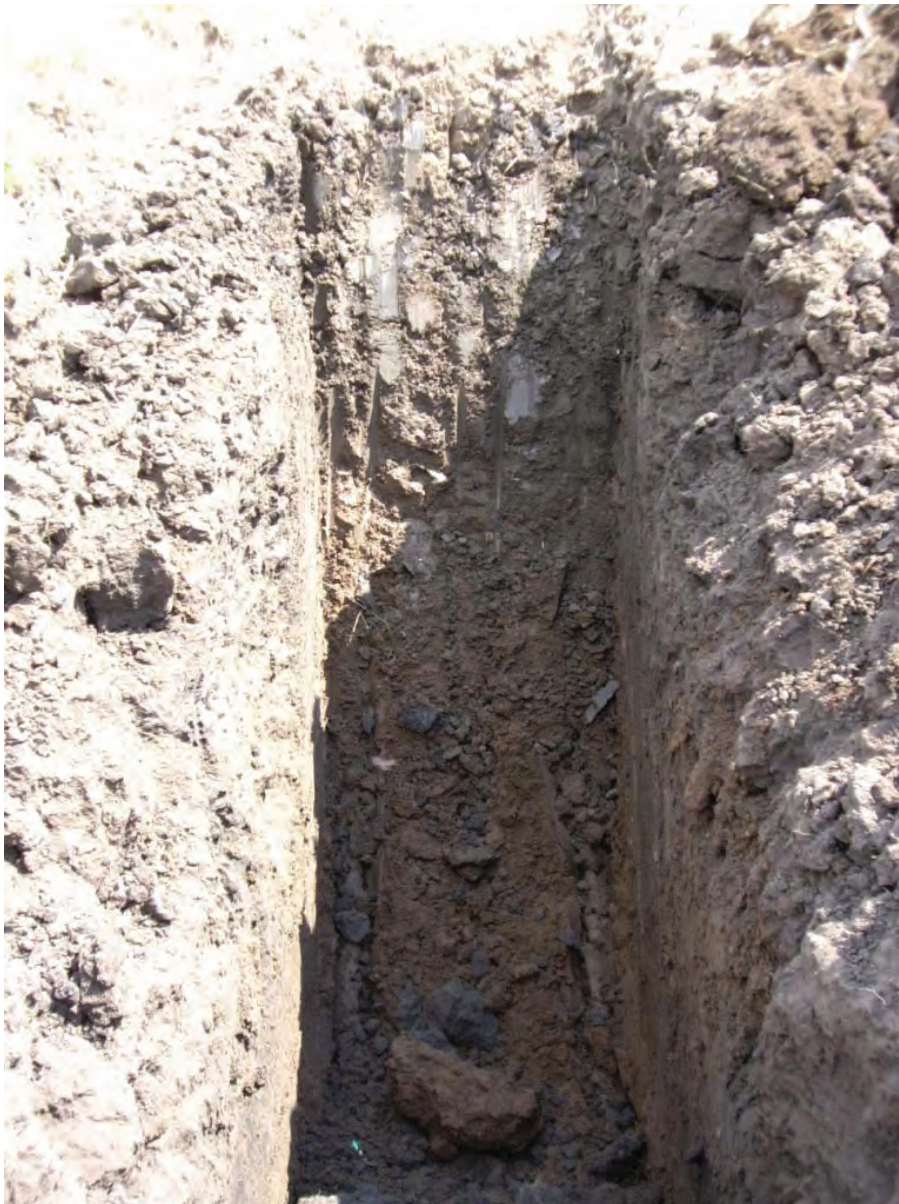
Figure 1127

Description
Test pit excavation exposing Brown Chromosol soil profile (TU Id; Hazlemere LRA soil type)

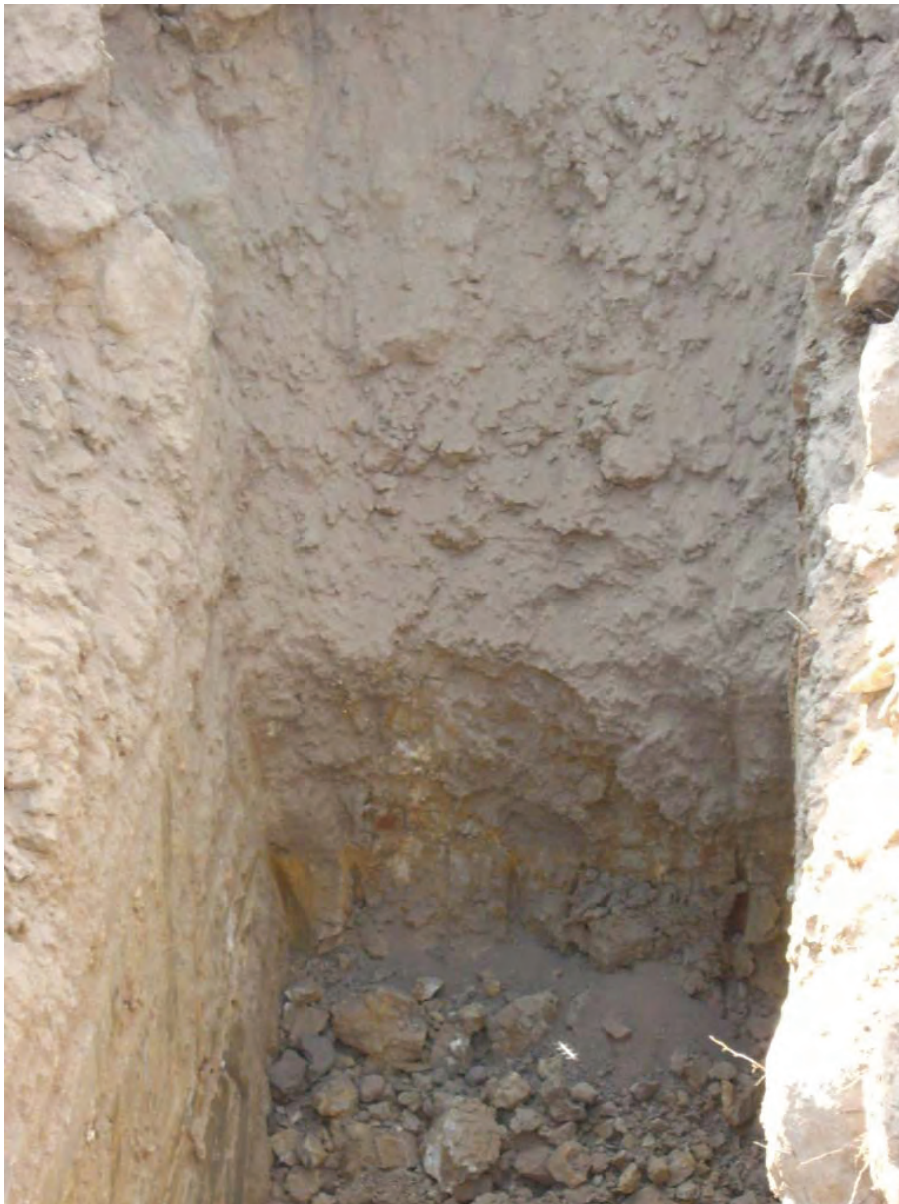
Figure 1228

Description
Test pit excavation exposing Brown Sodosol soil profile (TU IVd; Braemar (shallow) LRA soil type)

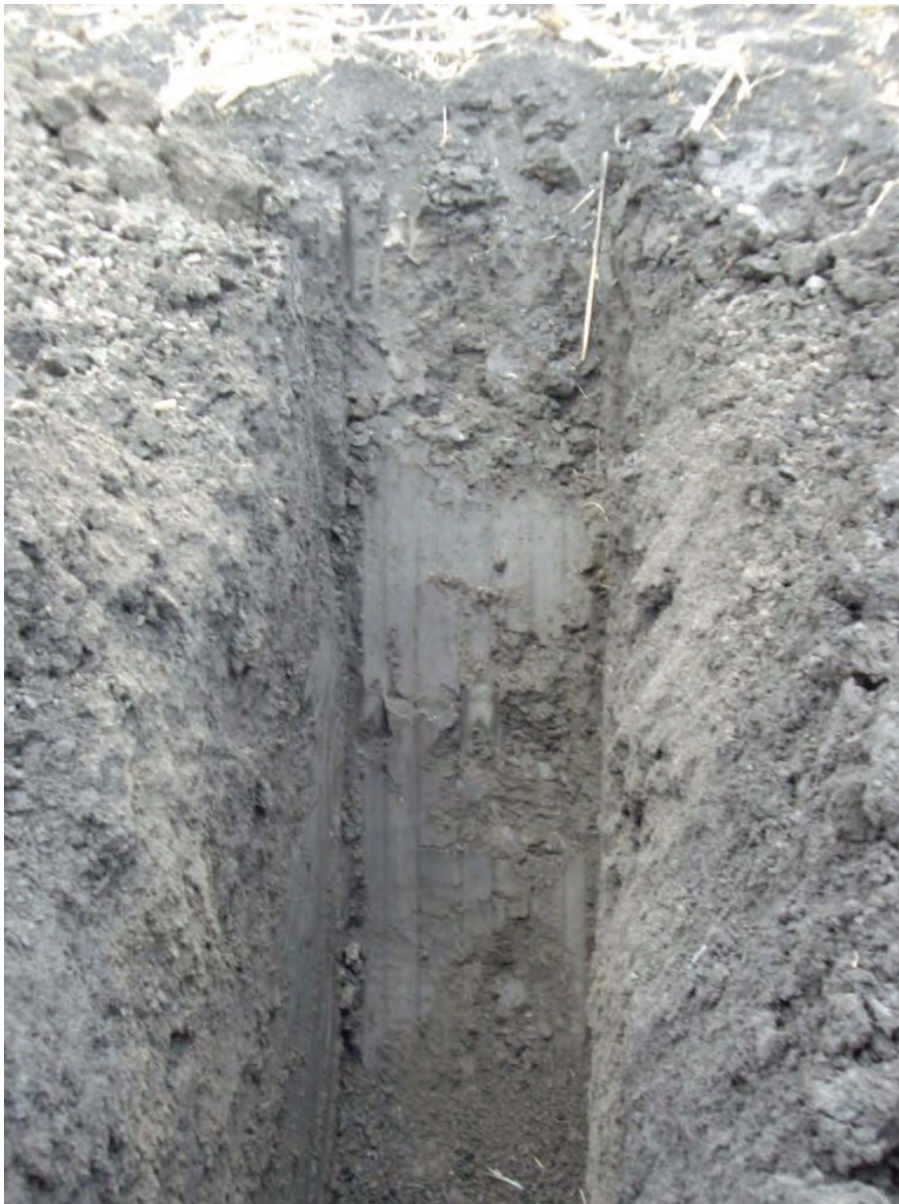
Figure 1329

Description
Test pit excavation exposing Black Vertosol soil profile (TU 1b; Mywybilla LRA soil type)

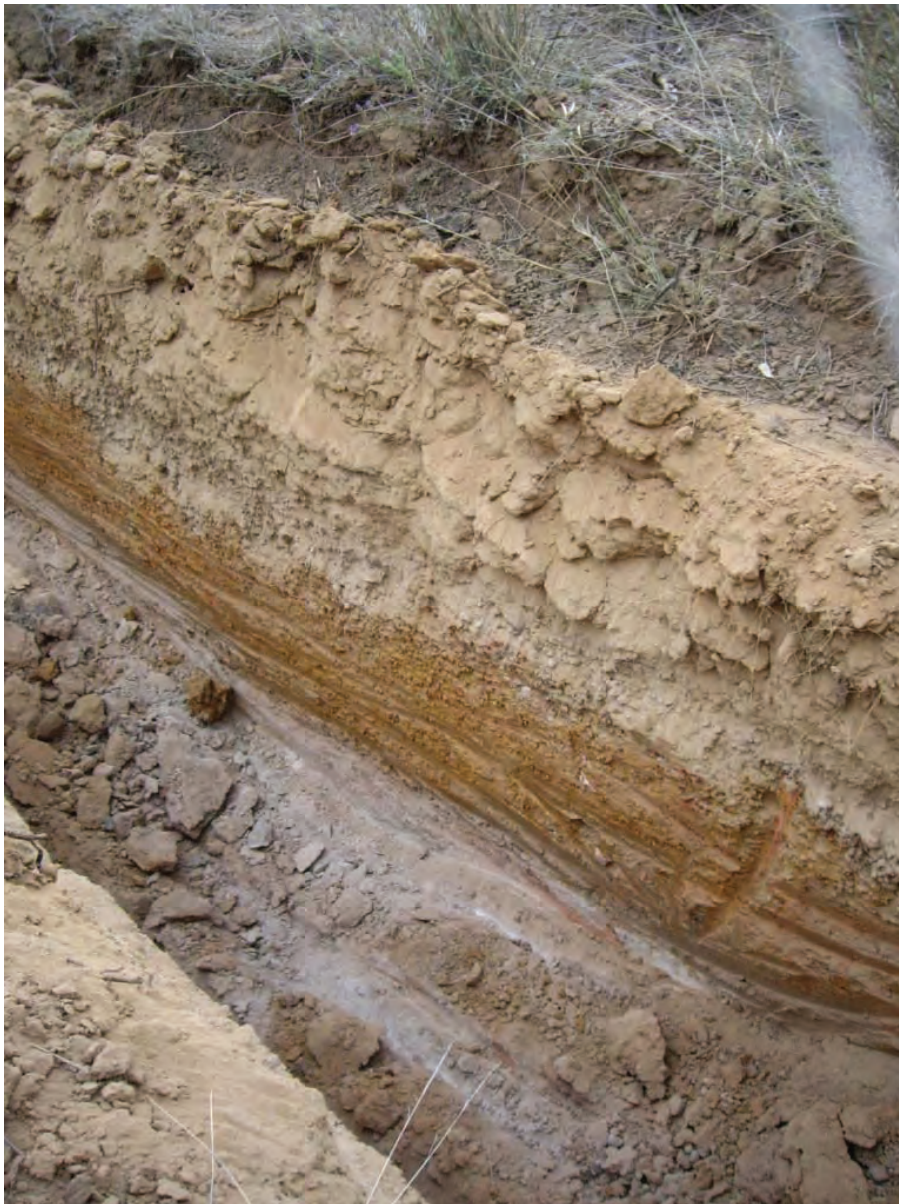
Figure 1430

Description
Test pit excavation exposing Yellow Chromosol soil profile (TU IVa; Cutthroat LRA soil type)

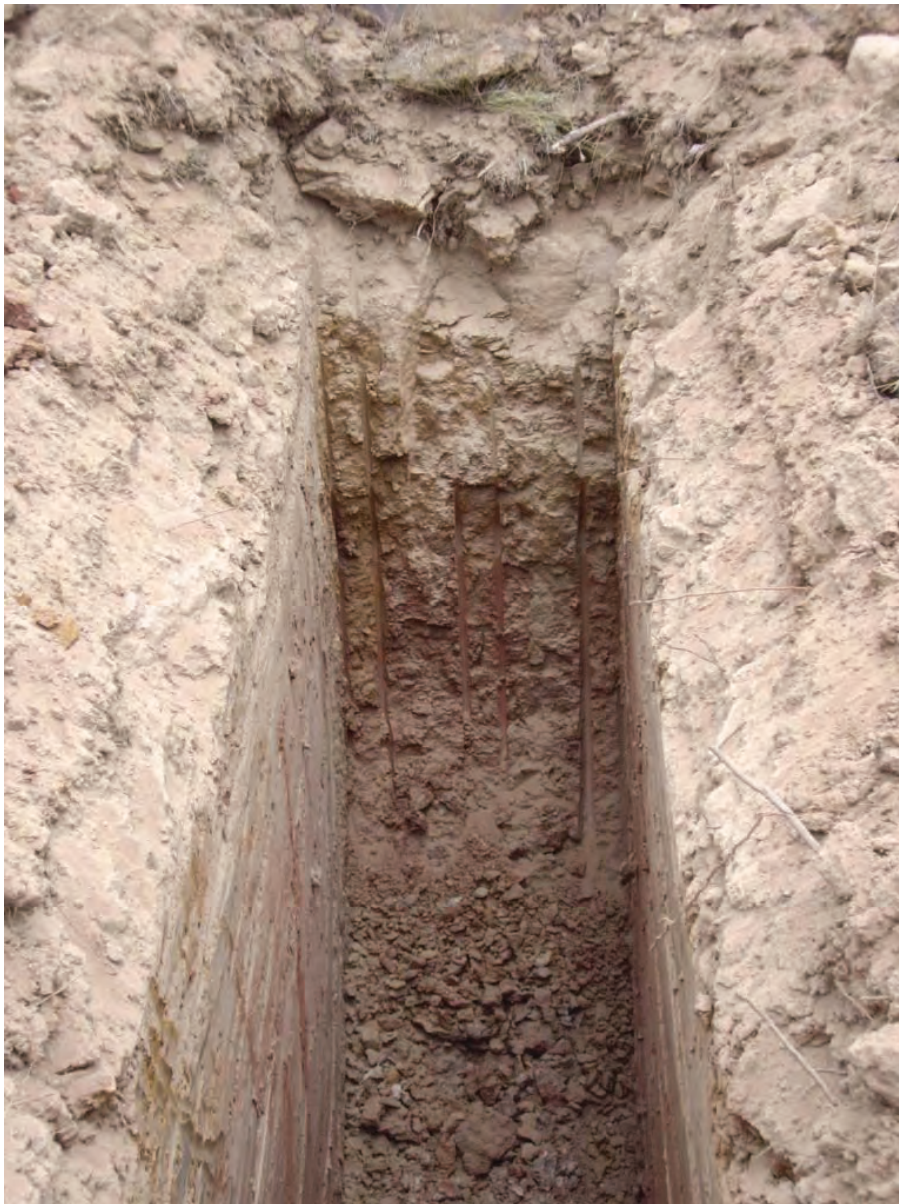
Figure 1531

Description
Test pit excavation exposing Red Chromosol soil profile (TU IIb; Leyburn LRA soil type)

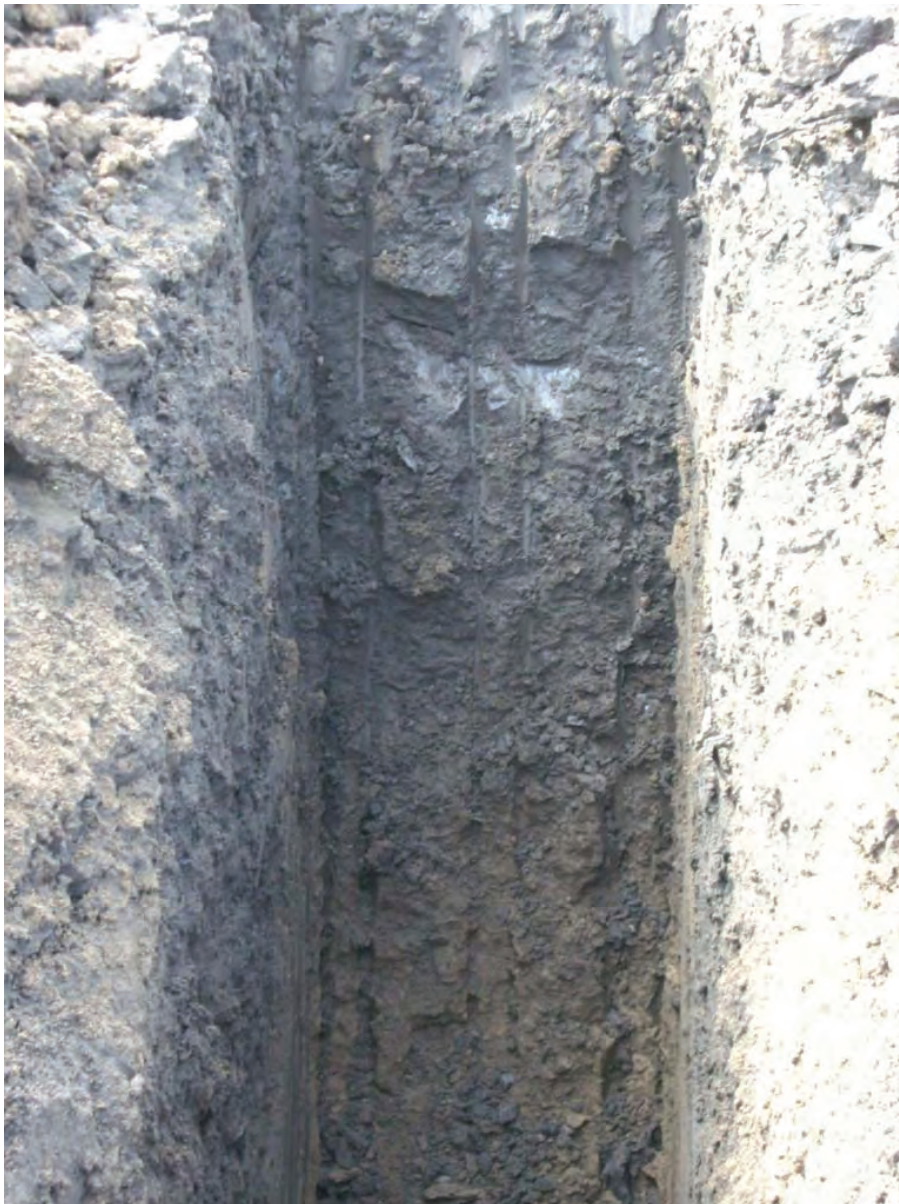
Figure 1632

Description
Test pit excavation exposing Black Vertosol soil profile (TU 1a; Condamine LRA soil type)

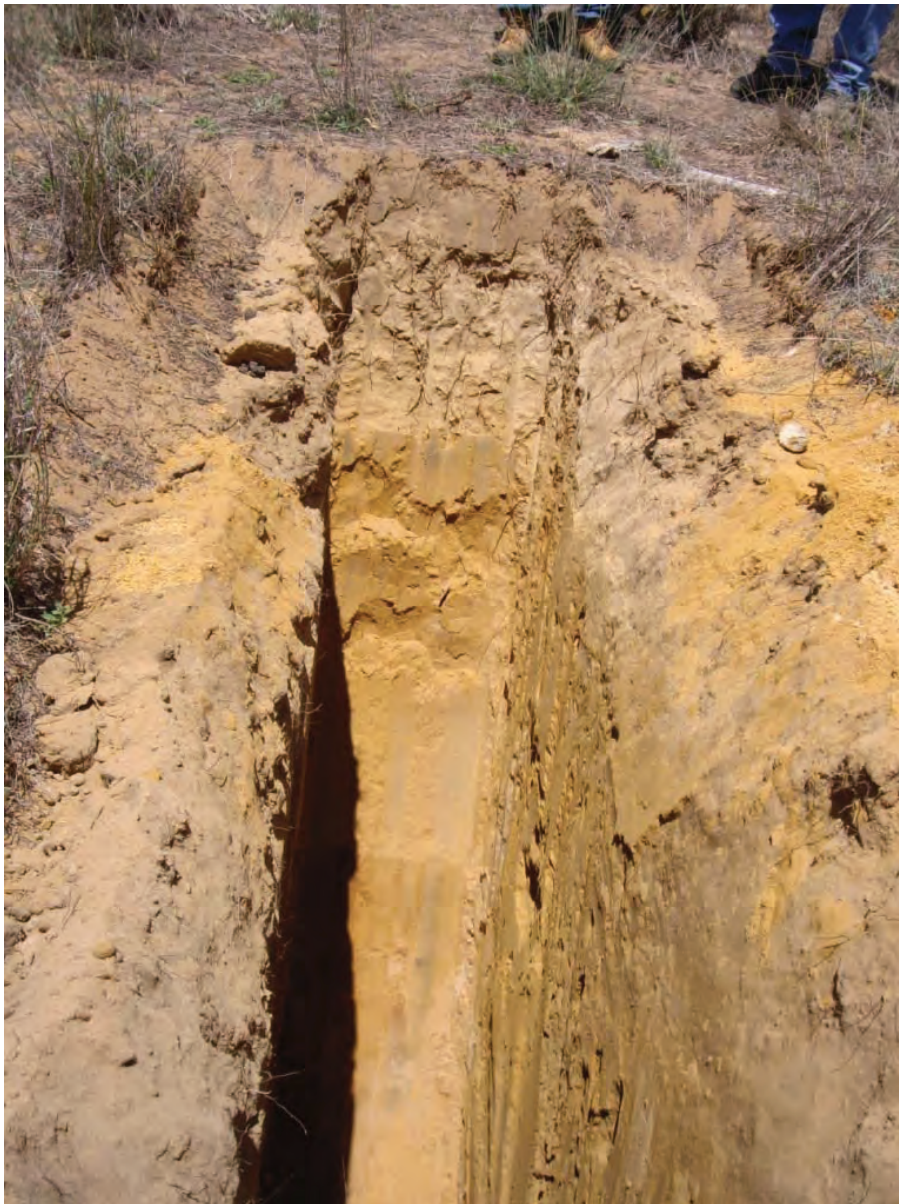
Figure 1733

Description
Test pit excavation exposing Yellow Tenosol soil profile (TU 1lb; Marella LRA soil type)

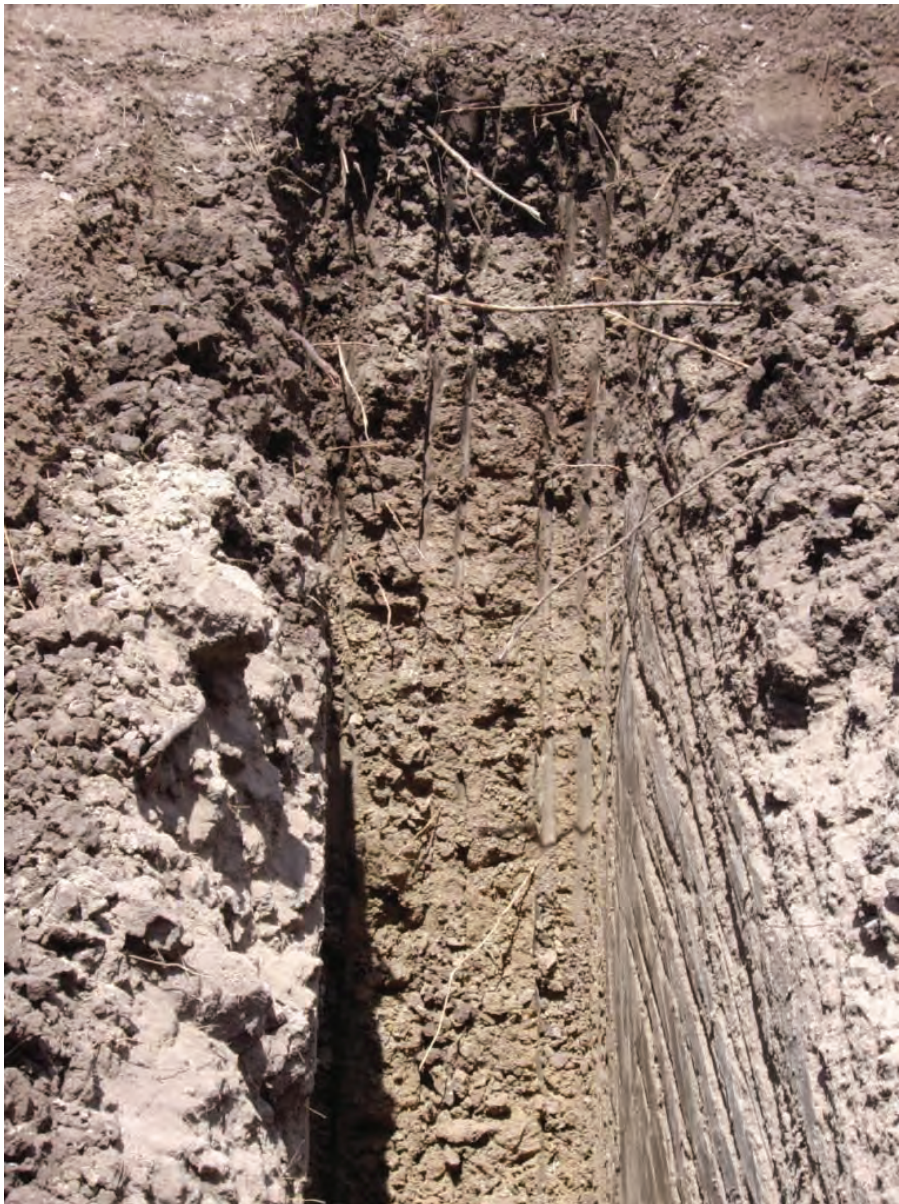
Figure 1834

Location ID	Feature/Exposure Type	Location Co-ordinates		
		Zone	Easting	Northing
CTP16	Grey Vertosol Profile		0275688	6857279

Description
Test pit excavation exposing Grey Vertosol soil profile (TU Illb; Calingunee LRA soil type)

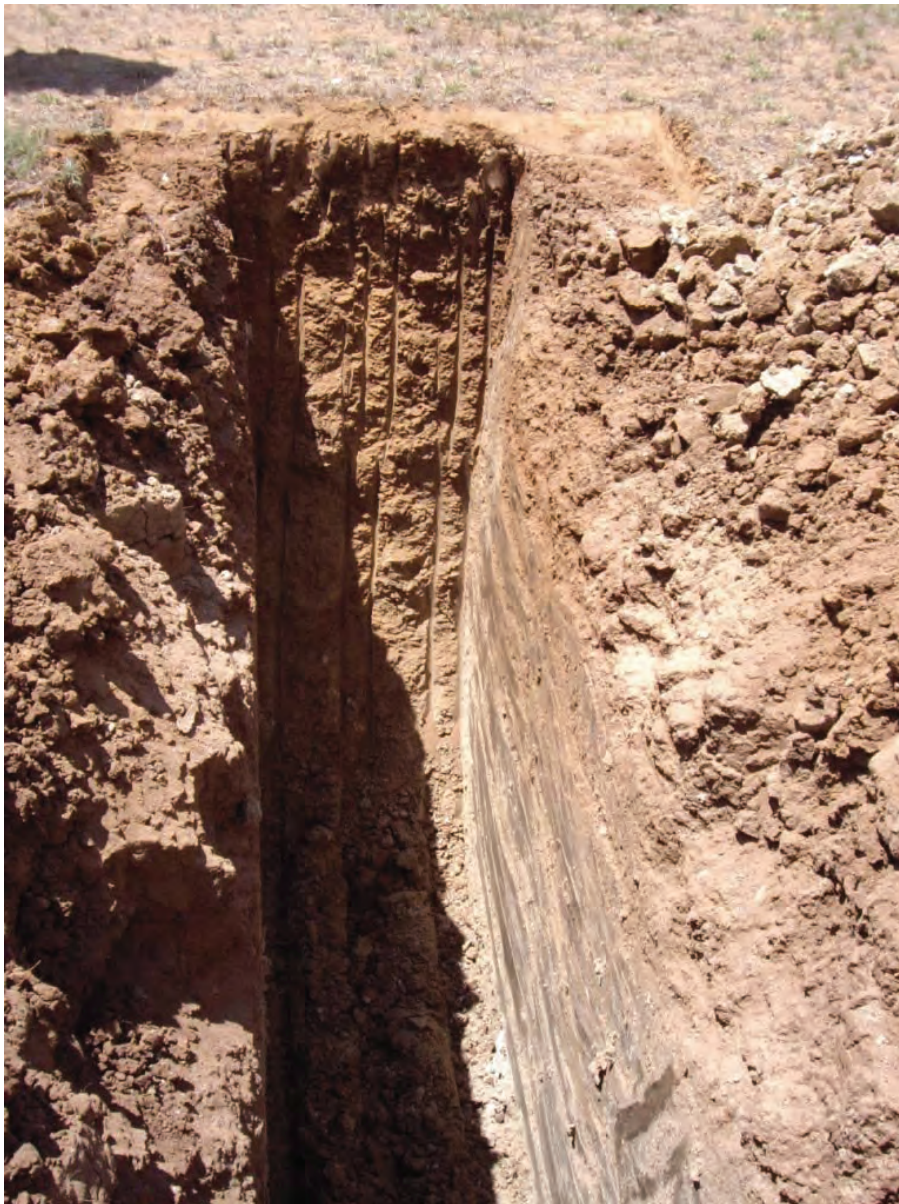
Figure 1935

Location ID	Feature/Exposure Type	Location Co-ordinates		
		Zone	Easting	Northing
CTP17	Grey Vertosol Profile		0266038	6861232

Description
Test pit excavation exposing Red Sodosol soil profile (TU IIa; Murra Cul Cul LRA soil type)
